# LEAD CAMES OF A STAINED GLASS WINDOW 52583 – PB SB ALLOY – UNKNOWN – SWITZERLAND

**Artefact name** Lead comes of a stained glass window 52583

**Authors** Alice Gerber. (Haute École Arc Neuchâtel, Neuchâtel, Neuchâtel, Switzerland)

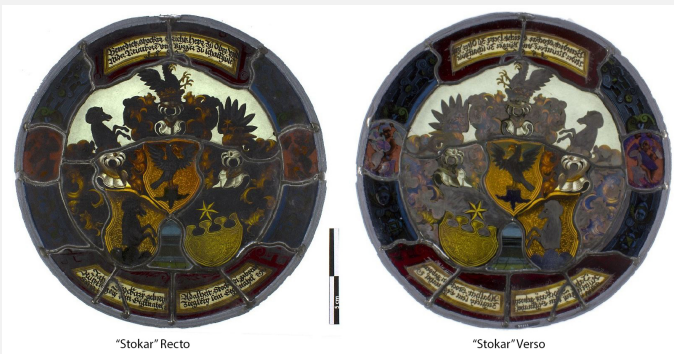
Fig. 1: Stained glass panel "Stokar" both sides,

The object is made of incolor and colored glass (light blue, pink and red) decored with grisaille, silver yellow stain and blue enamel. The glass parts are crimped with lead-alloy comes. The comes are fastened to one another by welding points of a lead-tin alloy on both side of the panel (Fig. 1).

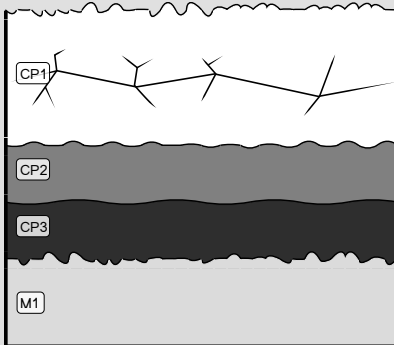
Fig. 4: Stratigraphic representation of the corrosion structure of the lead came observed macroscopically under binocular microscope using the MiCorr application. The characteristics of the strata are only accessible by clicking on the drawing that redirects you to the search tool by stratigraphy representation, Credit HE-Arc CR, A.Gerber.

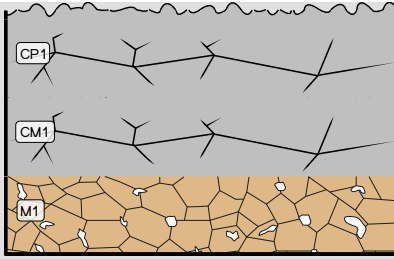
Fig. 10: Stratigraphic representation of the lead came in cross-section (dark field) using the MiCorr application with reference to Fig. 8. The characteristics of the strata are only accessible by clicking on the drawing that redirects you to the search tool by stratigraphy representation, Credit HE-Arc CR, A.Gerber.
