# LEAD CAMES OF A STAINED GLASS WINDOW 52583 - PB SB ALLOY - UNKNOWN - SWITZERLAND

**Artefact name** Lead cames of a stained glass window 52583

**Authors** Alice Gerber. (Haute École Arc Neuchâtel, Neuchâtel, Neuchâtel, Switzerland)

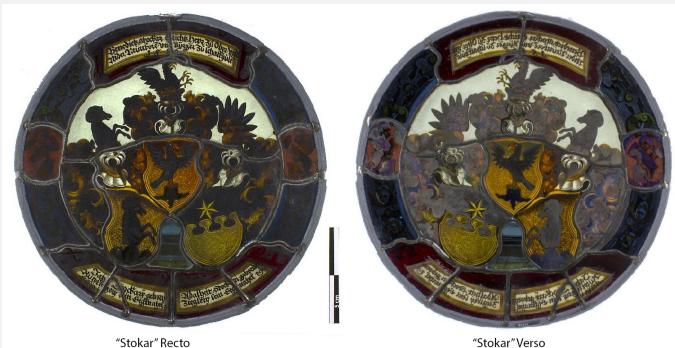
Fig. 1: Stained glass panel "Stokar" both sides,

The object is made of incolor and colored glass (light blue, pink and red) decored with grisaille, silver yellow stain and blue enamel. The glass parts are crimped with lead-alloy cames. The cames are fastened to one another by welding points of a lead-tin alloy on both side of the panel (Fig. 1).

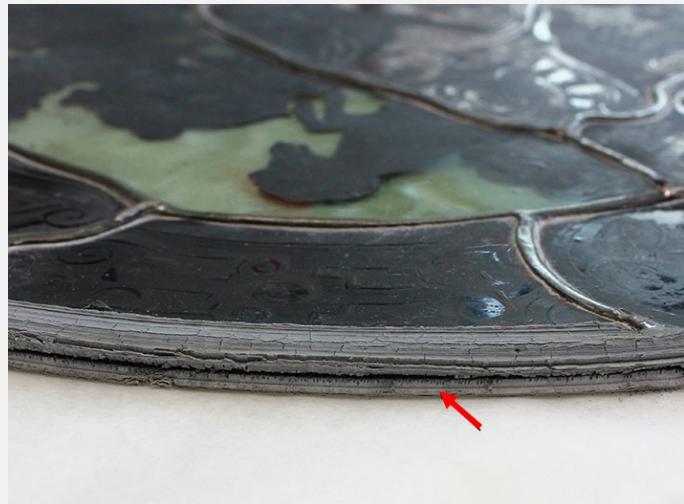
The "stokar" window, which is of interest here, was restored in 2008, just before it was put on display. The restoration consisted of replacing some of the lead cames. Thus, while the object is dated to the 16th century, the replaced cames were new when they entered the display case. In 2018, they were completely corroded. In comparison, the other stained glass panel, with older lead cames, was placed in the same display case at the same time. For this second panel, the cames are slightly corroded in 2018, but not as badly as those of the 'Stokar' panel. The metal chosen by the restorer reacted more strongly with the corrosive environment (the display case) than the historical metal.

Fig. 2: Corroded "modern" lead came on the "Stokar" stained glass panel with location of the sampling area,

The sample is a piece of metal taken from the corroded lead came of the stained glass (Fig. 2). This came was replaced during the 2009 restoration. The purpose was to understand why this new metal has been completely corroded in a few years (Fig. 2, 3 and 5), while the historical metal next to it is not affected at all.

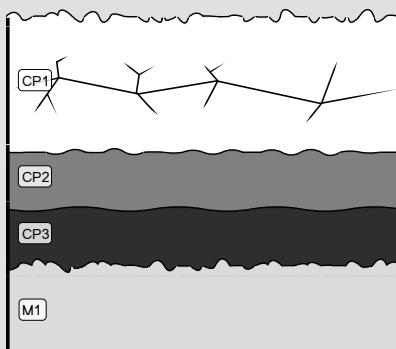
Fig. 4: Stratigraphic representation of the corrosion structure of the lead came observed macroscopically under binocular microscope using the MiCorr application. The characteristics of the strata are only accessible by clicking on the drawing that redirects you to the search tool by stratigraphy representation, Credit HE-Arc CR, A.Gerber.

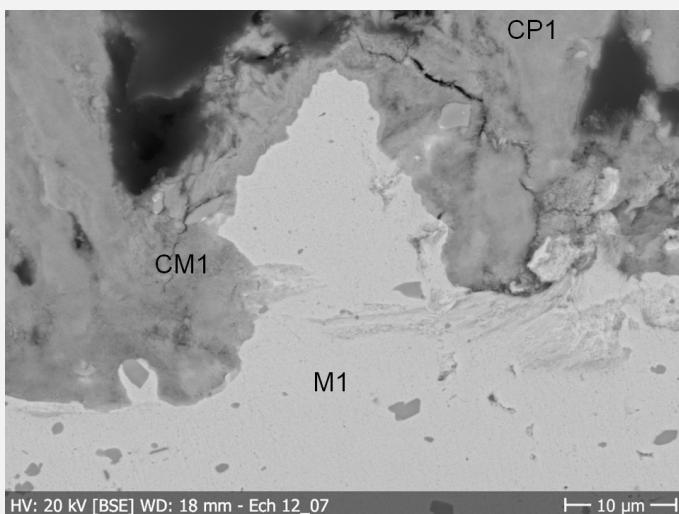
Corrosion develops specifically on cames made of a lead-antimony alloy, where antimony inclusions constitute the cathode (0.150 V/SHE) versus lead (-0.125 V/SHE) which corrodes as an anode in presence of lead acetate (the electrolyte). Fig. 8 shows that corrosion does not attack the antimony nodules in the alloy, it progresses by mineralizing the lead around these nodules.

Fig. 8: SEM image (BSE mode) of a detail of the cross-section of the corroded lead came. The area in light grey is the metal, the corrosion is in darker grey with a blurred appearance. Sb-dots are dark grey. Corrosion progresses around them, without mineralising them,

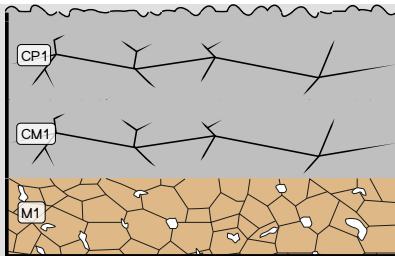
Fig. 10: Stratigraphic representation of the lead came in cross-section (dark field) using the MiCorr application with reference to Fig. 8. The characteristics of the strata are only accessible by clicking on the drawing that redirects you to the search tool by stratigraphy representation, Credit HE-Arc CR, A.Gerber.

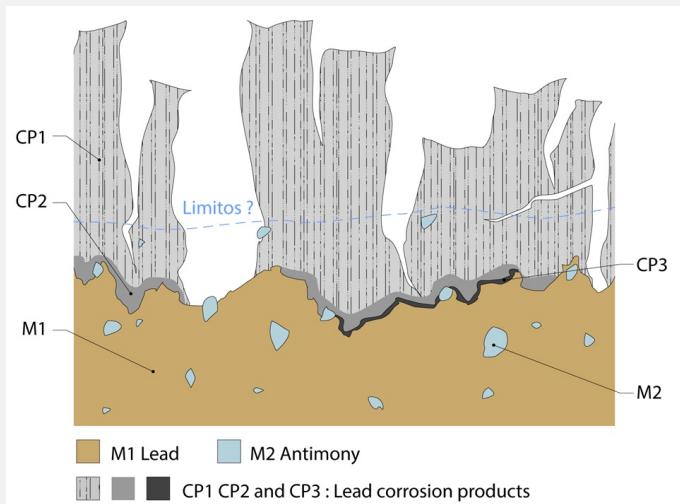
Fig. 11 shows an optimised stratigraphic representation of the corrosion structure. It is to be noted that CP1, CP2 and CP3 although visible on some cross-sections (Fig. 9) could not be differentiated by analysis.

The limit of the original surface lies somewhere in the corrosion layers. Antimony nodules are inferior markers of the limit of the original surface.

Fig. 11: Optimised stratigraphic representation of a corroded lead came integrating additional information based on the analyses carried out,
