LEAD CAMES OF A STAINED GLASS WINDOW 52583 – PB SB ALLOY – UNKNOWN – SWITZERLAND

Artefact name Lead comes of a stained glass window 52583

Authors Alice Gerber. (Haute École Arc Neuchâtel, Neuchâtel, Neuchâtel, Switzerland)

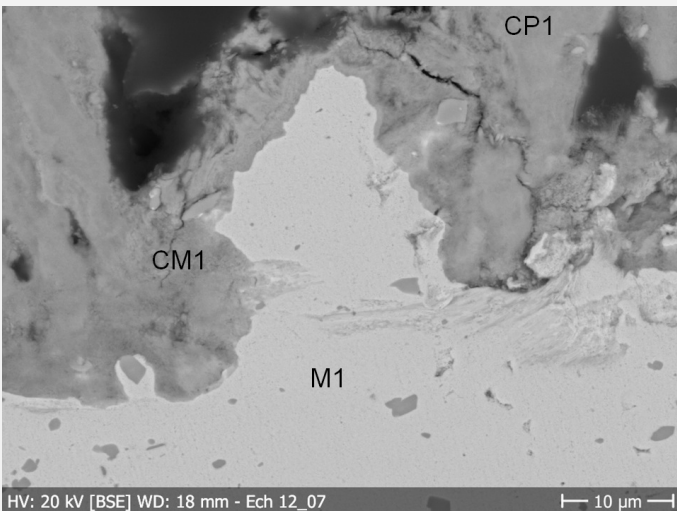
Corrosion develops specifically on comes made of a lead-antimony alloy, where antimony inclusions constitute the cathode (0.150 V/SHE) versus lead (-0.125 V/SHE) which corrodes as an anode in presence of lead acetate (the electrolyte). Fig. 8 shows that corrosion does not attack the antimony nodules in the alloy, it progresses by mineralizing the lead around these nodules.

Fig. 8: SEM image (BSE mode) of a detail of the cross-section of the corroded lead came. The area in light grey is the metal, the corrosion is in darker grey with a blurred appearance. Sb-dots are dark grey. Corrosion progresses around them, without mineralising them,
