# LEAD CAMES OF A STAINED GLASS WINDOW 52583 – PB SB ALLOY – UNKNOWN – SWITZERLAND

**Artefact name** Lead comes of a stained glass window 52583

**Authors** Alice Gerber. (Haute École Arc Neuchâtel, Neuchâtel, Neuchâtel, Switzerland)

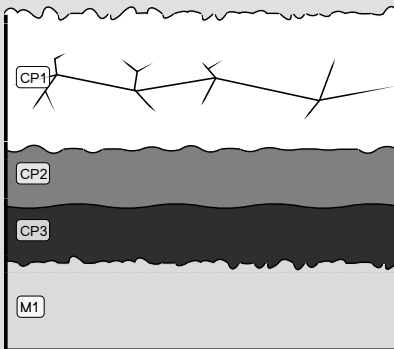
Fig. 4: Stratigraphic representation of the corrosion structure of the lead came observed macroscopically under binocular microscope using the MiCorr application. The characteristics of the strata are only accessible by clicking on the drawing that redirects you to the search tool by stratigraphy representation, Credit HE-Arc CR, A.Gerber.

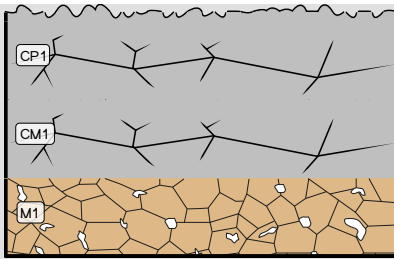
Fig. 10: Stratigraphic representation of the lead came in cross-section (dark field) using the MiCorr application with reference to Fig. 8. The characteristics of the strata are only accessible by clicking on the drawing that redirects you to the search tool by stratigraphy representation, Credit HE-Arc CR, A.Gerber.
