FUNERAL MASK IVC 11595 – CU/AG, WITH SURFACE ENRICHMENT (AG) – UNKNOWN – PERU

Artefact name	Funeral mask Ivc 11595
Authors	Christian. Degrygn (HE-Arc CR, Neuchâtel, Neuchâtel, Switzerland) & Naima. Gutknecht (HE-Arc CR, Neuchâtel, Neuchâtel, Switzerland) & Valentin. Boissonnas (HE-Arc CR, Neuchâtel, Neuchâtel, Switzerland)
Url	/artefacts/1582/

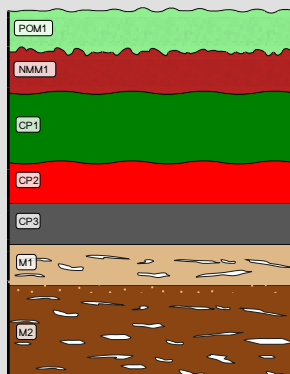
Fig. 15: Stratigraphic representation of the cross-section (dark field) from Figs. 3a or 4 (front of the object) using the MiCorr application. The characteristics of the strata are only accessible by clicking on the drawing that redirects you to the search tool by stratigraphy representation, Credit HE-Arc CR, N. Gutknecht.

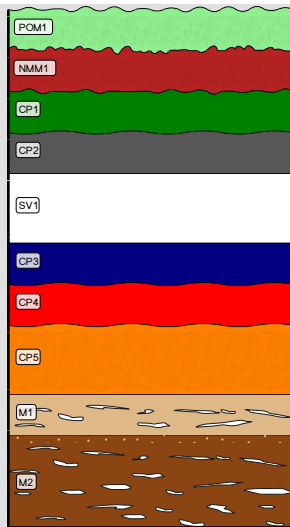
Fig. 16: Stratigraphic representation of the cross-section (dark field) from Figs. 3b and 4 (back of the object) using the MiCorr application. CP2 is CP3 while CP3 is CP4 and CP4 is CP2 in Fig. 3b. The characteristics of the strata are only accessible by clicking on the drawing that redirects you to the search tool by stratigraphy representation, Credit HE-Arc CR, N. Gutknecht.
