FUNERAL MASK IVC 11595 – CU/AG, WITH SURFACE ENRICHMENT (AG) – UNKNOWN – PERU

Artefact name	Funeral mask Ivc 11595
Authors	Christian. Degrygn (HE-Arc CR, Neuchâtel, Neuchâtel, Switzerland) & Naima. Gutknecht (HE-Arc CR, Neuchâtel, Neuchâtel, Switzerland) & Valentin. Boissonnas (HE-Arc CR, Neuchâtel, Neuchâtel, Switzerland)
Url	/artefacts/1582/

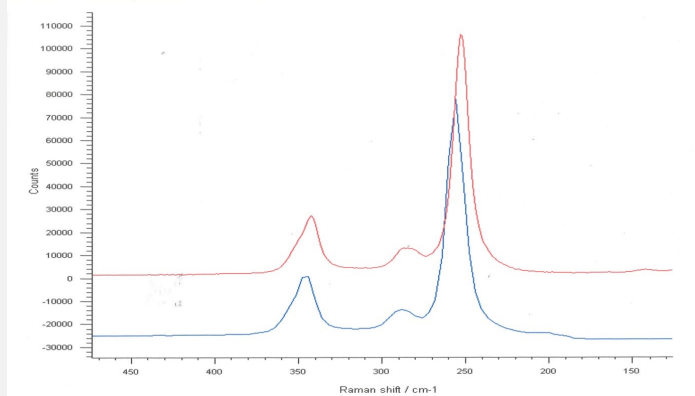
The silver sulphide (HgS, cinnabar, Fig. 13), present as a red pigment on the silver surface, could have been reduced through an electrochemical process in the presence of chlorides (Keune 2005). The released sulfur recombined with the silver to form black silver sulphide. Above that layer a porous mercury- and silver rich stratum has formed (see Hg & Ag on cartography Fig. 8). It remains unclear if the limitos is located in the silver enriched surface or within this silver-mercury compound (Fig. 7).

Fig. 13: Raman analysis of the red pigment on the surface (red line) and the references for cinnabar (blue line). Method of analysis: Raman spectroscopy, HKB,

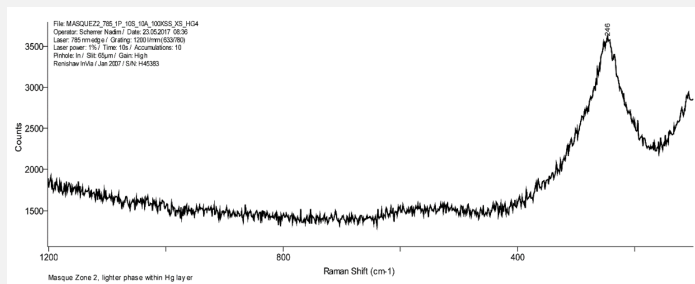
Fig. 14: Raman analysis of the mercury compounds from the cross section. Method of analysis: Raman spectroscopy, HKB,
