FUNERAL MASK IVC 11595 – CU/AG, WITH SURFACE ENRICHMENT (AG) – UNKNOWN – PERU

Artefact name	Funeral mask Ivc 11595
Authors	Christian. Degrygn (HE-Arc CR, Neuchâtel, Neuchâtel, Switzerland) & Naima. Gutknecht (HE-Arc CR, Neuchâtel, Neuchâtel, Switzerland) & Valentin. Boissonnas (HE-Arc CR, Neuchâtel, Neuchâtel, Switzerland)
Url	/artefacts/1582/

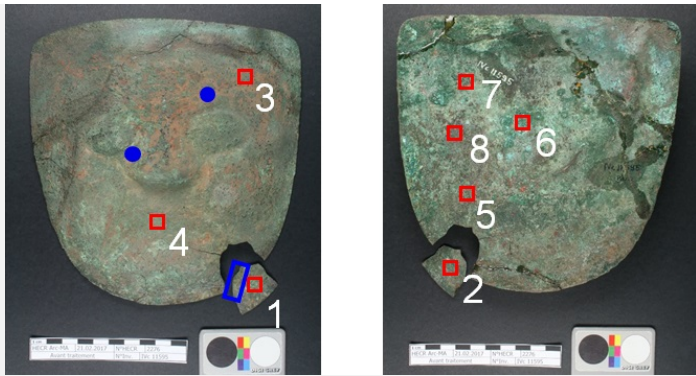
Fig. 2: Front (left) and back (right) faces showing the location of XRF analyses (red squares), sampling areas for SEM-EDS (blue points) and sampling area for examination on cross-section (blue rectangle),

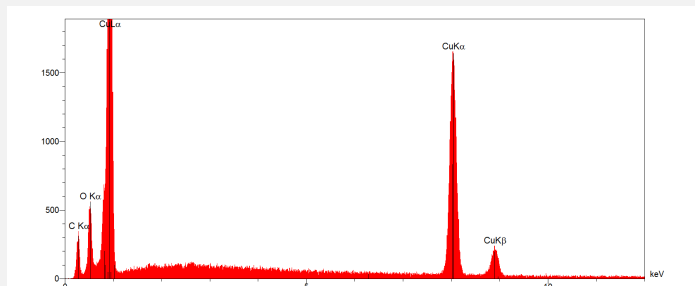
Fig. 12: EDS analysis of the red surface pigment from a surface sample. Method of analysis: SEM-EDS, Lab of Electronic Microscopy and Microanalysis, IMA (Néode), HEI Arc,

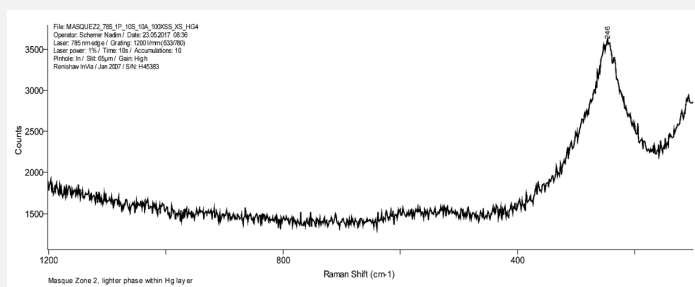
Fig. 14: Raman analysis of the mercury compounds from the cross section. Method of analysis: Raman spectroscopy, HKB,

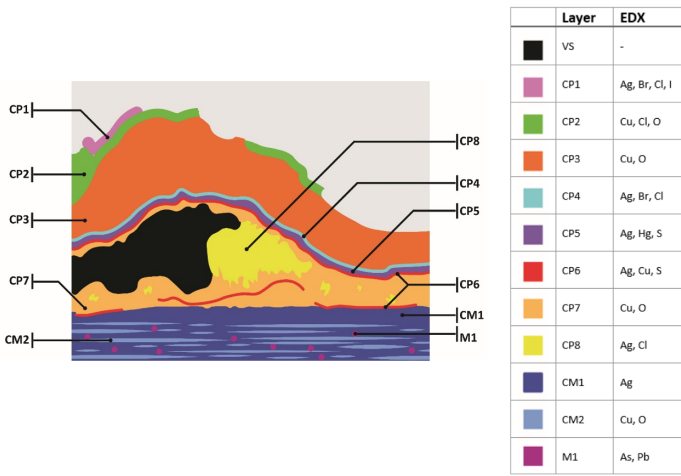
Fig. 17: Improved stratigraphic representation of the funeral mask (Fig. 3) based on the results from the SEM-EDS analyses,
