COFFEE FILTER – AL ALLOY – MODERN TIMES – FRANCE

Artefact name	Coffee filter
Authors	Christian. Degriigny (HE-Arc CR, Neuchâtel, Neuchâtel, Switzerland)
Url	/artefacts/1586/

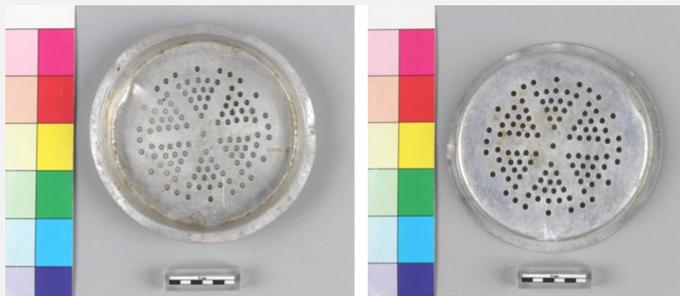
Fig. 1: Front and back sides of a coffee filter,

Description of the artefact	Coffee filter with traces of use (deposits, deformation) and presence of local filiform corrosion (Fig. 1). Dimensions: \varnothing .ext. = 10cm.
Type of artefact	Household implement
Origin	Château de Germolles, Mellecey, Bourgogne, France
Recovering date	Unknown
Chronology category	Modern Times
chronology tpq	<input type="text" value="1960"/> A.D. ∨
chronology taq	<input type="text" value="2000"/> A.D. ∨
Chronology comment	20th century
Burial conditions / environment	Outdoor atmosphere
Artefact location	Château de Germolles, Mellecey, Bourgogne
Owner	Château de Germolles, Mellecey, Bourgogne

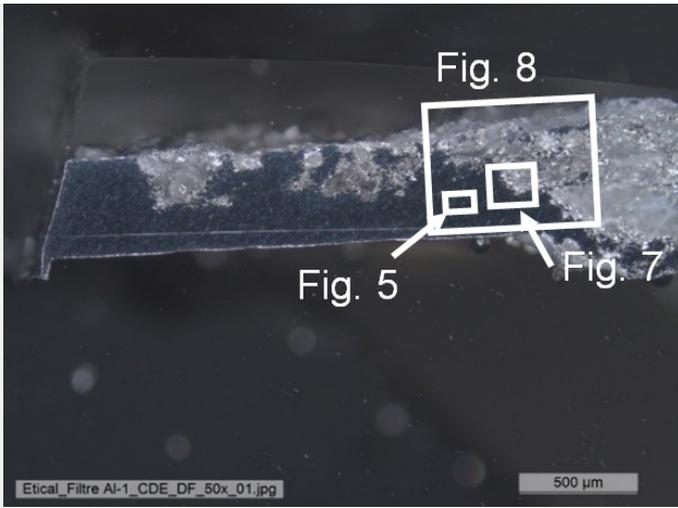
Fig. 4: Micrograph of the cross-section of the fragment sampled from the coffee filter showing the location of Figs. 5, 7 and 8, dark field,

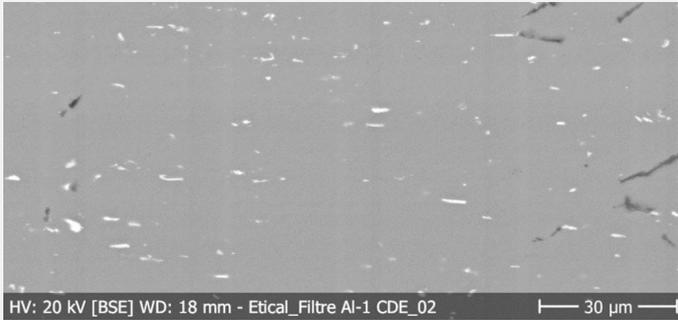
The metal is a relatively pure aluminium alloy with numerous elongated inclusions (Fig. 5). From their chemical composition they can be interpreted as Al_3Fe intermetallic compounds (Fig. 6). Inter- and transgranular corrosion has developed so extensively that some grains (not elongated) are outlined (Fig. 7).

Fig. 5: SEM image of the metal sample from Fig. 4 (detail), BSE-mode. We observe the presence of numerous elongated inclusions,

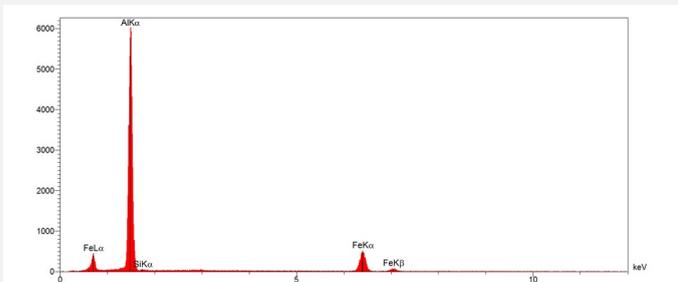
Fig. 6: EDS spectrum of the elongated white inclusions of Fig. 5,

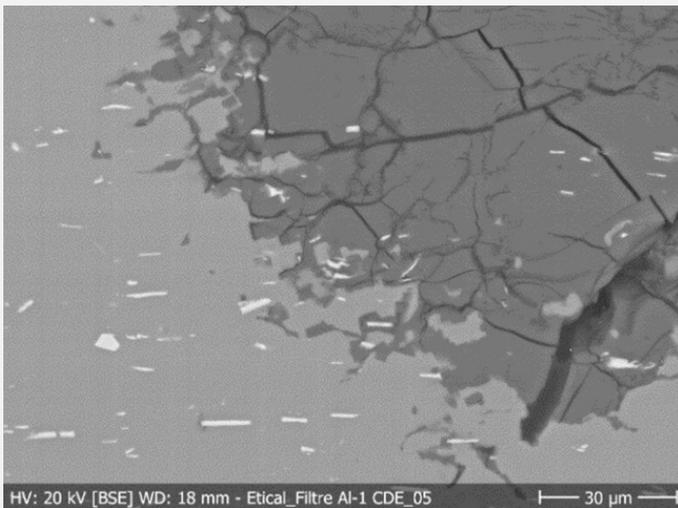
Fig. 7: SEM image of the metal sample from Fig. 4 (detail), BSE-mode. Extensive inter- and transgranular corrosion has developed within the metal,

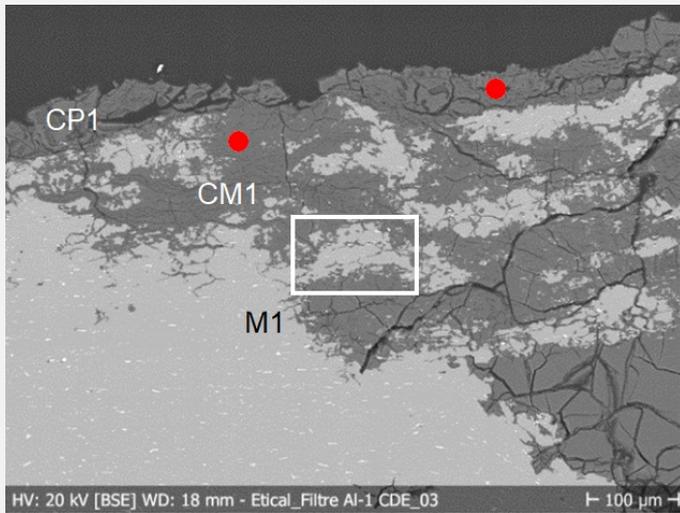
The average thickness of the corrosion layer (CP1) is about 50 micrometers, but may be thinner or thicker depending on the area. Intergranular corrosion developed locally to extend through the entire thickness of the metal. EDS-SEM analysis indicates that the metal is, as expected, covered by a layer rich in Al and O containing chlorides (red spots on Fig. 8) and surprisingly Na (white rectangle on Fig. 8, Figs. 9 and 10). Chlorides do not seem to form active corrosion. A new examination carried out after 4 months (Fig. 11) shows new forms of alteration with a local enrichment of Na, C and O (Na₂CO₃?).

Fig. 8: SEM picture (detail of Fig. 4 with location (red spots) of EDS analyses of Fig. 9), BSE-mode. From bottom to top left: the metal (M1) in light grey, the corroded metal (CM1) and CP1. The area selected for elemental chemical distributions (Figs. 10 and 11) is marked by a rectangle,

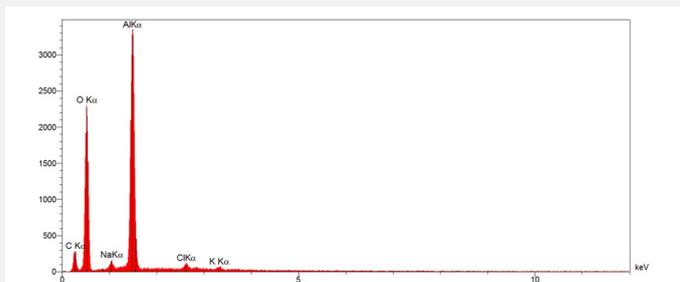
Fig. 9: EDS spectrum of red spots in Fig. 8,

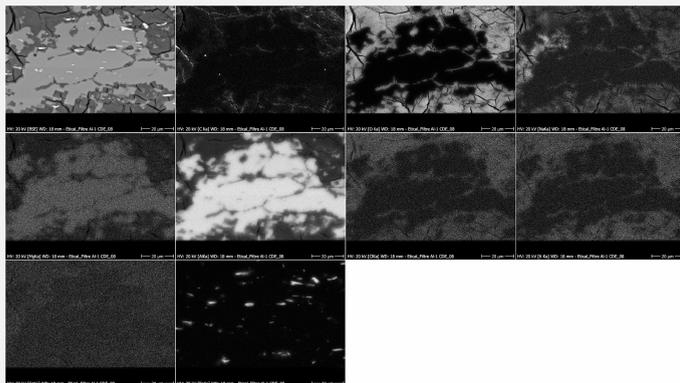
Fig. 10: SEM image, BSE-mode, and elemental chemical distribution of the selected area of Fig. 8. Method of examination: SEM-EDS, Lab of Electronic Microscopy and Microanalysis, IMA (Néode), HEI Arc,

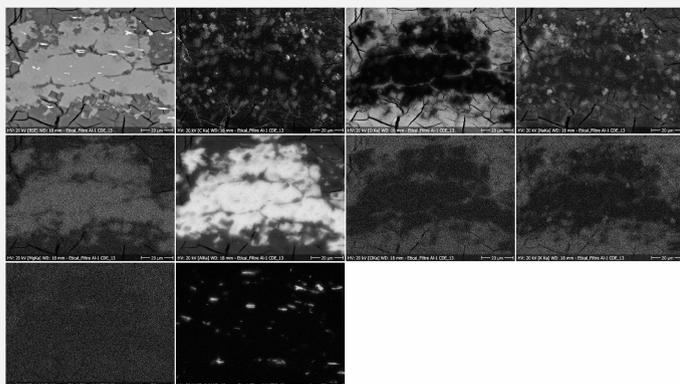
Fig. 11: SEM image, BSE-mode, and elemental chemical distribution of the selected area of Fig. 8 reexamined after 4 months: new forms of alteration with a local enrichment of Na, C and O are observed,

This aluminium alloy has a composition similar to a primary aluminium with an Al content between 99 and 99.8 mass%. The main impurity is Fe forming intermetallic (Al_3Fe) inclusions. The metal was stamped and punctured. It is locally covered by a relatively thick layer of corrosion (probably aluminium oxide) which has formed as a result of surface filiform corrosion which has degenerated into extensive intergranular corrosion. Chlorides have been identified but the progress of the corrosion might be due to Na, C and O-rich compounds ($Na_2CO_3?$).
