# COFFEE FILTER – AL ALLOY – MODERN TIMES – FRANCE

**Artefact name** Coffee filter

**Authors** Christian. Degriigny (HE-Arc CR, Neuchâtel, Neuchâtel, Switzerland)

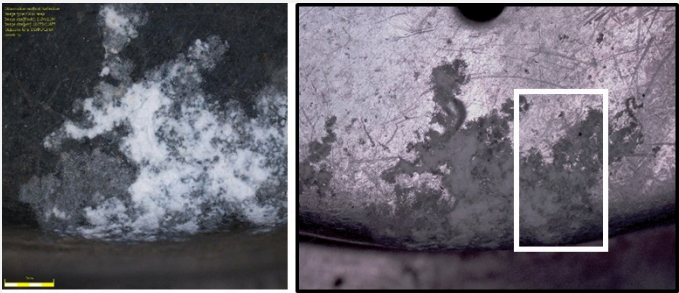
Fig. 3: Detail of the back side of the coffee filter showing the location of the sampling area (white rectangle),

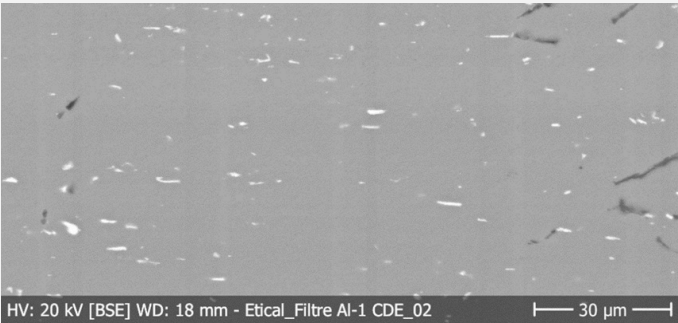
The metal is a relatively pure aluminium alloy with numerous elongated inclusions (Fig. 5). From their chemical composition they can be interpreted as Al<sub>3</sub>Fe intermetallic compounds (Fig. 6). Inter- and transgranular corrosion has developed so extensively that some grains (not elongated) are outlined (Fig. 7).

Fig. 5: SEM image of the metal sample from Fig. 4 (detail), BSE-mode. We observe the presence of numerous elongated inclusions,

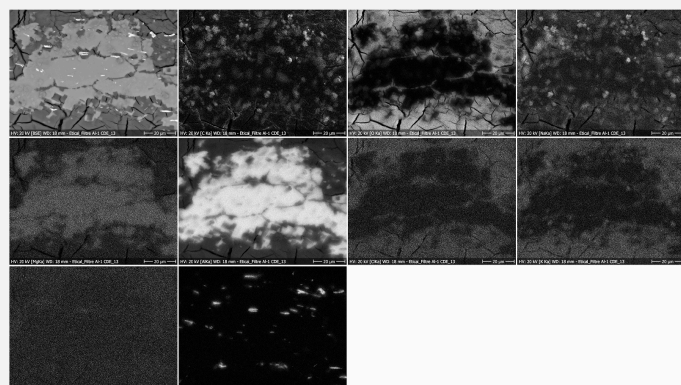
Fig. 11: SEM image, BSE-mode, and elemental chemical distribution of the selected area of Fig. 8 reexamined after 4 months: new forms of alteration with a local enrichment of Na, C and O are observed,
