# COFFEE FILTER – AL ALLOY – MODERN TIMES – FRANCE

**Artefact name** Coffee filter

**Authors** Christian. Degriigny (HE-Arc CR, Neuchâtel, Neuchâtel, Switzerland)

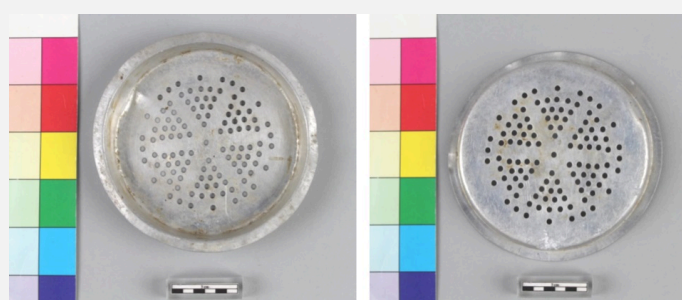
Fig. 1: Front and back sides of a coffee filter,

| <b>Description of the artefact</b> | Coffee filter with traces of use (deposits, deformation) and presence of local filiform corrosion (Fig. 1). Dimensions: ø.ext. = 10cm. |

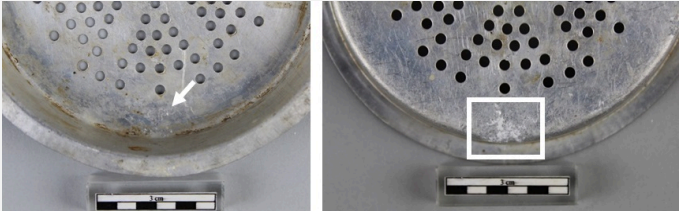
Fig. 2: Detail of the front (left) and back (right) sides of the coffee filter showing the location of Fig. 3,

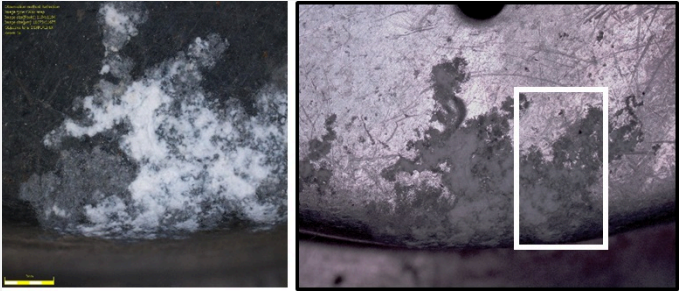
Fig. 3: Detail of the back side of the coffee filter showing the location of the sampling area (white rectangle),

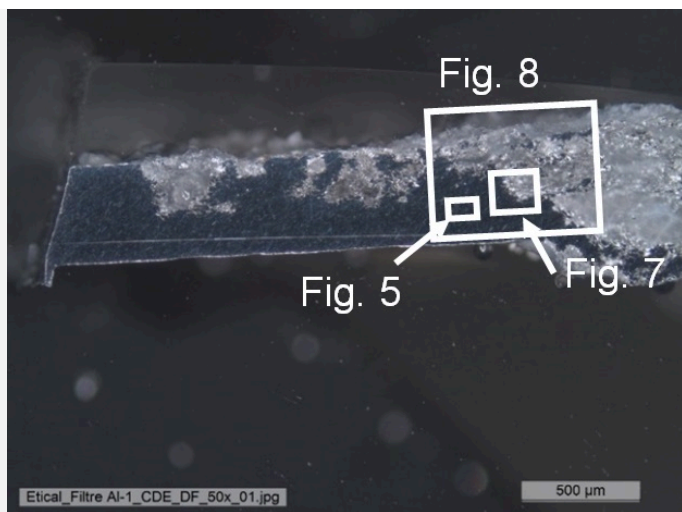
Fig. 4: Micrograph of the cross-section of the fragment sampled from the coffee filter showing the location of Figs. 5, 7 and 8, dark field,

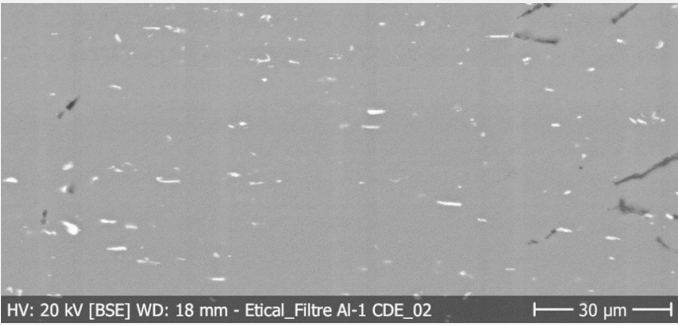
The metal is a relatively pure aluminium alloy with numerous elongated inclusions (Fig. 5). From their chemical composition they can be interpreted as Al<sub>3</sub>Fe intermetallic compounds (Fig. 6). Inter- and transgranular corrosion has developed so extensively that some grains (not elongated) are outlined (Fig. 7).

Fig. 5: SEM image of the metal sample from Fig. 4 (detail), BSE-mode. We observe the presence of numerous elongated inclusions,

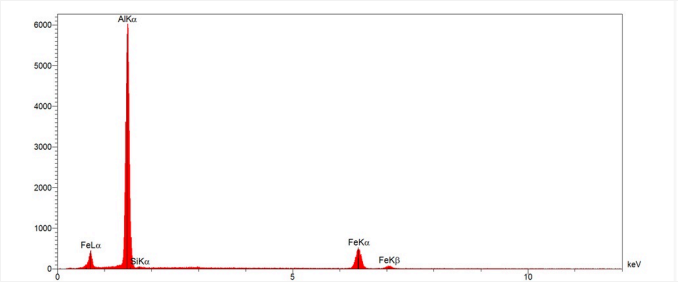
Fig. 6: EDS spectrum of the elongated white inclusions of Fig. 5,

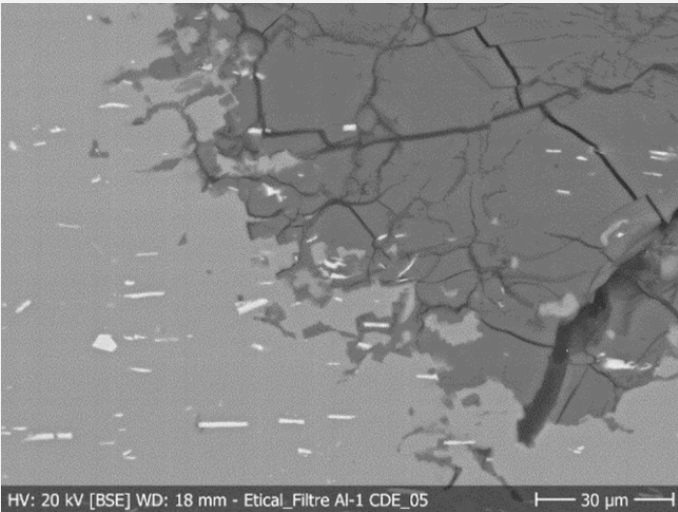
Fig. 7: SEM image of the metal sample from Fig. 4 (detail), BSE-mode. Extensive inter- and transgranular corrosion has developed within the metal,

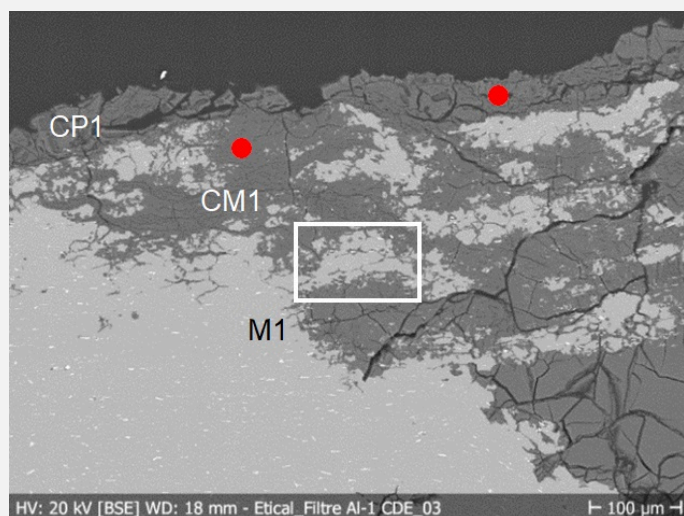
The average thickness of the corrosion layer (CP1) is about 50 micrometers, but may be thinner or thicker depending on the area. Intergranular corrosion developed locally to extend through the entire thickness of the metal. EDS-SEM analysis indicates that the metal is, as expected, covered by a layer rich in Al and O containing chlorides (red spots on Fig. 8) and surprisingly Na (white rectangle on Fig. 8, Figs. 9 and 10). Chlorides do not seem to form active corrosion. A new examination carried out after 4 months (Fig. 11) shows new forms of alteration with a local enrichment of Na, C and O ( $\text{Na}_2\text{CO}_3$ ?).

Fig. 8: SEM picture (detail of Fig. 4 with location (red spots) of EDS analyses of Fig. 9), BSE-mode. From bottom to top left: the metal (M1) in light grey, the corroded metal (CM1) and CP1. The area selected for elemental chemical distributions (Figs. 10 and 11) is marked by a rectangle,

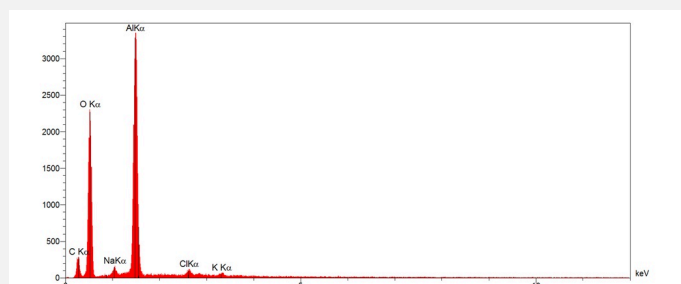
Fig. 9: EDS spectrum of red spots in Fig. 8,

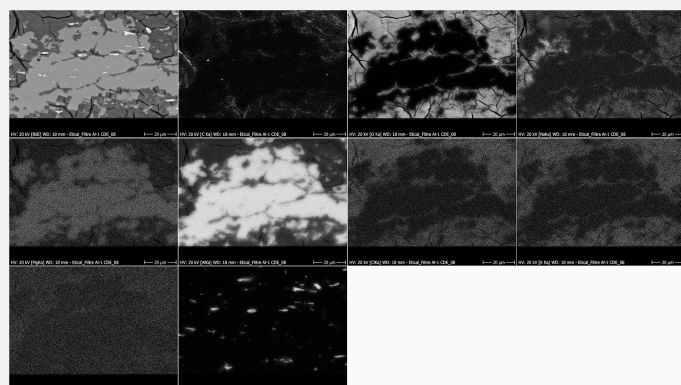
Fig. 10: SEM image, BSE-mode, and elemental chemical distribution of the selected area of Fig. 8. Method of examination: SEM-EDS, Lab of Electronic Microscopy and Microanalysis, IMA (Néode), HEI Arc,

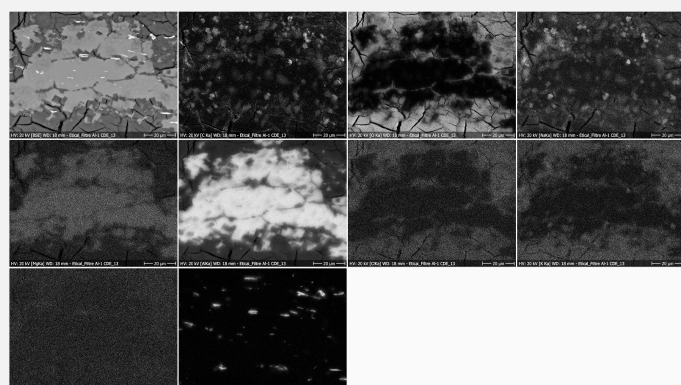
Fig. 11: SEM image, BSE-mode, and elemental chemical distribution of the selected area of Fig. 8 reexamined after 4 months: new forms of alteration with a local enrichment of Na, C and O are observed,
