# COFFEE FILTER – AL ALLOY – MODERN TIMES – FRANCE

**Artefact name** Coffee filter

**Authors** Christian. Degriigny (HE-Arc CR, Neuchâtel, Neuchâtel, Switzerland)

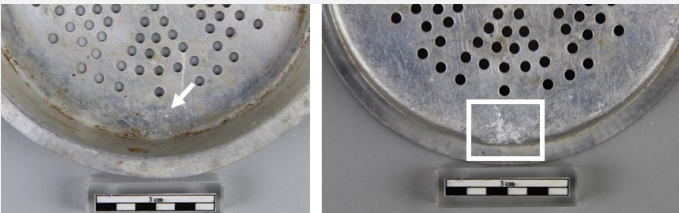
Fig. 2: Detail of the front (left) and back (right) sides of the coffee filter showing the location of Fig. 3,

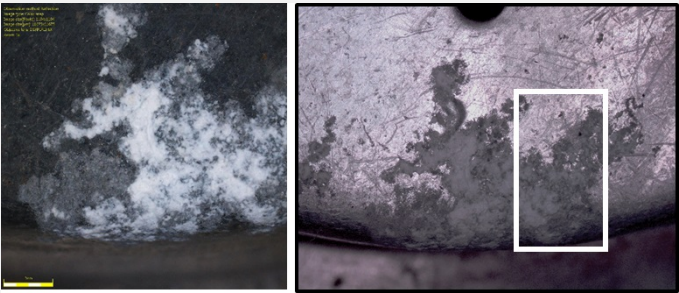
Fig. 3: Detail of the back side of the coffee filter showing the location of the sampling area (white rectangle),

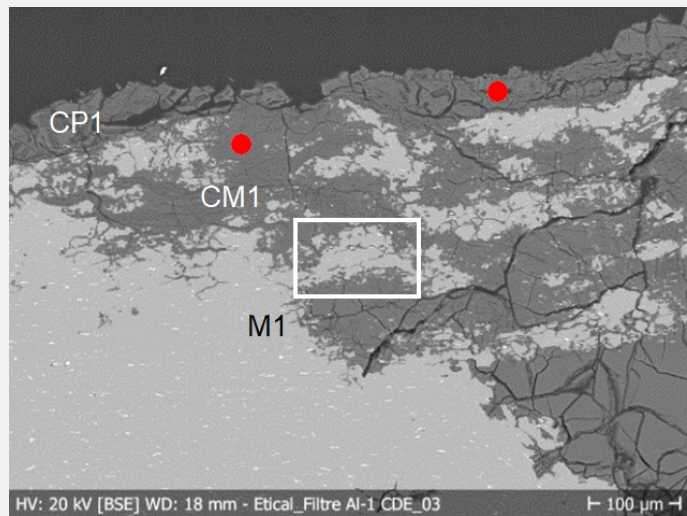
The average thickness of the corrosion layer (CP1) is about 50 micrometers, but may be thinner or thicker depending on the area. Intergranular corrosion developed locally to extend through the entire thickness of the metal. EDS-SEM analysis indicates that the metal is, as expected, covered by a layer rich in Al and O containing chlorides (red spots on Fig. 8) and surprisingly Na (white rectangle on Fig. 8, Figs. 9 and 10). Chlorides do not seem to form active corrosion. A new examination carried out after 4 months (Fig. 11) shows new forms of alteration with a local enrichment of Na, C and O (Na2CO3?).

Fig. 8: SEM picture (detail of Fig. 4 with location (red spots) of EDS analyses of Fig. 9), BSE-mode. From bottom to top left: the metal (M1) in light grey, the corroded metal (CM1) and CP1. The area selected for elemental chemical distributions (Figs. 10 and 11) is marked by a rectangle,

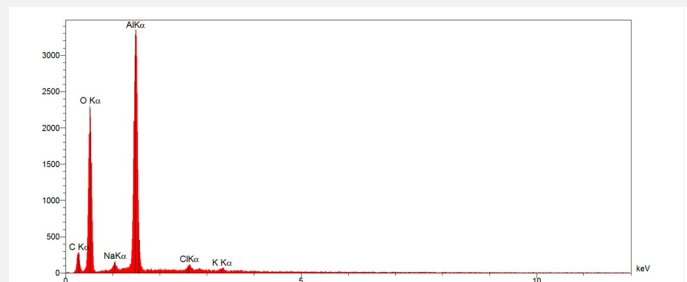
Fig. 9: EDS spectrum of red spots in Fig. 8,

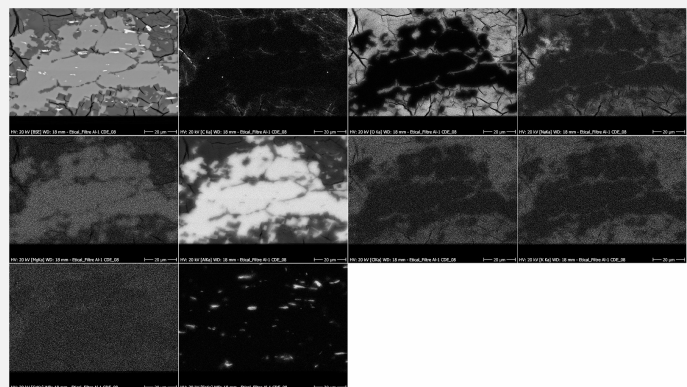
Fig. 10: SEM image, BSE-mode, and elemental chemical distribution of the selected area of Fig. 8. Method of examination: SEM-EDS, Lab of Electronic Microscopy and Microanalysis, IMA (Néode), HEI Arc,

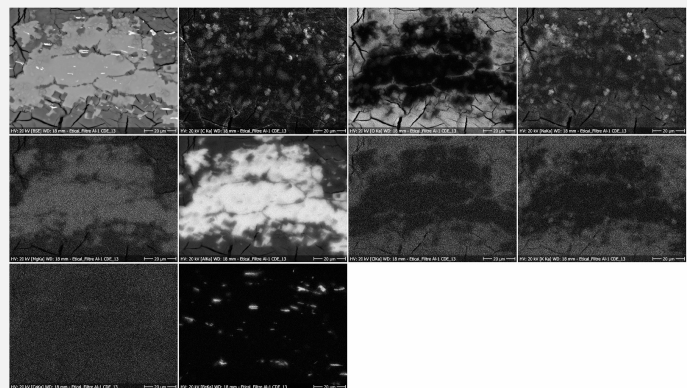
Fig. 11: SEM image,BSE-mode, and elemental chemical distribution of the selected area of Fig. 8 reexamined after 4 months: new forms of alteration with a local enrichment of Na, C and O are observed,
