# SWORD GRIP NG-1980-27-H-693 – LEADED BRASS – 18TH CENTURY – UNITED KINGDOM

| Artefact name | Sword grip NG-1980-27-H-693 |
| Authors | Amelia. Hammond (The Mariners' Museum and Park, Newport News, Virginia, United States) |

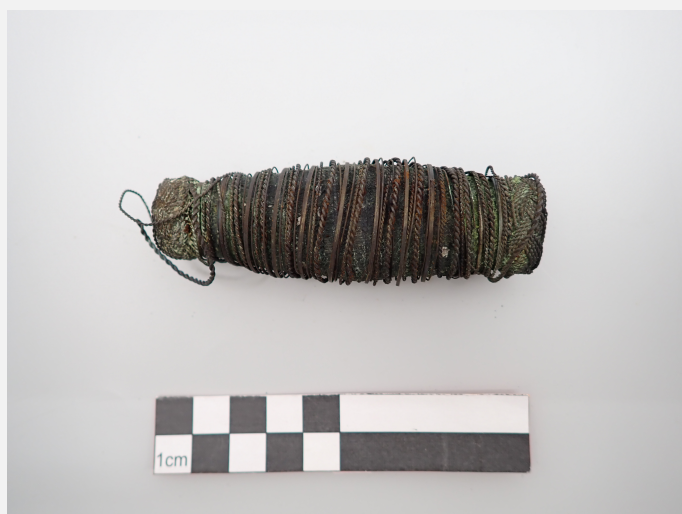
Fig. 1: Overview image of sword grip from the Hollandia shipwreck,

| Description of the artefact | This object is a sword grip, a composite object made from a wooden core with embedded leaded brass wire recovered from Hollandia, a Dutch East India Company ship. The wire is loose in some areas, and deeply embedded in others, with some periodic breakage throughout the piece. Some wire is twisted, and some is flattened. The wire presents locally black spots, brown fuzzies. |

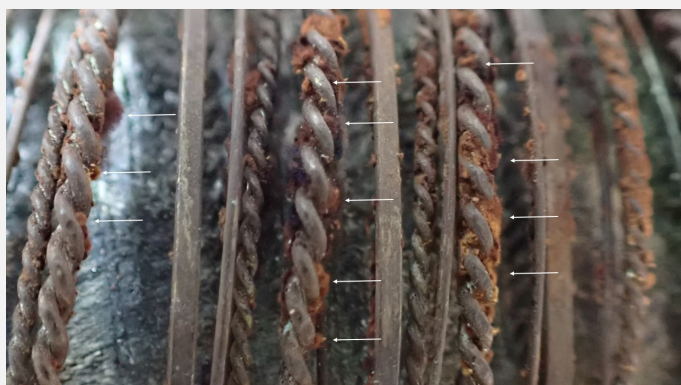
Fig. 2: Macro image of small brown fuzzies, some of which are indicated by arrows,

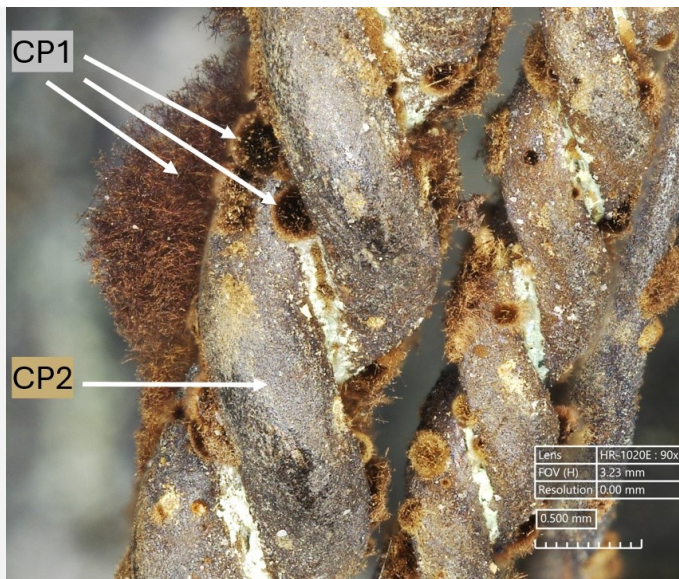
Fig. 3: Hirox image of black spots, brown fuzzies,

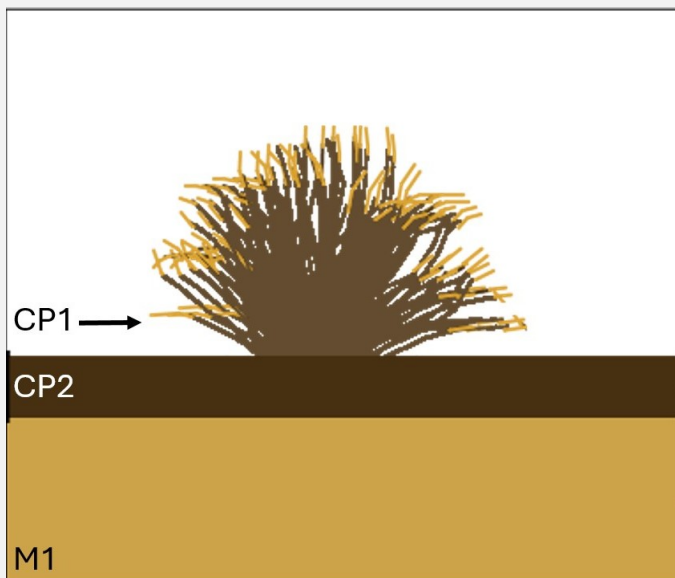
Fig. 4: Stratigraphic representation of brown fuzzies on copper-based wire by macroscopic and binocular observation,

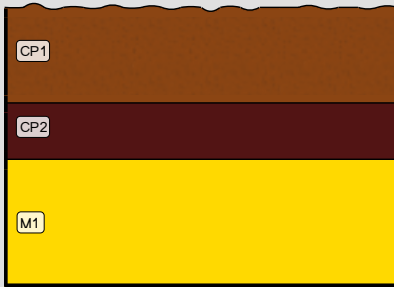
Fig. 5: Stratigraphic representation of the corrosion structure of brown fuzzies observed macroscopically under binocular microscope using the MiCorr application. The characteristics of the strata are only accessible by clicking on the drawing that redirects you to the search tool by stratigraphy representation. This representation can be compared to the stratigraphy in Fig. 4, credit Rijksmuseum Amsterdam, A.Hammond.

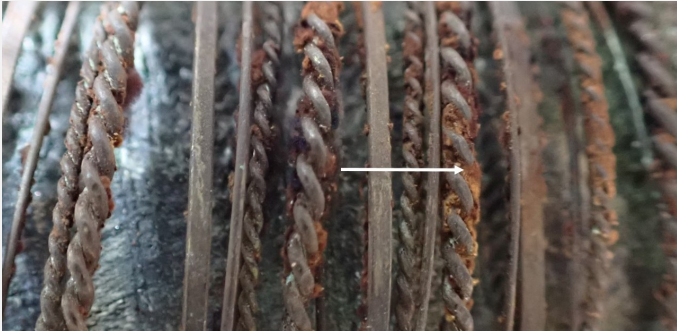
Fig. 6: Spot corrosion (brown fuzzies) was sampled from for SEM-EDX analysis,

| Description of sample | Sample of figs. 6 and 7 was collected from the surface of one of the twisted wires, in an area of thick corrosion, using a sterile scalpel blade. It was scraped from the surface of the object directly into a diveted slide, and was covered with a flat slide while being transported for X-ray diffraction. |

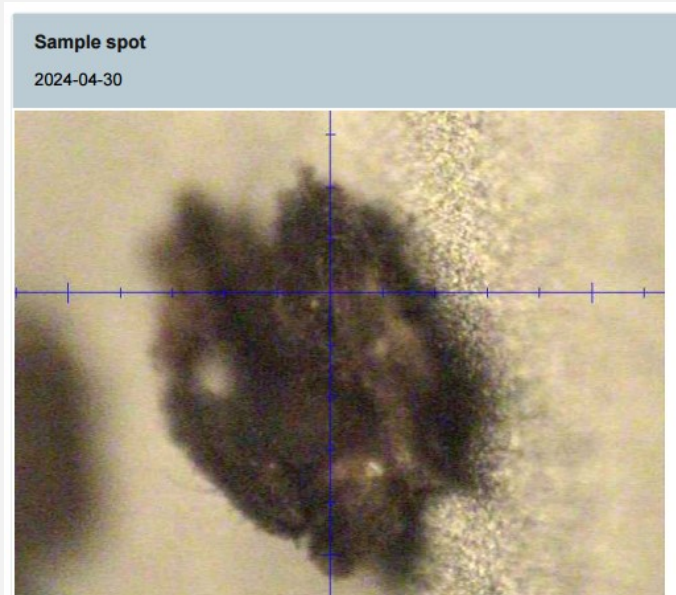
Fig. 7: Corrosion sampled for XRD analysis,

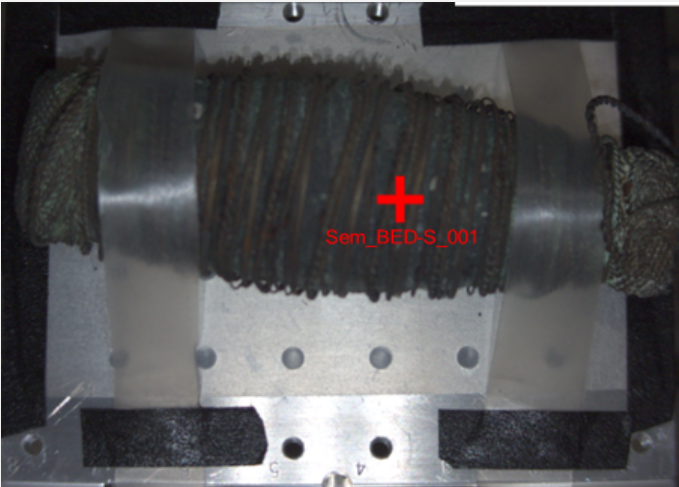
SEM-EDX observation and analysis of the brown fuzzies (Figs. 7 to 9) indicated major peaks of copper and sulfur with lower peaks of oxygen and carbon. XRD diffractograms of brown fuzzies (Fig. 7) matched with copper iron sulfide Bornite, iron oxide Hematite and copper sulfides Covellite  $\text{CuS}$  and Haycockite  $\text{CuFe}_5\text{S}_8$ , the latter might be the most probable due to the absence of iron in EDX analysis (Fig. 10).

Fig. 7: Image indicating spot analyzed in SEM-EDX analysis,

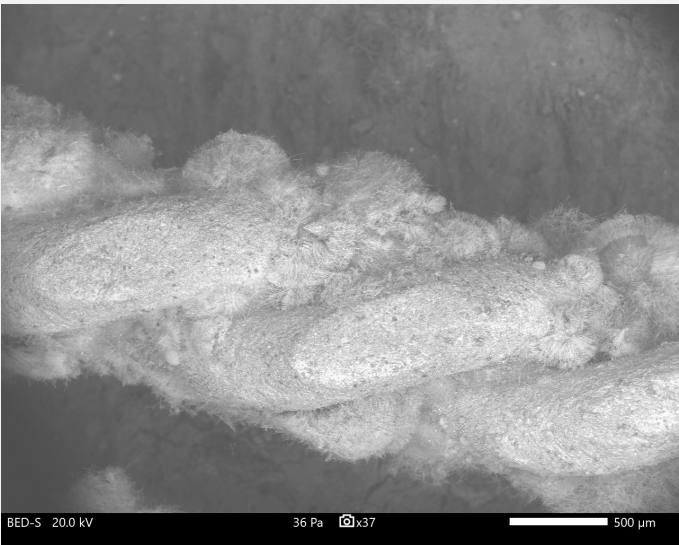
Fig. 8: SEM image of copper sulfide structure,

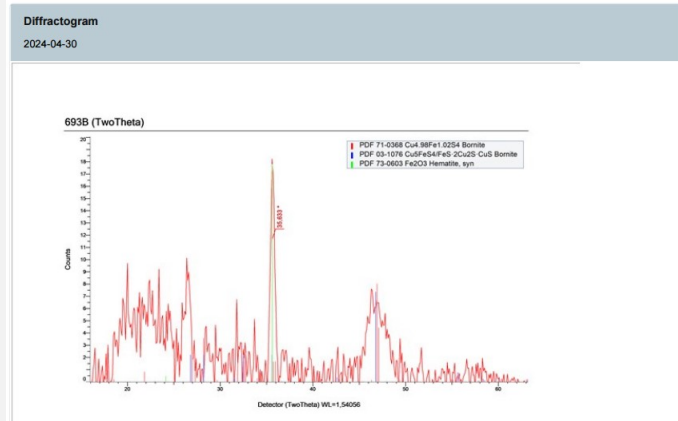
Fig.10: XRD diffractogram of the brown fuzzies,
