MILITARY ID TAG 5668-MXX-1008-1 - ZN PB ALLOY - MODERN TIMES - FRANCE

Artefact name	Military ID tag 5668-MXX-1008-1
Authors	Christian. Degryny (HE-Arc CR, Neuchâtel, Neuchâtel, Switzerland) & Marie-Jeanne. Scholl (HE-Arc CR, Neuchâtel, Neuchâtel, Switzerland) & Valentin. Boissonnas (HE-Arc CR, Neuchâtel, Neuchâtel, Switzerland)
Url	/artefacts/213/

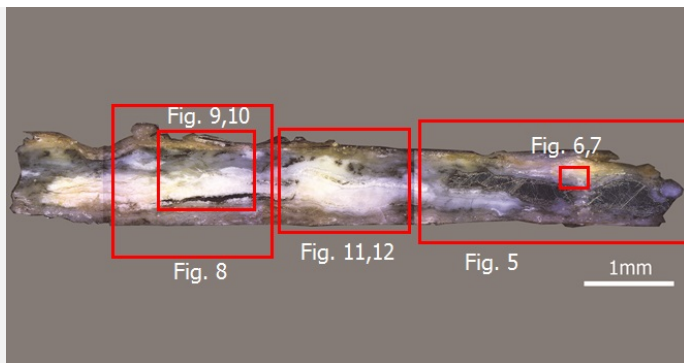
Fig. 4: Micrograph of the cross-section showing the locations of Figures 5-12. Unetched, dark field, 50x,

Description of sample	This sample was cut out of fragment b in Fig. 1. The cross-section shows the entire thickness of the plate (L = 8 mm, W= 1 mm). The corrosion goes through the whole metal thickness but a metallic core remains (Fig. 4).
Alloy	Zn Pb Alloy
Technology	Cold worked (laminated)
Lab number of sample	-
Sample location	HE-Arc CR, Neuchâtel, Neuchâtel
Responsible institution	Pôle d'Archéologie Interdépartemental Rhénan, Sélestat, Alsace
Date and aim of sampling	2013, metallography and chemical analyses

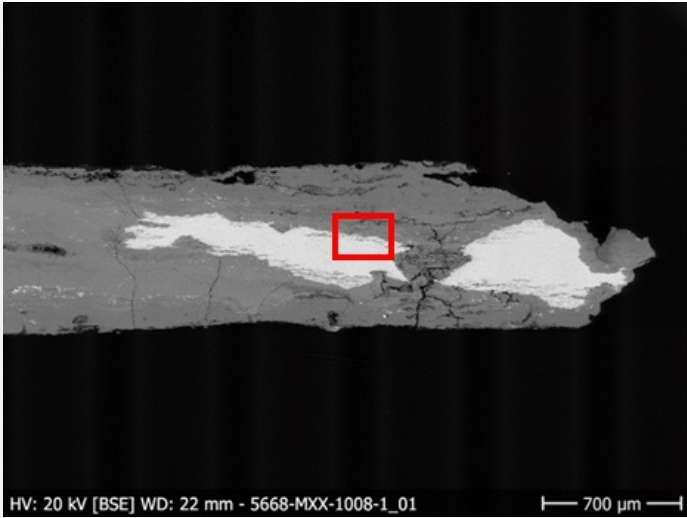
The remaining metal is an almost pure zinc alloy (Table 1) containing 1.8% in weight lead. Lead appears in the metal in the form of small flattened white Pb inclusions (Figs. 5 and 6), confirming the manufacturing technique, namely lamination. The etched metal does not show any specific microstructure (Fig. 7).

Fig. 5: SEM image of the cross-section, from Fig. 4 (detail), BSD-mode. Note the presence of Pb inclusions all through the thickness of the heavily cracked corrosion layers,

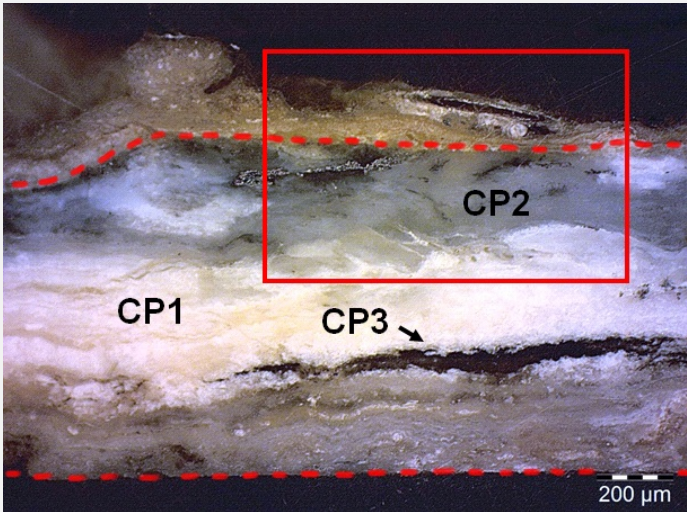
The corrosion structure is multi-layered: several corrosion products overlap. However they are not all continuous layers, since some of them are isolated. Most of the corrosion products layers show structural voids (up to 100 µm thick) and some cracks inside. Three layers can be distinguished (Fig. 8) which have the same elements but in different proportions (Figs. 9, 10 and table 2):

Fig. 8: Micrograph of the cross-section, from Fig. 4 (detail), unetched, dark field, 50x. View of the inner layers and the limit of the original surface (red line). We can see that the interfaces between the different layers are not well defined: some of the white corrosion product is found inside the inner grey layer. The micrograph of Fig. 9 is marked by a rectangular,

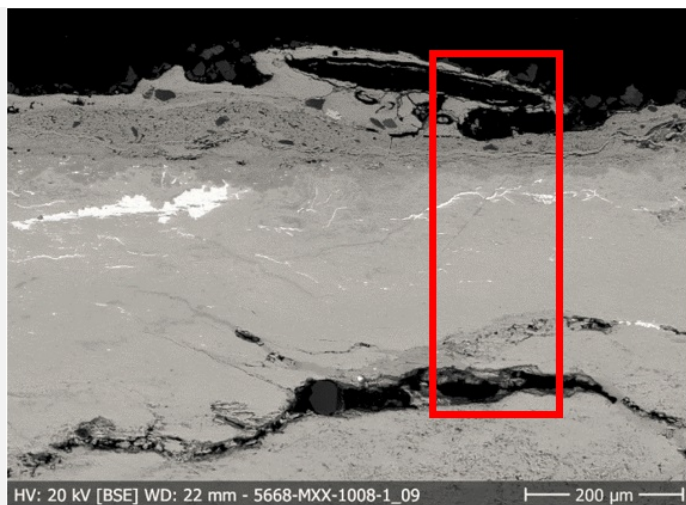
Fig. 9: SEM image of the cross-section from Fig. 8 (detail), BSD-mode. The mapped area (Fig. 10) is marked by a rectangle,

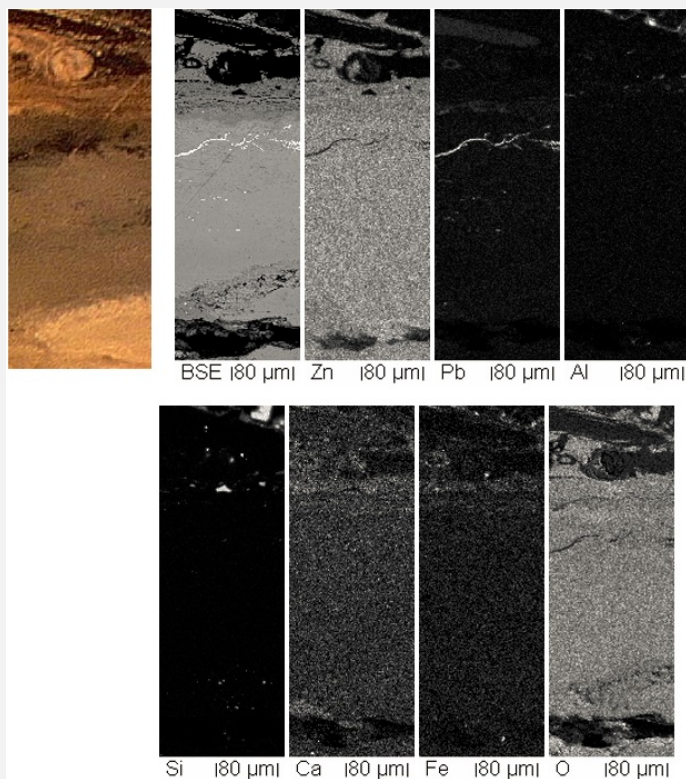
Fig. 10: SEM image of the cross-section from Fig. 9 (detail), SE-mode, and elemental chemical distribution. Method of examination: SEM/EDX, Lab of Electronic Microscopy and microanalysis, IMA (Néode), HEI Arc,

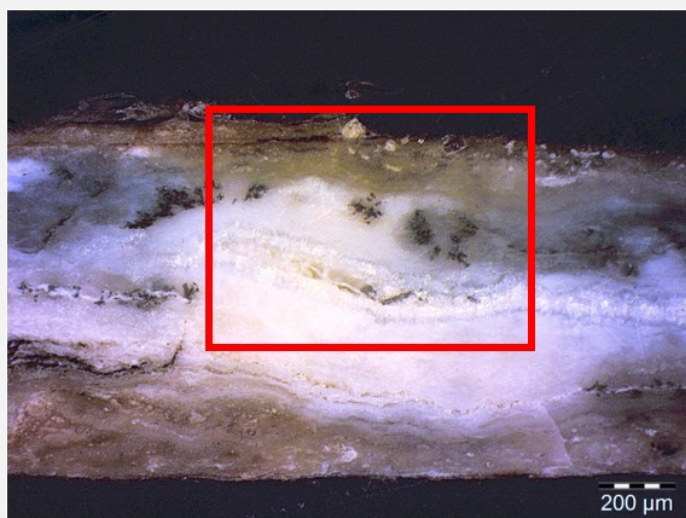
- Inner grey layer – CP2 (up to 1 mm thick) is a translucent, compact layer and constitutes most part of the corrosion products. Corroded metal appears inside this layer as lead inclusions within a black corrosion product (Figs. 11 and 12). Sulphur has also been detected by SEM-EDX inside this layer, near the surface, where the colour turns into grey-orange (zinc sulfide or sulphates but to be confirmed, table 2).

Fig. 11: Micrograph of the cross-section, from Fig. 4 (detail), unetched, dark field, 50x. The micrograph of Fig. 12 is marked by a rectangular,

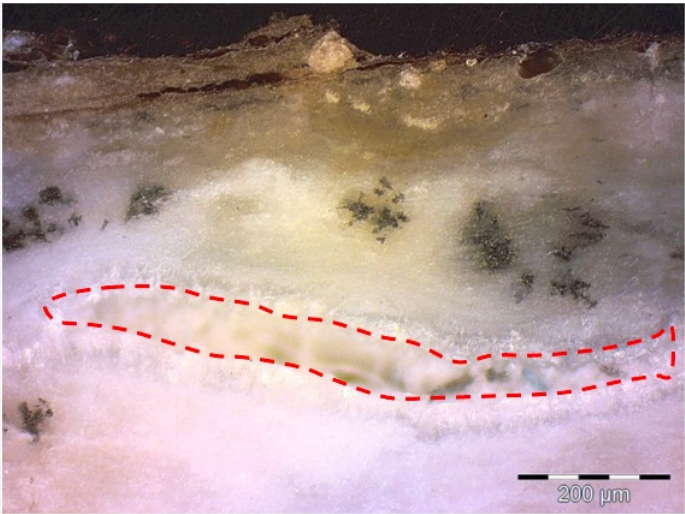
- Inner white layer – CP1 (up to 0.6 mm thick) is an opaque and powdery heap, occurring in different places inside inner grey layer and sometimes near the surface, as pitting corrosion. The interface between inner layers grey and white is diffuse. Localized aggregates showing a crystalline microstructure of thickness of 50 µm are located against the walls of a structural void, inside the white corrosion product (Fig. 12).

Fig. 12: Micrograph of the cross-section, from Fig. 9 (detail) unetched, dark field, 100x. Structural void (dotted red line) with aggregates,

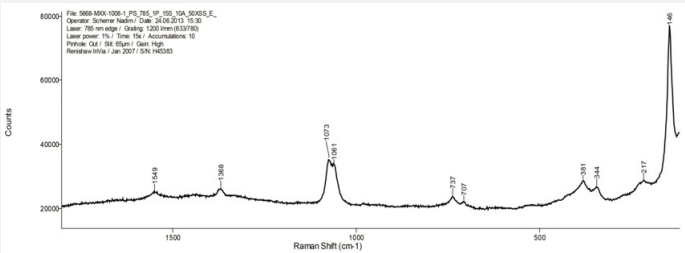
The inner grey layer has been identified by FTIR as a zinc carbonate (smithsonite), mixed with other unidentified corrosion products. Raman spectra seems to confirm it (Fig. 13). The exact composition of inner white layer is unknown. Inner white layer shows a bluish fluorescence under UV light and has been identified by FTIR as a mixture of zinc oxides and carbonates, that could be zinc hydroxycarbonates (hydrozincite). Raman spectroscopy shows also a mixture of carbonates and other corrosion products (Fig. 14). The inner black layer is a zinc carbonate as well, identified by FTIR and Raman spectroscopy (Fig. 15) appearing as a vein between layers grey and white (Fig. 8).

Fig. 13: Raman spectrum of inner grey layer (ZnCO₃ – smithsonite?). Settings: laser wavelength 532nm, acquisition time 10s, one accumulation, filter D2 (0.75-0.8mW), hole 500, slit 80, grating 600. Method of analysis: Raman spectroscopy, Art Technological Laboratory, Departement Conservation HKB,

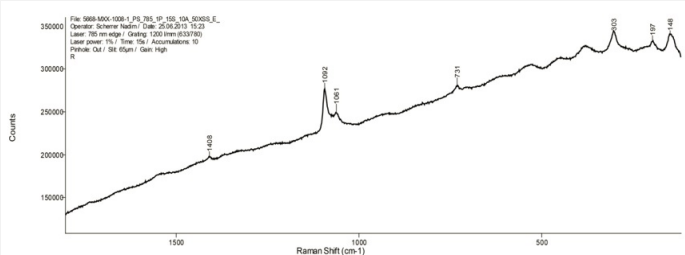
Fig. 14: Raman spectrum of inner white layer (zinc hydroxycarbonate?). Settings: laser wavelength 532nm, acquisition time 10s, one accumulation, filter D2 (0.75-0.8mW), hole 500, slit 80, grating 600. Method of analysis: Raman spectroscopy, Art Technological Laboratory, Departement Conservation HKB,

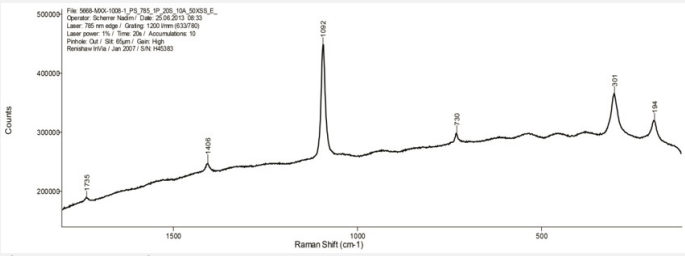
Fig. 15: Raman spectrum of inner black layer (zinc carbonate?). Settings: laser wavelength 532nm, acquisition time 10s, one accumulation, filter D2 (0.75-0.8mW), hole 500, slit 80, grating 600. Method of analysis: Raman spectroscopy, Art Technological Laboratory, Departement Conservation HKB,

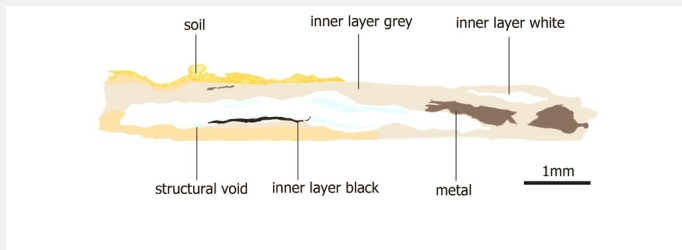
Fig. 16: Improved stratigraphic representation of the stratigraphy of corrosion layers on the military tag from visual observations and analyses,

Strate	Composition
Soil (S)	Elements from soil, organic elements
Grey corrosion product (CP1)	Zinc carbonate (smithsonite) + S
White corrosion product (CP2)	Zinc hydroxycarbonate + mixture of CP
Black corrosion product (CP3)	Zinc carbonate
Corroded metal (CM)	
Metal (M)	Zn-Pb

The military tag is made of a laminated sheet of zinc-lead alloy. The corrosion has entirely penetrated the objet leaving though some spots of remaining original metal inside the corrosion products. Lead particles are not affected by the corrosion process. The main corrosion products are zinc carbonates (smithsonite) and hydroxycarbonates (hydrozincite) but mixtures of different corrosion products can occur. These corrosion products are intermixed and heavily cracked.
