MILITARY ID TAG 5668-MXX-1008-1 - ZN PB ALLOY - MODERN TIMES - FRANCE

Artefact name Military ID tag 5668-MXX-1008-1

Authors Christian. Degrygn (HE-Arc CR, Neuchâtel, Neuchâtel, Switzerland) & Marie-Jeanne. Scholl (HE-Arc CR, Neuchâtel, Neuchâtel, Switzerland) & Valentin. Boissonnas (HE-Arc CR, Neuchâtel, Neuchâtel, Switzerland)

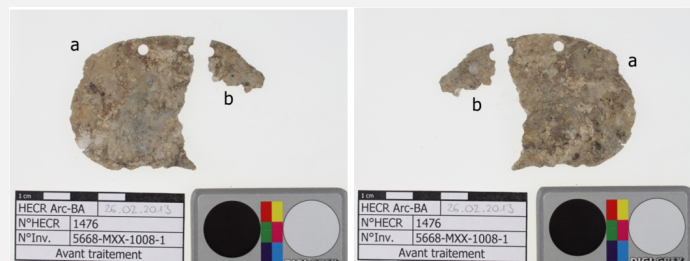
Fig. 1: German military ID tag from First World War, recto and verso, 2013,

Description of the artefact Fragments from an oval shaped plate with two circular holes at the central upper edge. Information concerning the soldier were given in the centre of the plate. The plate is covered with sediments. Dimensions (70 x 50 mm initially): L = 65mm; W = 50mm; T = 1 mm; WT = 6.3g.

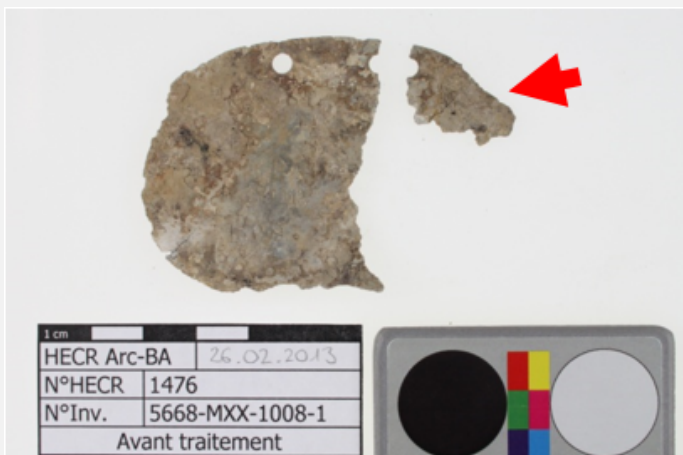
Fig. 2: Location of sample,

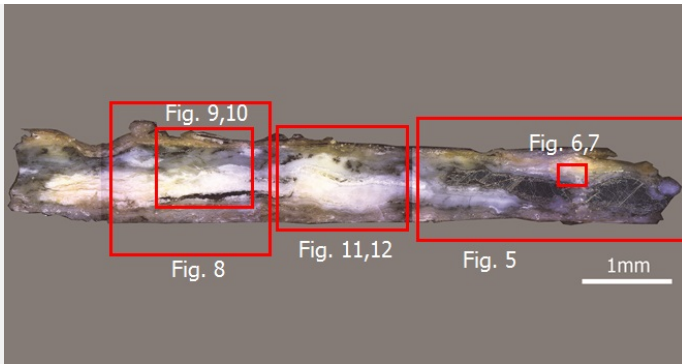
Fig. 4: Micrograph of the cross-section showing the locations of Figures 5-12. Unetched, dark field, 50x,

Description of sample	This sample was cut out of fragment b in Fig. 1. The cross-section shows the entire thickness of the plate (L = 8 mm, W= 1 mm). The corrosion goes through the whole metal thickness but a metallic core remains (Fig. 4).
Alloy	Zn Pb Alloy
Technology	Cold worked (laminated)
Lab number of sample	-
Sample location	HE-Arc CR, Neuchâtel, Neuchâtel
Responsible institution	Pôle d'Archéologie Interdépartemental Rhénan, Sélestat, Alsace
Date and aim of sampling	2013, metallography and chemical analyses

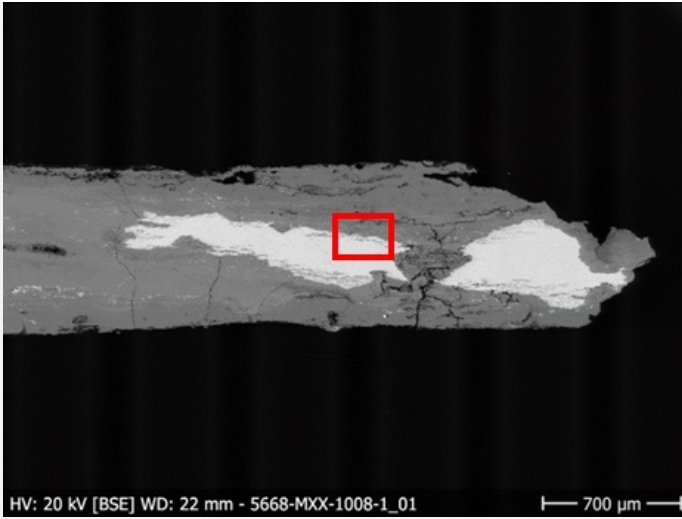
The remaining metal is an almost pure zinc alloy (Table 1) containing 1.8% in weight lead. Lead appears in the metal in the form of small flattened white Pb inclusions (Figs. 5 and 6), confirming the manufacturing technique, namely lamination. The etched metal does not show any specific microstructure (Fig. 7).

Fig. 5: SEM image of the cross-section, from Fig. 4 (detail), BSD-mode. Note the presence of Pb inclusions all through the thickness of the heavily cracked corrosion layers,

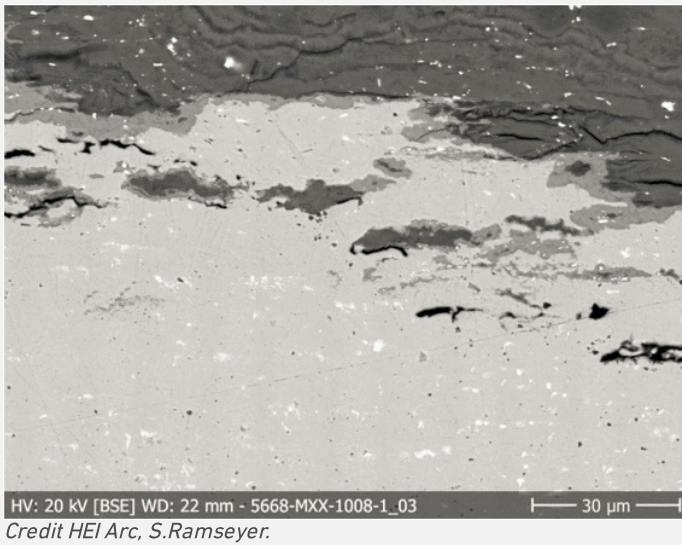
Fig. 6: SEM image of the cross-section, from Fig. 5 (detail), BSD-mode,

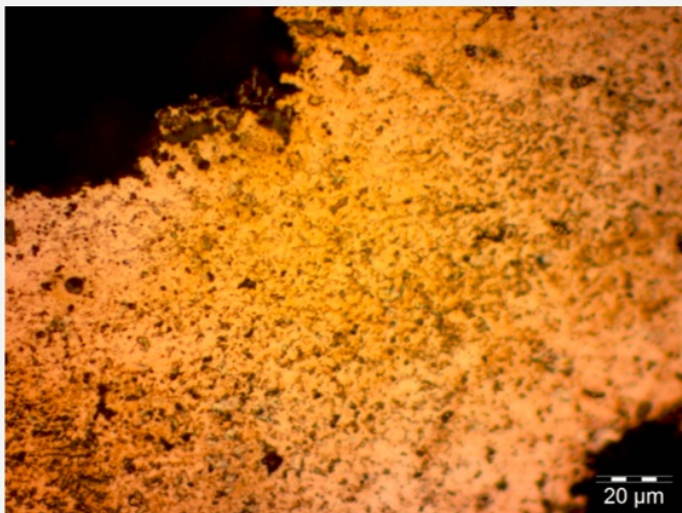
Fig. 7: Micrograph of the cross-section, etched, bright field, 500x,

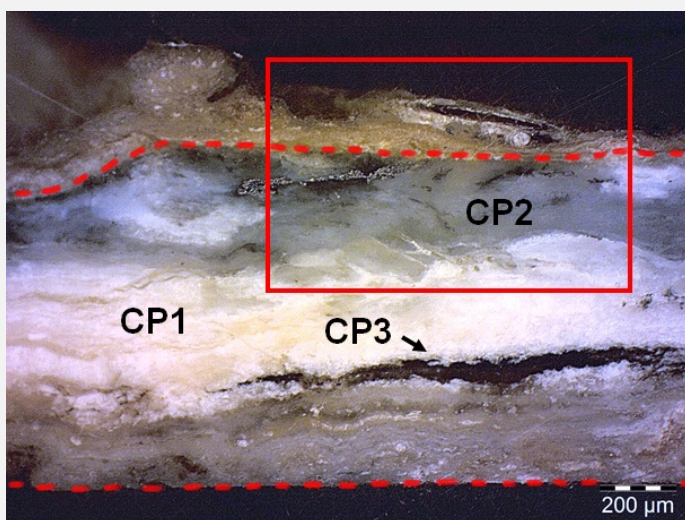
The corrosion structure is multi-layered: several corrosion products overlap. However they are not all continuous layers, since some of them are isolated. Most of the corrosion products layers show structural voids (up to 100 µm thick) and some cracks inside. Three layers can be distinguished (Fig. 8) which have the same elements but in different proportions (Figs. 9, 10 and table 2):

Fig. 8: Micrograph of the cross-section, from Fig. 4 (detail), unetched, dark field, 50x. View of the inner layers and the limit of the original surface (red line). We can see that the interfaces between the different layers are not well defined: some of the white corrosion product is found inside the inner grey layer. The micrograph of Fig. 9 is marked by a rectangle,

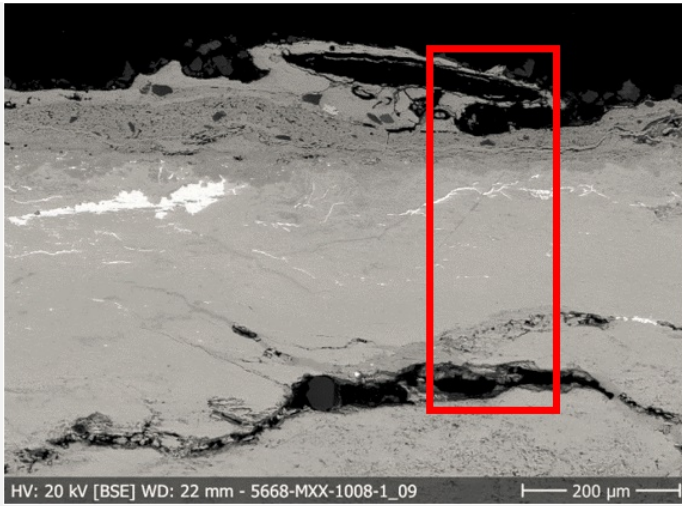
Fig. 9: SEM image of the cross-section from Fig. 8 (detail), BSD-mode. The mapped area (Fig. 10) is marked by a rectangle,

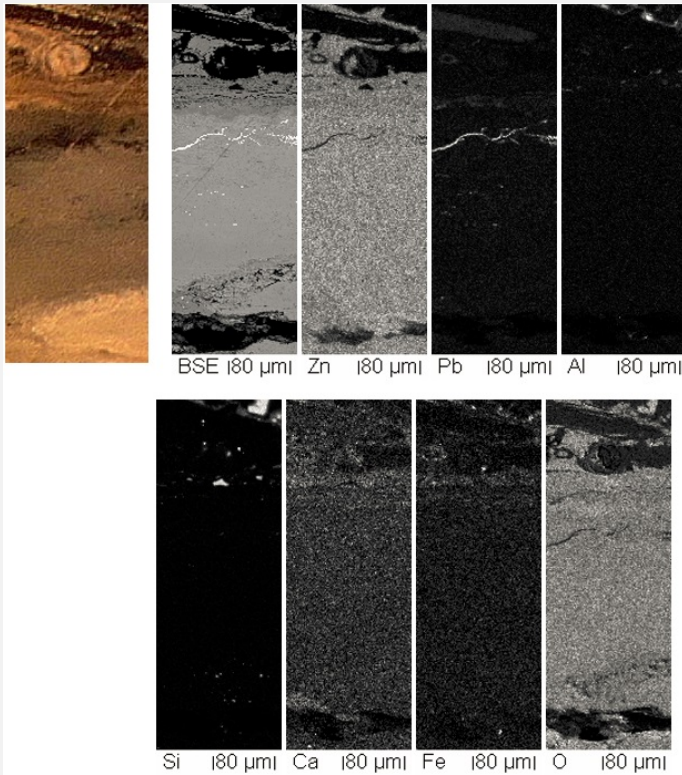
Fig. 10: SEM image of the cross-section from Fig. 9 (detail), SE-mode, and elemental chemical distribution. Method of examination: SEM/EDX, Lab of Electronic Microscopy and microanalysis, IMA (Néode), HEI Arc,

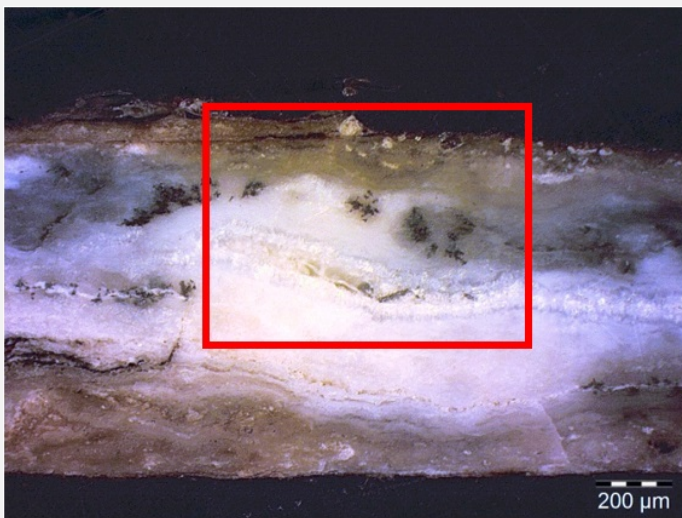
- **Inner grey layer – CP2** (up to 1 mm thick) is a translucent, compact layer and constitutes most part of the corrosion products. Corroded metal appears inside this layer as lead inclusions within a black corrosion product (Figs. 11 and 12). Sulphur has also been detected by SEM-EDX inside this layer, near the surface, where the colour turns into grey-orange (zinc sulfide or sulphates but to be confirmed, table 2).

Fig. 11: Micrograph of the cross-section, from Fig. 4 (detail), unetched, dark field, 50x. The micrograph of Fig. 12 is marked by a rectangular,

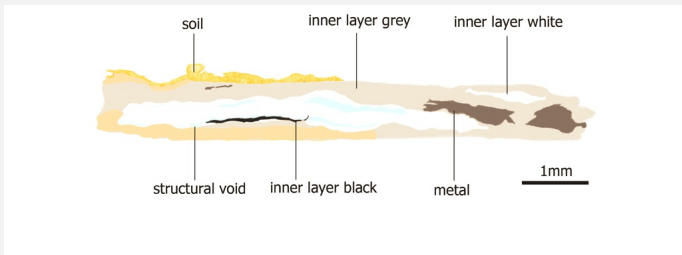
Fig. 16: Improved stratigraphic representation of the stratigraphy of corrosion layers on the military tag from visual observations and analyses,

Strate	Composition
Soil (S)	Elements from soil, organic elements
Grey corrosion product (CP1)	Zinc carbonate (smithsonite) + S
White corrosion product (CP2)	Zinc hydroxycarbonate + mixture of CP
Black corrosion product (CP3)	Zinc carbonate
Corroded metal (CM)	
Metal (M)	Zn-Pb

The military tag is made of a laminated sheet of zinc-lead alloy. The corrosion has entirely penetrated the objet leaving though some spots of remaining original metal inside the corrosion products. Lead particles are not affected by the corrosion process. The main corrosion products are zinc carbonates (smithsonite) and hydroxycarbonates (hydrozincite) but mixtures of different corrosion products can occur. These corrosion products are intermixed and heavily cracked.
