MILITARY ID TAG 5668-MXX-1008-1 - ZN PB ALLOY - MODERN TIMES - FRANCE

Artefact name Military ID tag 5668-MXX-1008-1

Authors Christian. Degrigny (HE-Arc CR, Neuchâtel, Neuchâtel, Switzerland) & Marie-Jeanne. Scholl (HE-Arc CR, Neuchâtel,

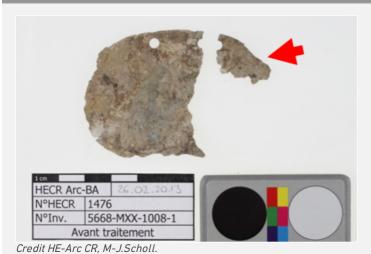
Fig. 2: Location of sample,

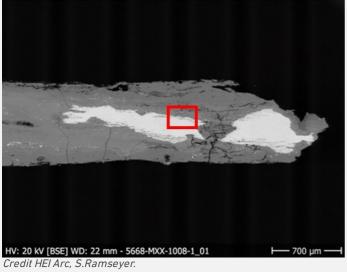
The remaining metal is an almost pure zinc alloy (Table 1) containing 1.8% in weight lead. Lead appears in the metal in the form of small flattened white Pb inclusions (Figs. 5 and 6), confirming the manufacturing technique, namely lamination. The etched metal does not show any specific microstructure (Fig. 7).

Fig. 6: SEM image of the cross-section, from Fig. 5 (detail), BSD-mode,

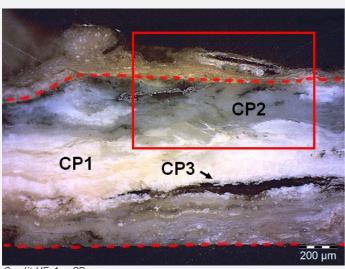
The corrosion structure is multi-layered: several corrosion products overlap. However they are not all continuous layers, since some of them are isolated. Most of the corrosion products layers show structural voids (up to $100 \mu m$ thick) and some cracks inside. Three layers can be distinguished (Fig. 8) which have the same elements but in different proportions (Figs. 9, 10 and table 2):

Fig. 8: Micrograph of the cross-section, from Fig. 4 (detail), unetched, dark field, 50x. View of the inner layers and the limit of the original surface (red line). We can see that the interfaces between the different layers are not well defined: some of the white corrosion product is found inside the inner grey layer. The micrograph of Fig. 9 is marked by a rectangular,

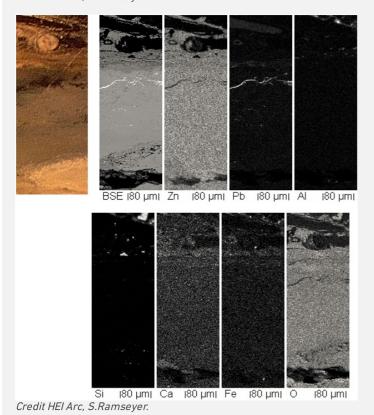
Fig. 10: SEM image of the cross-section from Fig. 9 (detail), SE-mode, and elemental chemical distribution. Method of examination: SEM/EDX, Lab of Electronic Microscopy and microanalysis, IMA (Néode), HEI Arc,

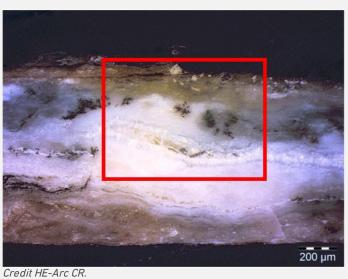
- <u>Inner grey layer</u> CP2 (up to 1 mm thick) is a translucent, compact layer and constitutes most part of the corrosion products. Corroded metal appears inside this layer as lead inclusions within a black corrosion product (Figs. 11 and 12). Sulphur has also been detected by SEM-EDX inside this layer, near the surface, where the colour turns into grey-orange (zinc sulfide or sulphates but to be confirmed, table 2).

Fig. 11: Micrograph of the cross-section, from Fig. 4 (detail), unetched, dark field, 50x. The micrograph of Fig. 12 is marked by a rectangular,
