MILITARY ID TAG 5668-MXX-1008-1 - ZN PB ALLOY - MODERN TIMES - FRANCE

Artefact name Military ID tag 5668-MXX-1008-1

Authors Christian. Degryny (HE-Arc CR, Neuchâtel, Neuchâtel, Switzerland) & Marie-Jeanne. Scholl (HE-Arc CR, Neuchâtel, Neuchâtel, Switzerland) & Valentin. Boissonnas (HE-Arc CR, Neuchâtel, Neuchâtel, Switzerland)

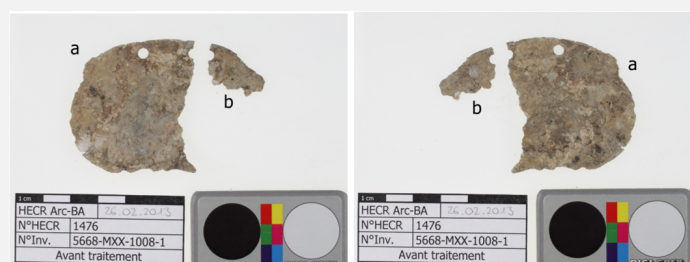
Fig. 1: German military ID tag from First World War, recto and verso, 2013,

Description of the artefact Fragments from an oval shaped plate with two circular holes at the central upper edge. Information concerning the soldier were given in the centre of the plate. The plate is covered with sediments. Dimensions (70 x 50 mm initially): L = 65mm; W = 50mm; T = 1 mm; WT = 6.3g.

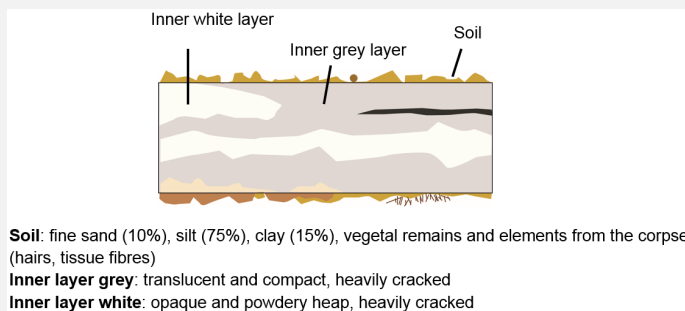
Fig. 3: Stratigraphic representation of the military tag in cross-section by macroscopic observation,

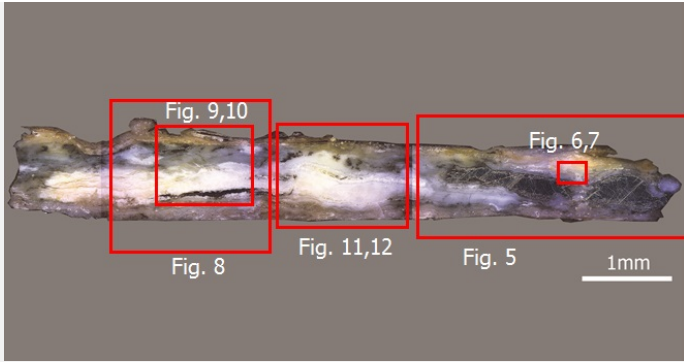
Fig. 4: Micrograph of the cross-section showing the locations of Figures 5-12. Unetched, dark field, 50x,

Description of sample	This sample was cut out of fragment b in Fig. 1. The cross-section shows the entire thickness of the plate (L = 8 mm, W= 1 mm). The corrosion goes through the whole metal thickness but a metallic core remains (Fig. 4).
Alloy	Zn Pb Alloy
Technology	Cold worked (laminated)
Lab number of sample	-
Sample location	HE-Arc CR, Neuchâtel, Neuchâtel
Responsible institution	Pôle d'Archéologie Interdépartemental Rhénan, Sélestat, Alsace
Date and aim of sampling	2013, metallography and chemical analyses

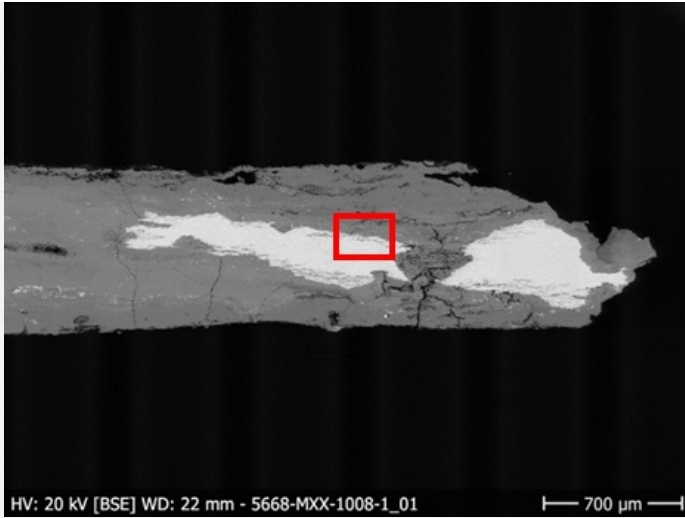
The remaining metal is an almost pure zinc alloy (Table 1) containing 1.8% in weight lead. Lead appears in the metal in the form of small flattened white Pb inclusions (Figs. 5 and 6), confirming the manufacturing technique, namely lamination. The etched metal does not show any specific microstructure (Fig. 7).

Fig. 5: SEM image of the cross-section, from Fig. 4 (detail), BSD-mode. Note the presence of Pb inclusions all through the thickness of the heavily cracked corrosion layers,

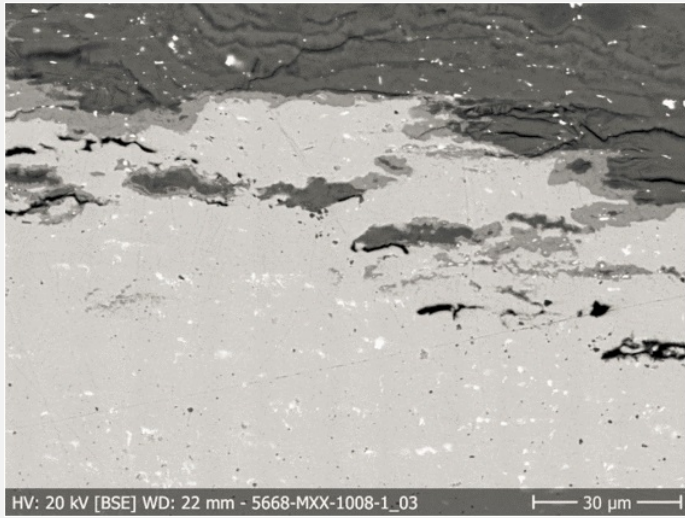
Fig. 6: SEM image of the cross-section, from Fig. 5 (detail), BSD-mode,

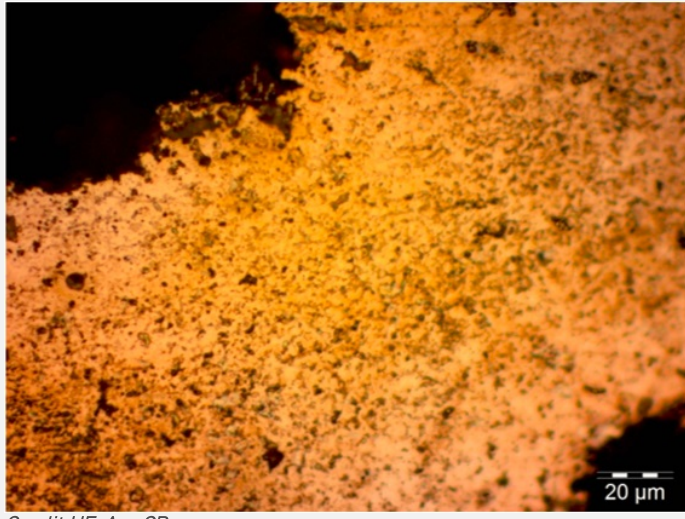
Fig. 7: Micrograph of the cross-section, etched, bright field, 500x,

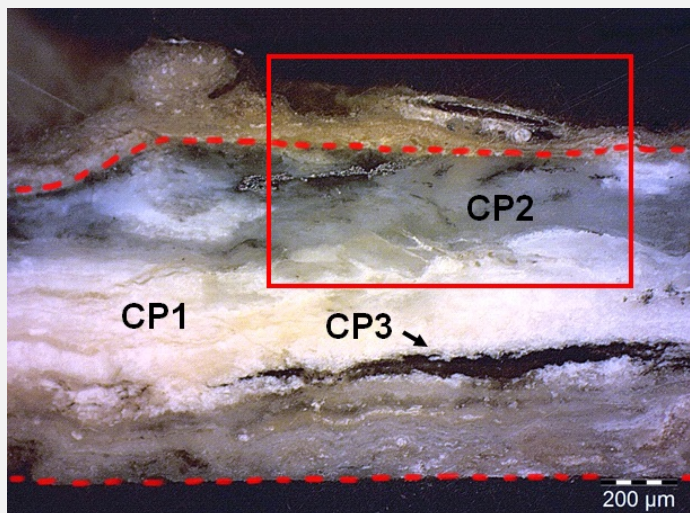
The corrosion structure is multi-layered: several corrosion products overlap. However they are not all continuous layers, since some of them are isolated. Most of the corrosion products layers show structural voids (up to 100 µm thick) and some cracks inside. Three layers can be distinguished (Fig. 8) which have the same elements but in different proportions (Figs. 9, 10 and table 2):

Fig. 8: Micrograph of the cross-section, from Fig. 4 (detail), unetched, dark field, 50x. View of the inner layers and the limit of the original surface (red line). We can see that the interfaces between the different layers are not well defined: some of the white corrosion product is found inside the inner grey layer. The micrograph of Fig. 9 is marked by a rectangular,

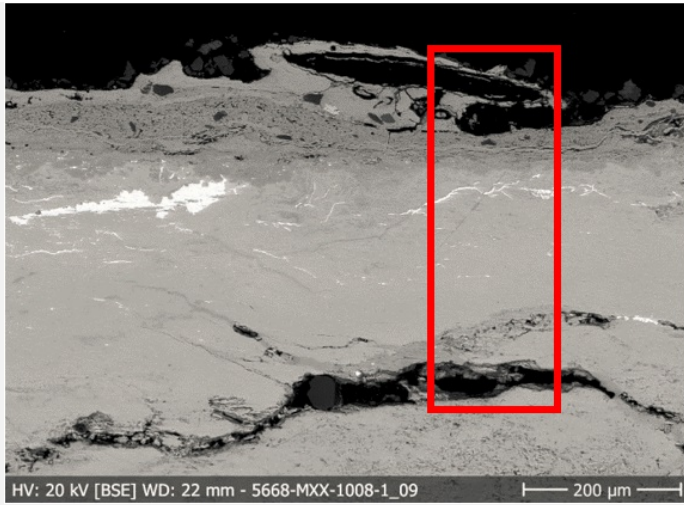
Fig. 9: SEM image of the cross-section from Fig. 8 (detail), BSD-mode. The mapped area (Fig. 10) is marked by a rectangle,

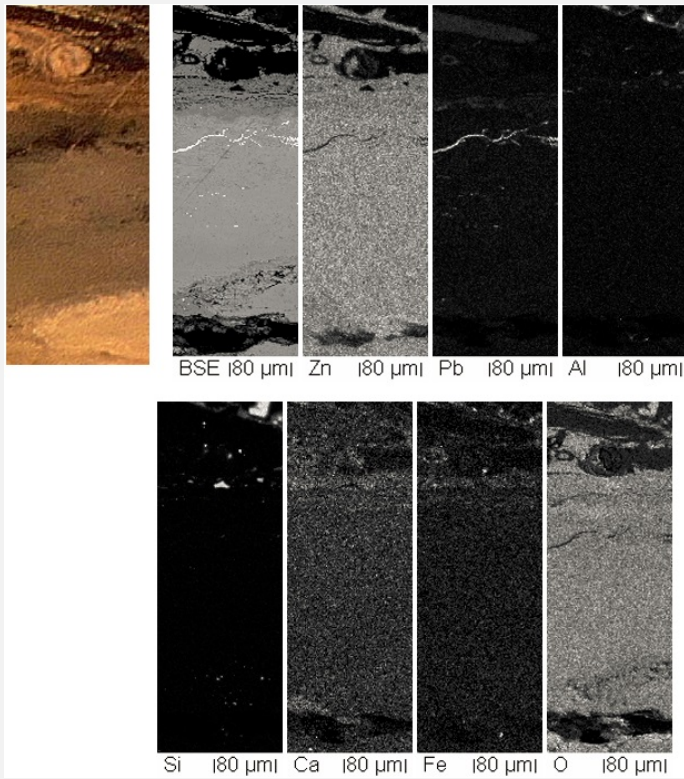
Fig. 10: SEM image of the cross-section from Fig. 9 (detail), SE-mode, and elemental chemical distribution. Method of examination: SEM/EDX, Lab of Electronic Microscopy and microanalysis, IMA (Néode), HEI Arc,

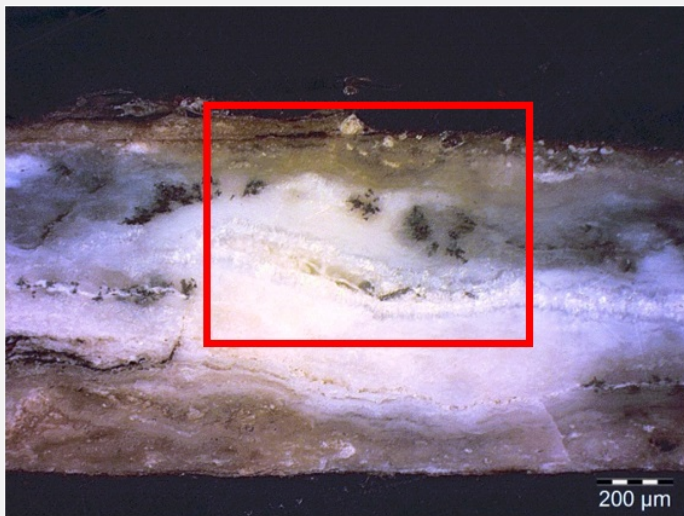
- **Inner grey layer – CP2** (up to 1 mm thick) is a translucent, compact layer and constitutes most part of the corrosion products. Corroded metal appears inside this layer as lead inclusions within a black corrosion product (Figs. 11 and 12). Sulphur has also been detected by SEM-EDX inside this layer, near the surface, where the colour turns into grey-orange (zinc sulfide or sulphates but to be confirmed, table 2).

Fig. 11: Micrograph of the cross-section, from Fig. 4 (detail), unetched, dark field, 50x. The micrograph of Fig. 12 is marked by a rectangular,

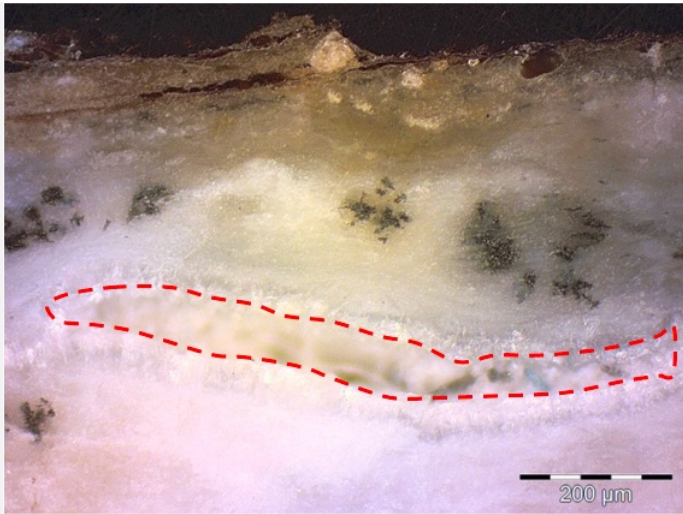
- **Inner white layer – CP1** (up to 0.6 mm thick) is an opaque and powdery heap, occurring in different places inside inner grey layer and sometimes near the surface, as pitting corrosion. The interface between inner layers grey and white is diffuse. Localized aggregates showing a crystalline microstructure of thickness of 50 µm are located against the walls of a structural void, inside the white corrosion product (Fig. 12).

Fig. 12: Micrograph of the cross-section, from Fig. 9 (detail) unetched, dark field, 100x. Structural void (dotted red line) with aggregates,

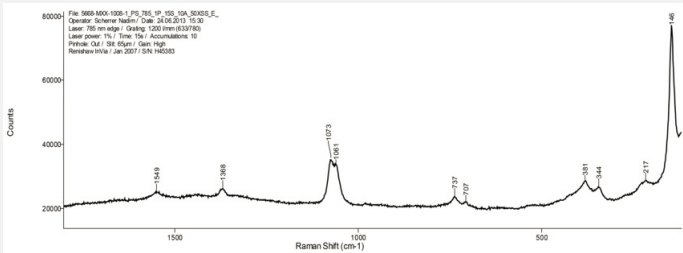
The inner grey layer has been identified by FTIR as a zinc carbonate (smithsonite), mixed with other unidentified corrosion products. Raman spectra seems to confirm it (Fig. 13). The exact composition of inner white layer is unknown. Inner white layer shows a bluish fluorescence under UV light and has been identified by FTIR as a mixture of zinc oxides and carbonates, that could be zinc hydroxycarbonates (hydrozincite). Raman spectroscopy shows also a mixture of carbonates and other corrosion products (Fig. 14). The inner black layer is a zinc carbonate as well, identified by FTIR and Raman spectroscopy (Fig. 15) appearing as a vein between layers grey and white (Fig. 8).

Fig. 13: Raman spectrum of inner grey layer (ZnCO₃ – smithsonite?). Settings: laser wavelength 532nm, acquisition time 10s, one accumulation, filter D2 (0.75-0.8mW), hole 500, slit 80, grating 600. Method of analysis: Raman spectroscopy, Art Technological Laboratory, Departement Conservation HKB,

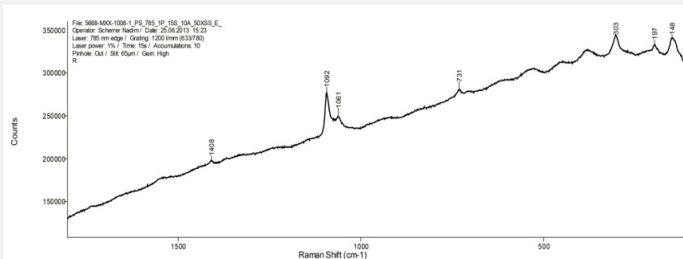
Fig. 14: Raman spectrum of inner white layer (zinc hydroxycarbonate?). Settings: laser wavelength 532nm, acquisition time 10s, one accumulation, filter D2 (0.75-0.8mW), hole 500, slit 80, grating 600. Method of analysis: Raman spectroscopy, Art Technological Laboratory, Departement Conservation HKB,

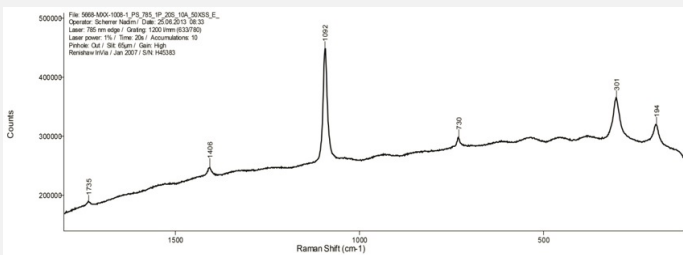
Fig. 15: Raman spectrum of inner black layer (zinc carbonate?). Settings: laser wavelength 532nm, acquisition time 10s, one accumulation, filter D2 (0.75-0.8mW), hole 500, slit 80, grating 600. Method of analysis: Raman spectroscopy, Art Technological Laboratory, Departement Conservation HKB,

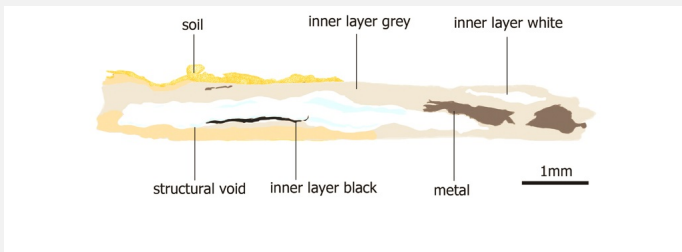
Fig. 16: Improved stratigraphic representation of the stratigraphy of corrosion layers on the military tag from visual observations and analyses,

The military tag is made of a laminated sheet of zinc-lead alloy. The corrosion has entirely penetrated the objet leaving though some spots of remaining original metal inside the corrosion products. Lead particles are not affected by the corrosion process. The main corrosion products are zinc carbonates (smithsonite) and hydroxycarbonates (hydrozincite) but mixtures of different corrosion products can occur. These corrosion products are intermixed and heavily cracked.
