MILITARY ID TAG 5668-MXX-1008-1 - ZN PB ALLOY - MODERN TIMES - FRANCE

Artefact name Military ID tag 5668-MXX-1008-1

Authors Christian. Degryny (HE-Arc CR, Neuchâtel, Neuchâtel, Switzerland) & Marie-Jeanne. Scholl (HE-Arc CR, Neuchâtel, Neuchâtel, Switzerland) & Valentin. Boissonnas (HE-Arc CR, Neuchâtel, Neuchâtel, Switzerland)

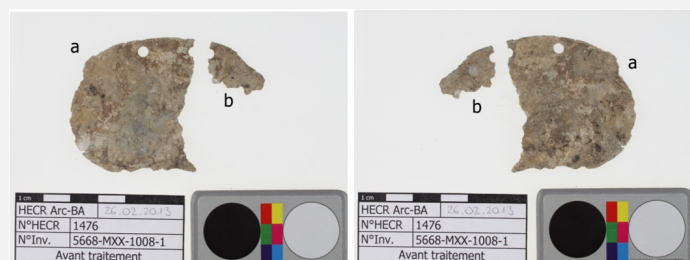
Fig. 1: German military ID tag from First World War, recto and verso, 2013,

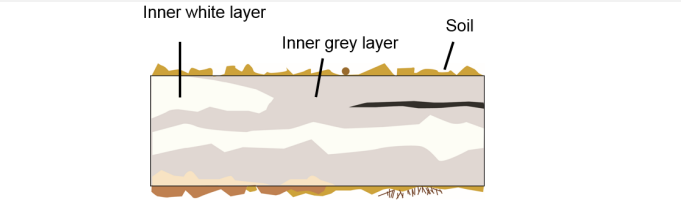
Soil: fine sand (10%), silt (75%), clay (15%), vegetal remains and elements from the corpse (hairs, tissue fibres)
Inner layer grey: translucent and compact, heavily cracked
Inner layer white: opaque and powdery heap, heavily cracked
Credit HE-Arc CR, M-J.Scholl.

Fig. 3: Stratigraphic representation of the military tag in cross-section by macroscopic observation,

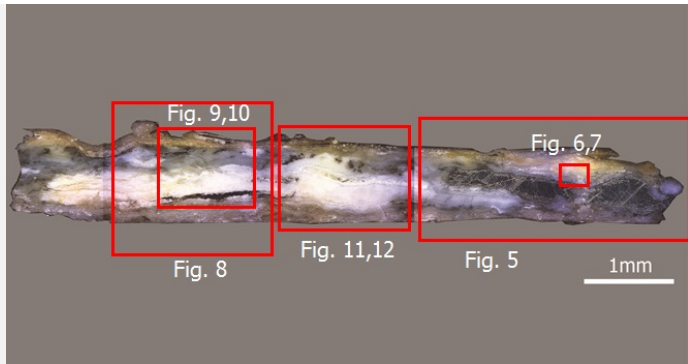
Fig. 4: Micrograph of the cross-section showing the locations of Figures 5-12. Unetched, dark field, 50x,

Description of sample	This sample was cut out of fragment b in Fig. 1. The cross-section shows the entire thickness of the plate (L = 8 mm, W= 1 mm). The corrosion goes through the whole metal thickness but a metallic core remains (Fig. 4).
Alloy	Zn Pb Alloy
Technology	Cold worked (laminated)
Lab number of sample	-
Sample location	HE-Arc CR, Neuchâtel, Neuchâtel
Responsible institution	Pôle d'Archéologie Interdépartemental Rhénan, Sélestat, Alsace
Date and aim of sampling	2013, metallography and chemical analyses

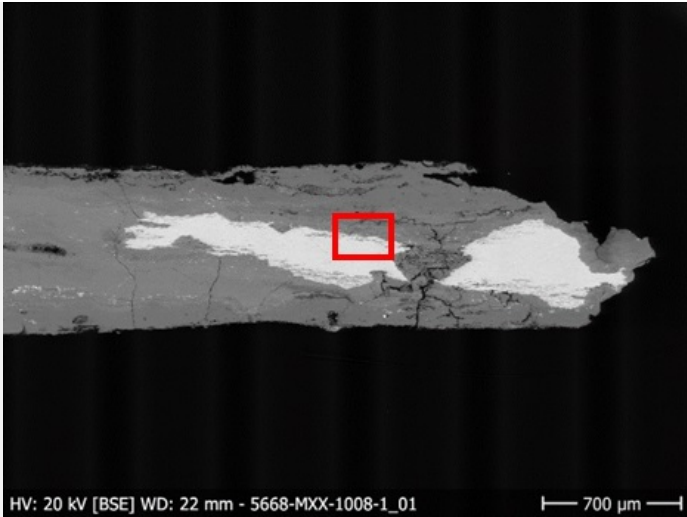
The remaining metal is an almost pure zinc alloy (Table 1) containing 1.8% in weight lead. Lead appears in the metal in the form of small flattened white Pb inclusions (Figs. 5 and 6), confirming the manufacturing technique, namely lamination. The etched metal does not show any specific microstructure (Fig. 7).

Fig. 5: SEM image of the cross-section, from Fig. 4 (detail), BSD-mode. Note the presence of Pb inclusions all through the thickness of the heavily cracked corrosion layers,

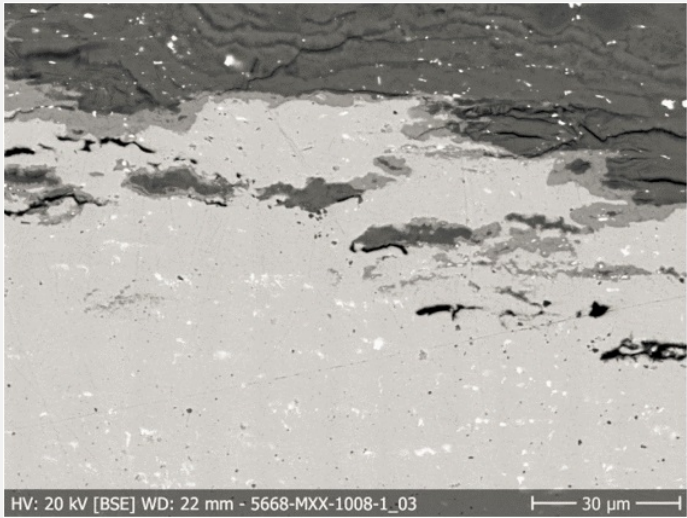
Fig. 6: SEM image of the cross-section, from Fig. 5 (detail), BSD-mode,

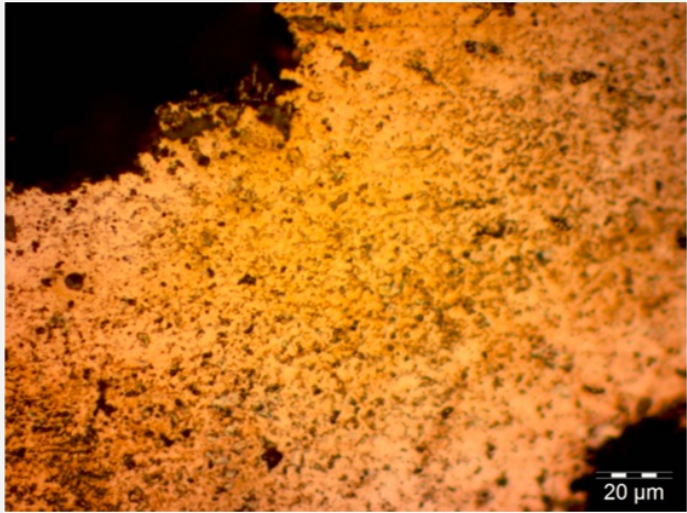
Fig. 7: Micrograph of the cross-section, etched, bright field, 500x,

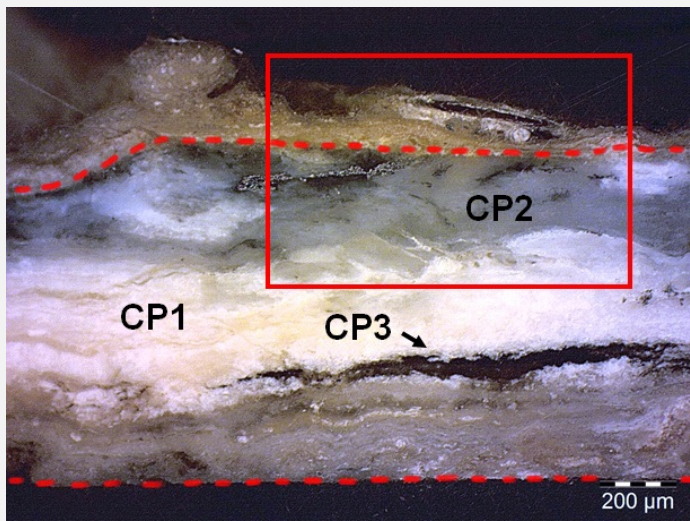
The corrosion structure is multi-layered: several corrosion products overlap. However they are not all continuous layers, since some of them are isolated. Most of the corrosion products layers show structural voids (up to 100 µm thick) and some cracks inside. Three layers can be distinguished (Fig. 8) which have the same elements but in different proportions (Figs. 9, 10 and table 2):

Fig. 8: Micrograph of the cross-section, from Fig. 4 (detail), unetched, dark field, 50x. View of the inner layers and the limit of the original surface (red line). We can see that the interfaces between the different layers are not well defined: some of the white corrosion product is found inside the inner grey layer. The micrograph of Fig. 9 is marked by a rectangle,

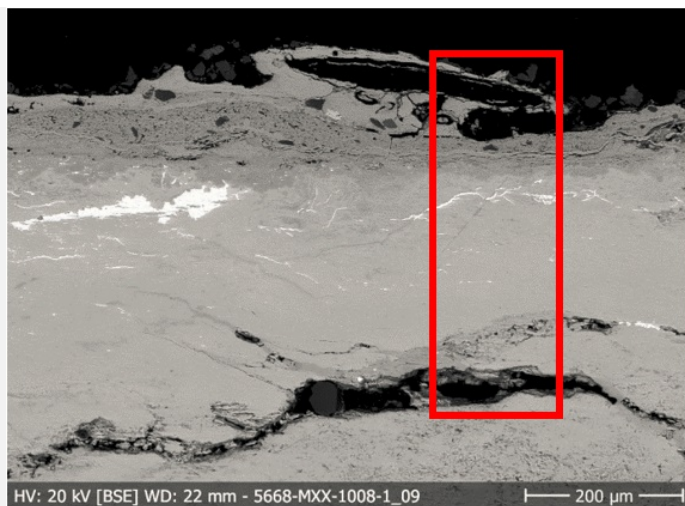
Fig. 9: SEM image of the cross-section from Fig. 8 (detail), BSD-mode. The mapped area (Fig. 10) is marked by a rectangle,

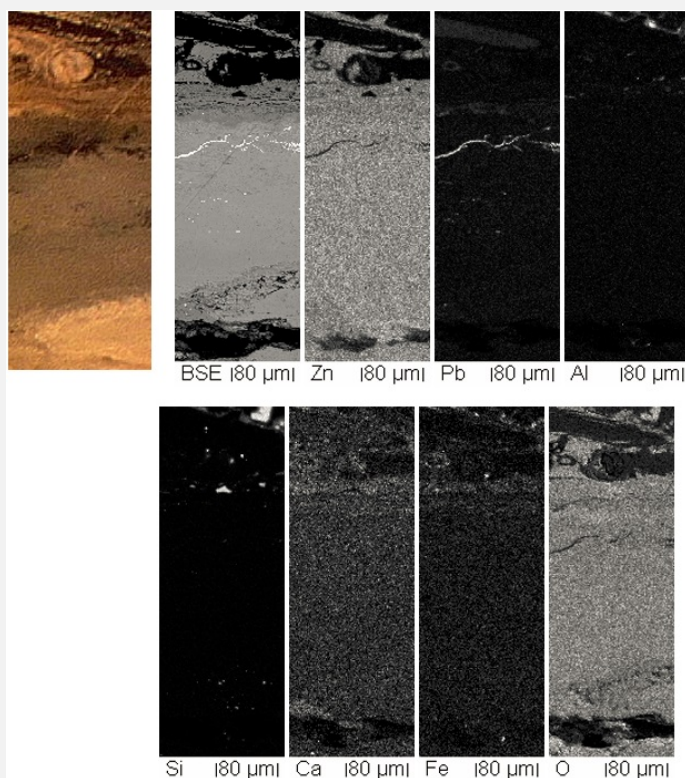
Fig. 10: SEM image of the cross-section from Fig. 9 (detail), SE-mode, and elemental chemical distribution. Method of examination: SEM/EDX, Lab of Electronic Microscopy and microanalysis, IMA (Néode), HEI Arc,

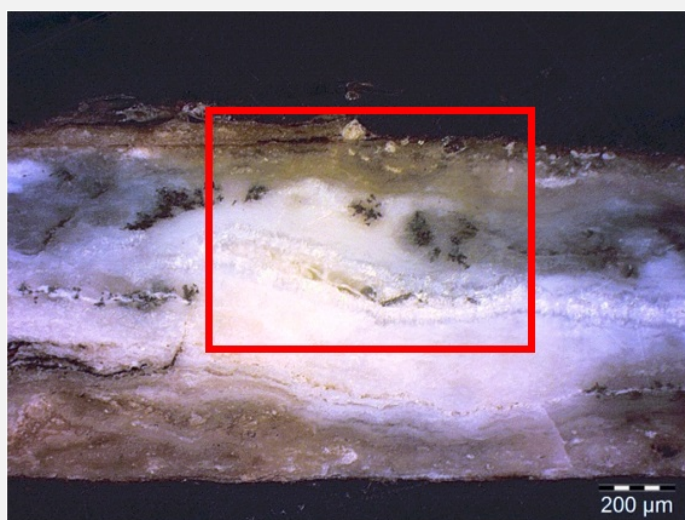
- Inner grey layer – CP2 (up to 1 mm thick) is a translucent, compact layer and constitutes most part of the corrosion products. Corroded metal appears inside this layer as lead inclusions within a black corrosion product (Figs. 11 and 12). Sulphur has also been detected by SEM-EDX inside this layer, near the surface, where the colour turns into grey-orange (zinc sulfide or sulphates but to be confirmed, table 2).

Fig. 11: Micrograph of the cross-section, from Fig. 4 (detail), unetched, dark field, 50x. The micrograph of Fig. 12 is marked by a rectangular,

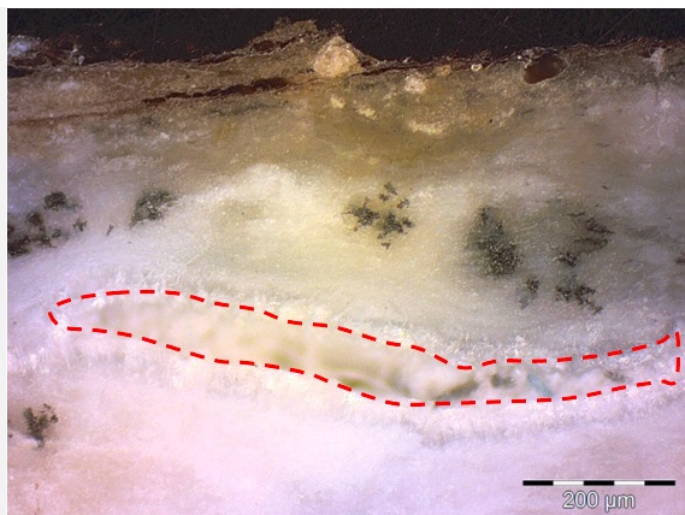
- Inner white layer – CP1 (up to 0.6 mm thick) is an opaque and powdery heap, occurring in different places inside inner grey layer and sometimes near the surface, as pitting corrosion. The interface between inner layers grey and white is diffuse. Localized aggregates showing a crystalline microstructure of thickness of 50 µm are located against the walls of a structural void, inside the white corrosion product (Fig. 12).

Fig. 12: Micrograph of the cross-section, from Fig. 9 (detail) unetched, dark field, 100x. Structural void (dotted red line) with aggregates,

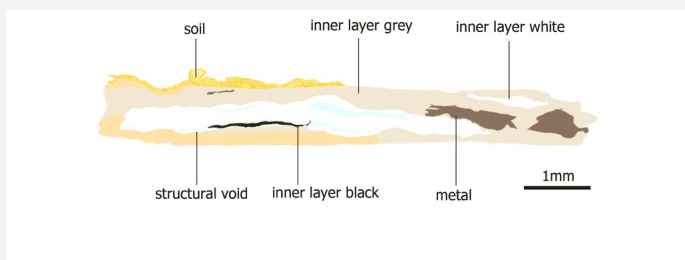
Based on the analyses carried out, the schematic representation of the stratigraphy of the military tag has been corrected.

Fig. 16: Improved stratigraphic representation of the stratigraphy of corrosion layers on the military tag from visual observations and analyses,

Strate	Composition
Soil (S)	Elements from soil, organic elements
Grey corrosion product (CP1)	Zinc carbonate (smithsonite) + S
White corrosion product (CP2)	Zinc hydroxycarbonate + mixture of CP
Black corrosion product (CP3)	Zinc carbonate
Corroded metal (CM)	
Metal (M)	Zn-Pb
