SACRIFICIAL ANODE VHS-8339 - ZN ALLOY - MODERN TIMES

Artefact name	Sacrificial anode VHS-8339
Authors	Marianne. Senn (EMPA, Dübendorf, Zurich, Switzerland) & Christian. Degrieny (HE-Arc CR, Neuchâtel, Neuchâtel, Switzerland)
Url	/artefacts/218/

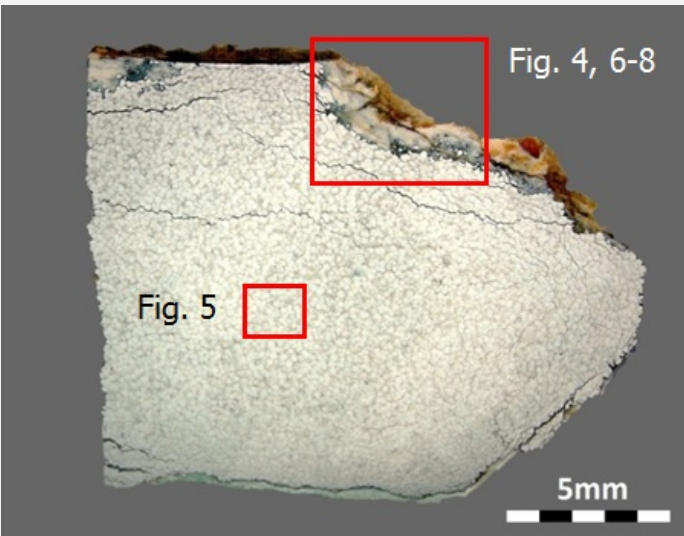
Fig. 3: Micrograph of the cross-section showing the locations of Figures 4 to 8,

The sample shows a cross-section from the sacrificial anode. The thickness of the corrosion crust is variable. Dimensions: L = 17mm; W = 14mm.

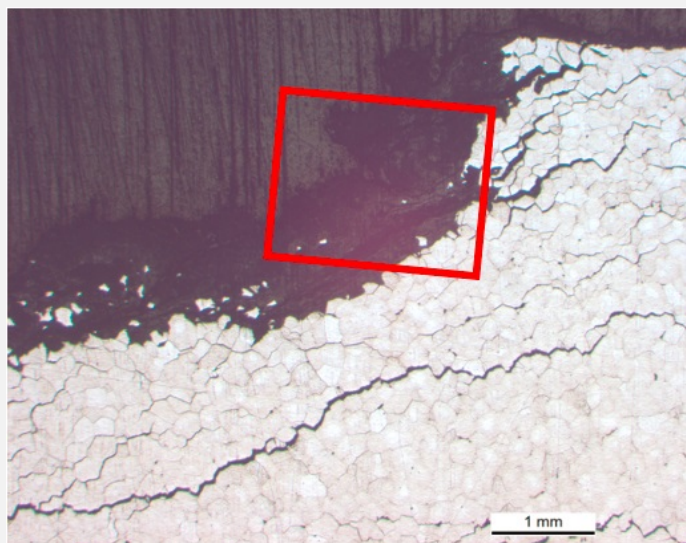
The remaining metal is an almost pure zinc alloy (Table 1). The oxygen content is not from the original alloy, but is due to secondary corrosion. The metal grains are visible without etching and present a polygonal structure (Figs. 4 and 5). The structure is recrystallised after annealing. The recrystallization of zinc alloys begins at room temperature.

Fig. 4: Micrograph of the metal sample from Fig. 3 (reversed picture, detail), unetched, bright field. Extensive intergranular corrosion is visible. The rectangle marks Fig. 6,

Extended intergranular corrosion has developed in the metal structure (Figs. 4, 5 & 6). The metal is covered by a corrosion crust that is hard to see in bright field and which contains remnant metal (Fig. 5). On most of the sample the corrosion crust is uniform. In areas we see cracks appearing as brown lines separating the corrosion crust (Figs. 6 and 7). In bright field the corrosion crust appears grey containing dark-grey zones (Fig. 6). Under polarized light, the corrosion crust appears white with darker parts including remnant metal (Fig. 7). It contains Zn and O as well as S along some cracks (Fig. 9). The cracks appear in brown.

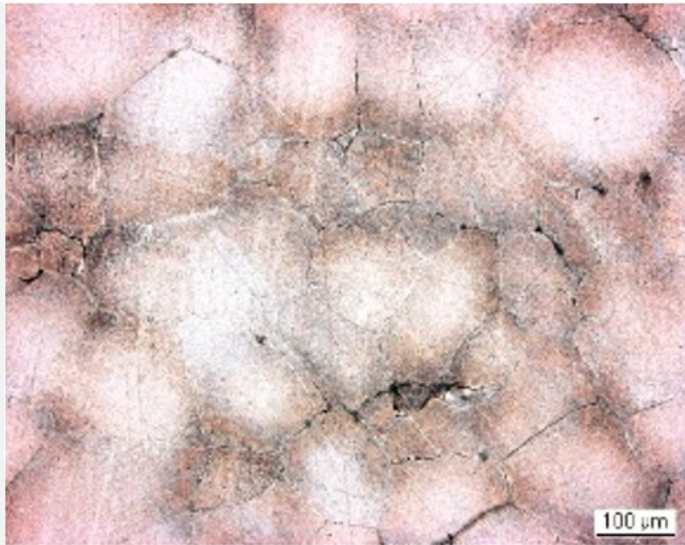
Fig. 5: Micrograph of the metal sample from Fig. 3 (detail), etched,

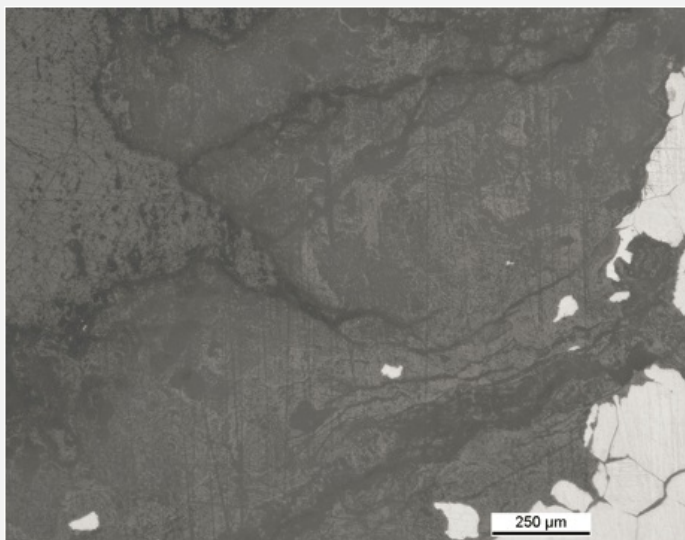
Elements	O	Al	Zn	Total
Light-grey corrosion part	23	<	77	98
Dark grey corrosion part	38	0.6	68	106

Table 2. Chemical composition (mass %) of the corrosion layer from Fig. 6. Method of analysis: SEM/EDX, Laboratory of Analytical Chemistry, Empa.

Fig. 6: Micrograph showing the metal - corrosion products interface from Fig. 4 (detail), unetched, bright field,

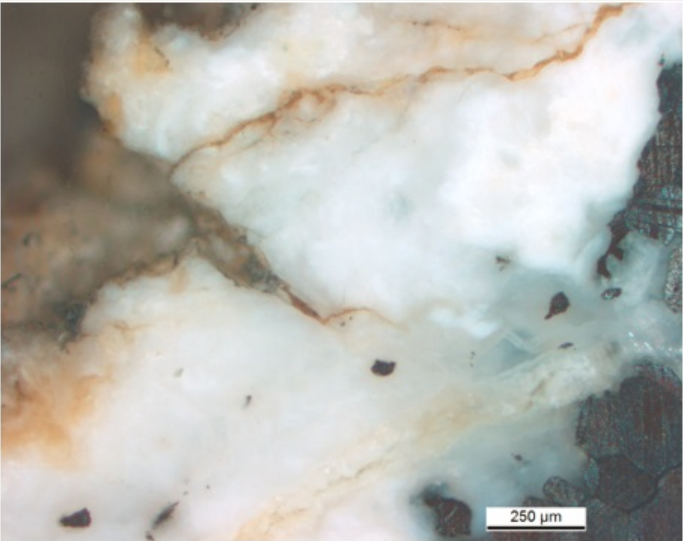
Fig. 7: Micrograph (same as Fig. 6), unetched, polarised light. We observe in dark-grey the metal, in white the corrosion crust separated by brown cracks including remnant metal,

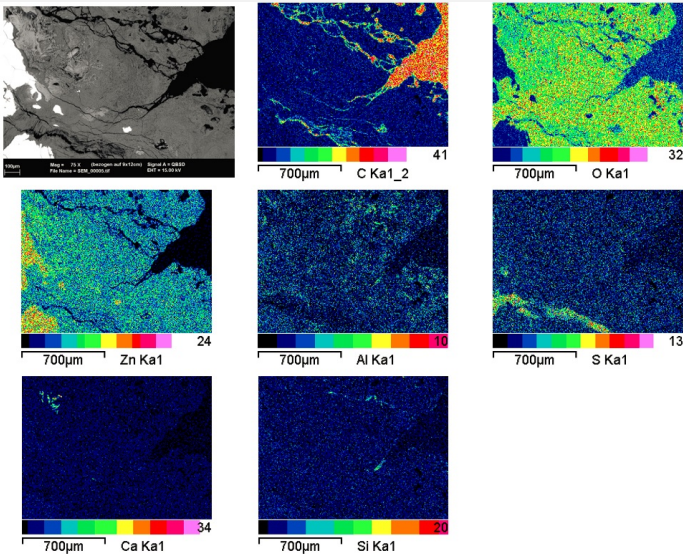
Fig. 8: SEM image, BSD-mode, and elemental chemical distribution of most of the area of Fig. 6 (reversed picture). Method of examination: SEM/EDX, Laboratory of Analytical Chemistry, Empa,
