SACRIFICIAL ANODE VHS-8339 – ZN ALLOY – MODERN TIMES

Artefact name Sacrificial anode VHS-8339

Authors Marianne. Senn (EMPA, Dübendorf, Zurich, Switzerland) & Christian. Degriy (HE-Arc CR, Neuchâtel, Neuchâtel, Switzerland)

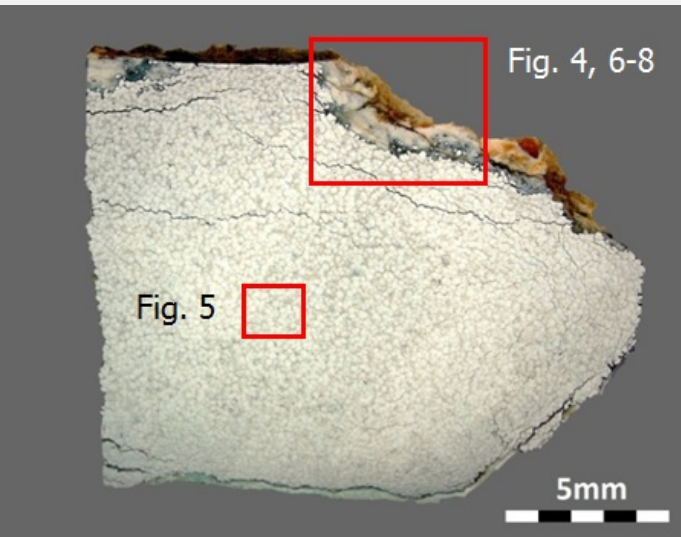
Fig. 3: Micrograph of the cross-section showing the locations of Figures 4 to 8,

The sample shows a cross-section from the sacrificial anode. The thickness of the corrosion crust is variable. Dimensions: L = 17mm; W = 14mm.

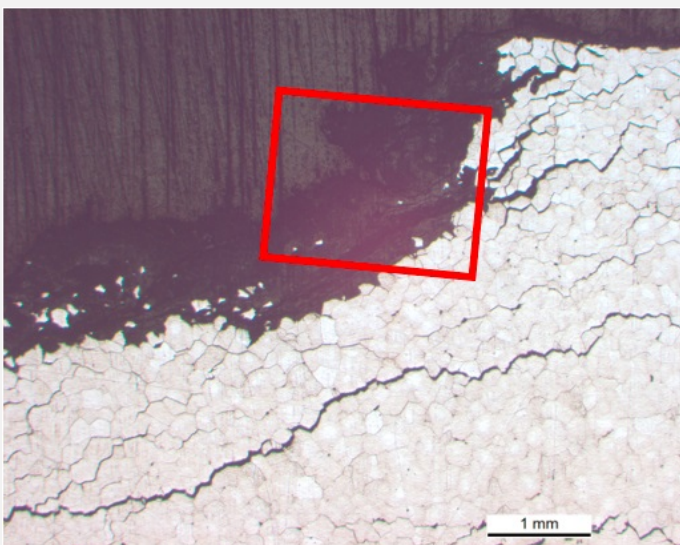
The remaining metal is an almost pure zinc alloy (Table 1). The oxygen content is not from the original alloy, but is due to secondary corrosion. The metal grains are visible without etching and present a polygonal structure (Figs. 4 and 5). The structure is recrystallised after annealing. The recrystallization of zinc alloys begins at room temperature.

Fig. 4: Micrograph of the metal sample from Fig. 3 (reversed picture, detail), unetched, bright field. Extensive intergranular corrosion is visible. The rectangle marks Fig. 6.

Extended intergranular corrosion has developed in the metal structure (Figs. 4, 5 & 6). The metal is covered by a corrosion crust that is hard to see in bright field and which contains remnant metal (Fig. 5). On most of the sample the corrosion crust is uniform. In areas we see cracks appearing as brown lines separating the corrosion crust (Figs. 6 and 7). In bright field the corrosion crust appears grey containing dark-grey zones (Fig. 6). Under polarized light, the corrosion crust appears white with darker parts including remnant metal (Fig. 7). It contains Zn and O as well as S along some cracks (Fig. 9). The cracks appear in brown.

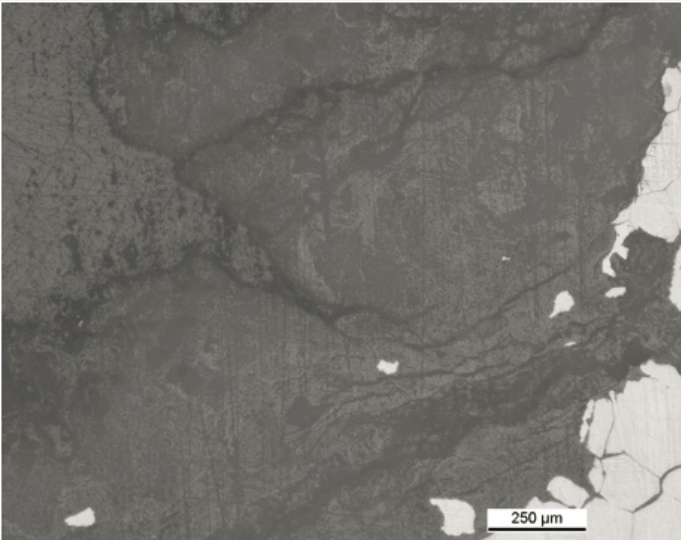
Elements	O	Al	Zn	Total
Light-grey corrosion part	23	<	77	98
Dark grey corrosion part	38	0.6	68	106

Fig. 6: Micrograph showing the metal - corrosion products interface from Fig. 4 (detail), unetched, bright field,

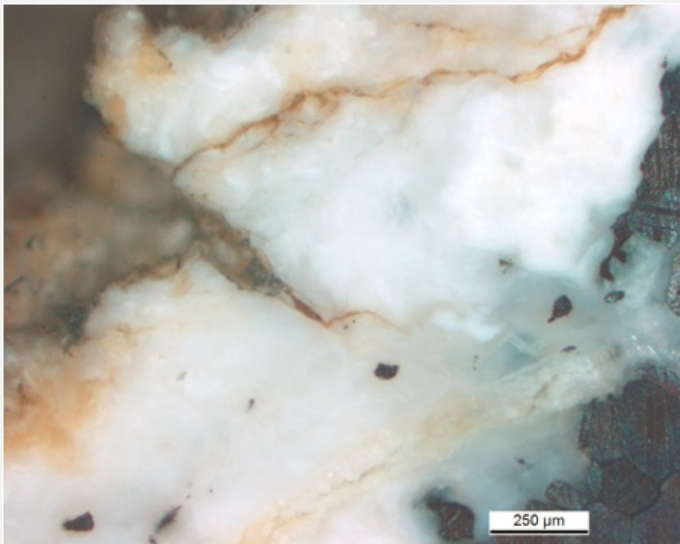
Fig. 7: Micrograph (same as Fig. 6), unetched, polarised light. We observe in dark-grey the metal, in white the corrosion crust separated by brown cracks including remnant metal,

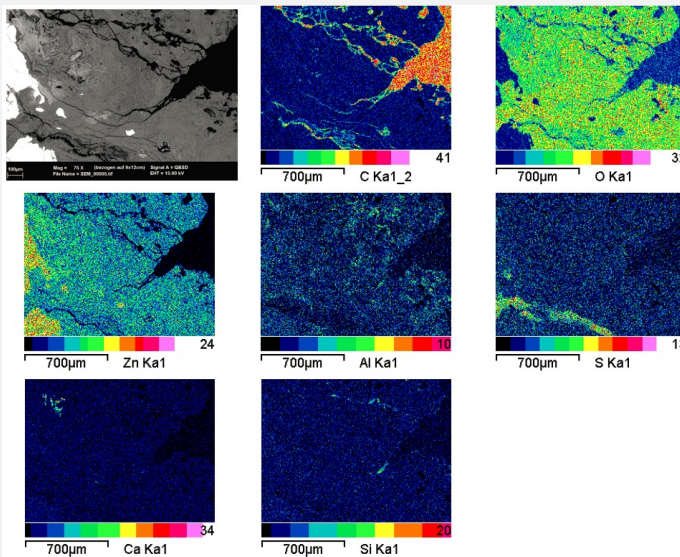
Fig. 8: SEM image, BSD-mode, and elemental chemical distribution of most of the area of Fig. 6 (reversed picture). Method of examination: SEM/EDX, Laboratory of Analytical Chemistry, Empa,
