## SACRIFICIAL ANODE VHS-8339 – ZN ALLOY – MODERN TIMES

**Artefact name** Sacrificial anode VHS-8339

**Authors** Marianne. Senn (EMPA, Dübendorf, Zurich, Switzerland) & Christian. Degrigny (HE-Arc CR, Neuchâtel, Neuchâtel, Switzerland)

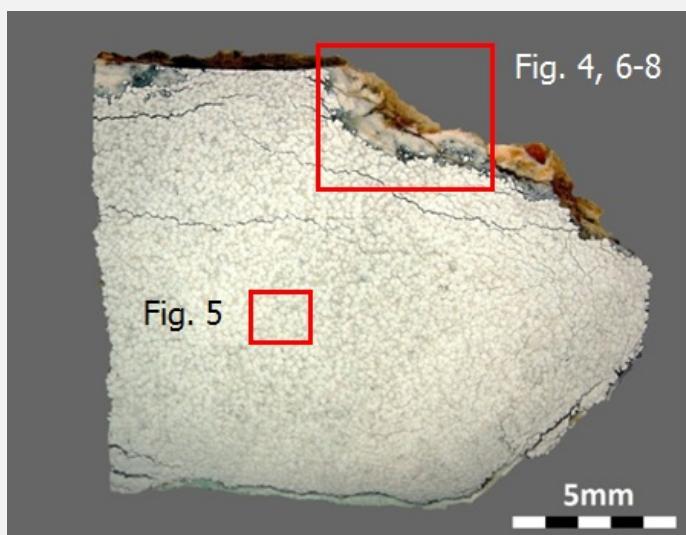
Fig. 3: Micrograph of the cross-section showing the locations of Figures 4 to 8,

The sample shows a cross-section from the sacrificial anode. The thickness of the corrosion crust is variable. Dimensions: L = 17mm; W = 14mm.

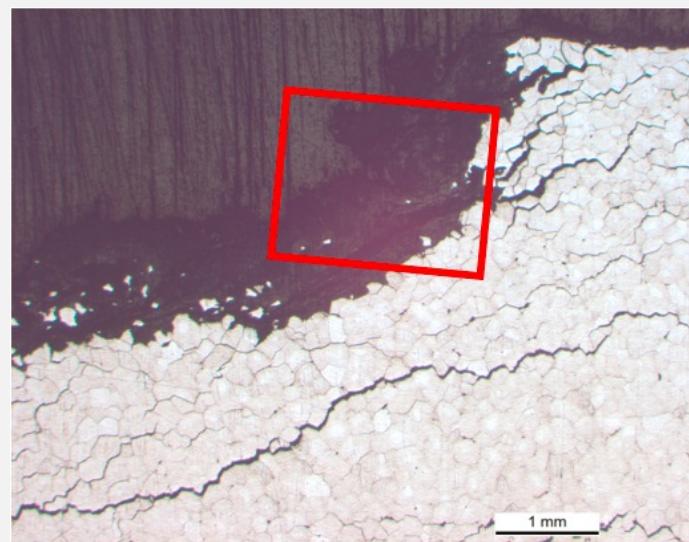
The remaining metal is an almost pure zinc alloy (Table 1). The oxygen content is not from the original alloy, but is due to secondary corrosion. The metal grains are visible without etching and present a polygonal structure (Figs. 4 and 5). The structure is recrystallised after annealing. The recrystallization of zinc alloys begins at room temperature.

Fig. 4: Micrograph of the metal sample from Fig. 3 (reversed picture, detail), unetched, bright field. Extensive intergranular corrosion is visible. The rectangle marks Fig. 6.

Extended intergranular corrosion has developed in the metal structure (Figs. 4, 5 & 6). The metal is covered by a corrosion crust that is hard to see in bright field and which contains remnant metal (Fig. 5). On most of the sample the corrosion crust is uniform. In areas we see cracks appearing as brown lines separating the corrosion crust (Figs. 6 and 7). In bright field the corrosion crust appears grey containing dark-grey zones (Fig. 6). Under polarized light, the corrosion crust appears white with darker parts including remnant metal (Fig. 7). It contains Zn and O as well as S along some cracks (Fig. 9). The cracks appear in brown.

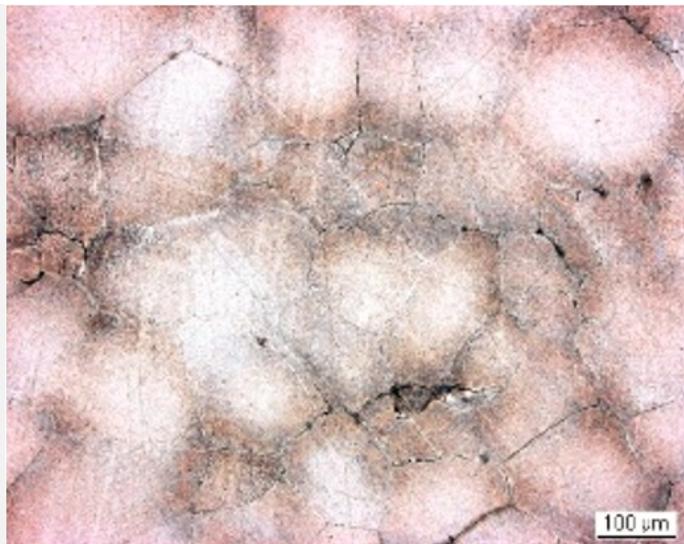
Fig. 5: Micrograph of the metal sample from Fig. 3 (detail), etched,

**Microstructure** Recrystallized structure (polygonal grains)

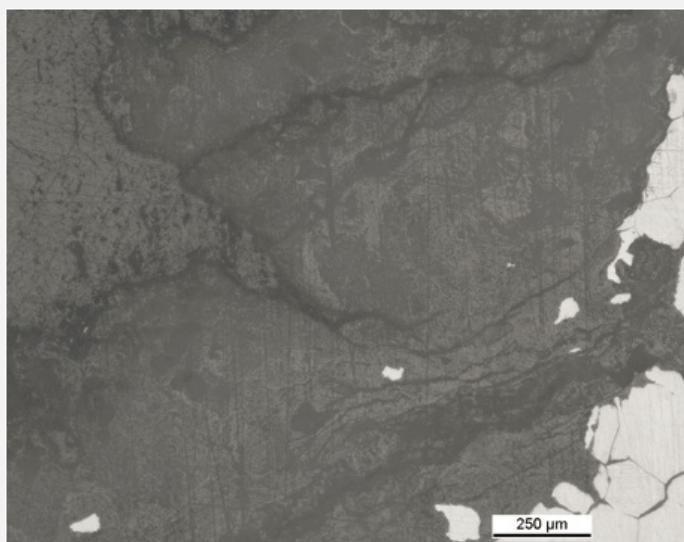
Elements	O	Al	Zn	Total
Light-grey corrosion part	23	<	77	98
Dark grey corrosion part	38	0.6	68	106

Table 2. Chemical composition (mass %) of the corrosion layer from Fig. 6. Method of analysis: SEM/EDX, Laboratory of Analytical Chemistry, Empa.

Fig. 6: Micrograph showing the metal - corrosion products interface from Fig. 4 (detail), unetched, bright field,
