SACRIFICIAL ANODE VHS-8339 - ZN ALLOY - MODERN TIMES

Artefact name Sacrificial anode VHS-8339

Authors Marianne. Senn (EMPA, Dübendorf, Zurich, Switzerland) & Christian. Degriigny (HE-Arc CR, Neuchâtel, Neuchâtel, Switzerland)

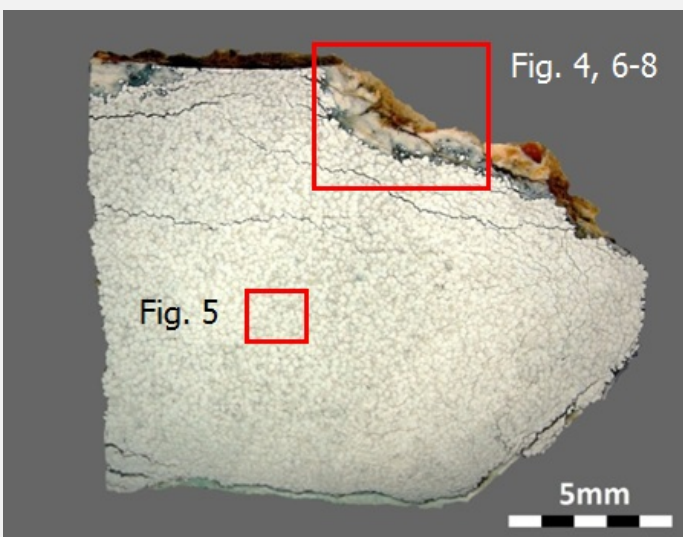
Fig. 3: Micrograph of the cross-section showing the locations of Figures 4 to 8,

The sample shows a cross-section from the sacrificial anode. The thickness of the corrosion crust is variable. Dimensions: L = 17mm; W = 14mm.

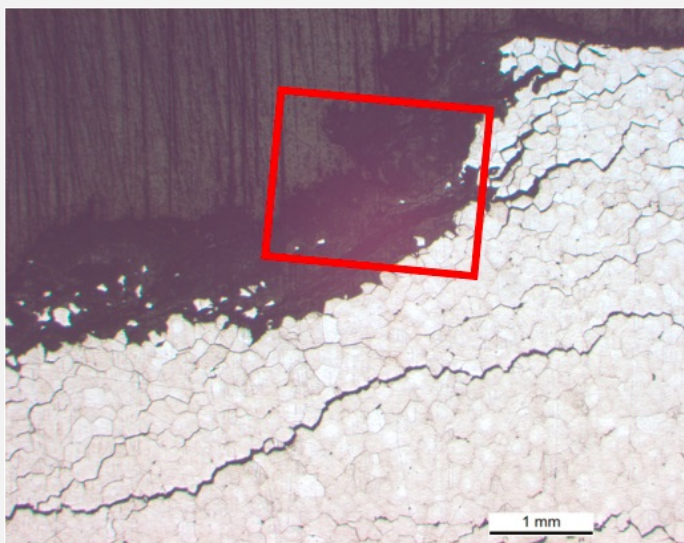
The remaining metal is an almost pure zinc alloy (Table 1). The oxygen content is not from the original alloy, but is due to secondary corrosion. The metal grains are visible without etching and present a polygonal structure (Figs. 4 and 5). The structure is recrystallised after annealing. The recrystallization of zinc alloys begins at room temperature.

Fig. 4: Micrograph of the metal sample from Fig. 3 (reversed picture, detail), unetched, bright field. Extensive intergranular corrosion is visible. The rectangle marks Fig. 6.

Extended intergranular corrosion has developed in the metal structure (Figs. 4, 5 & 6). The metal is covered by a corrosion crust that is hard to see in bright field and which contains remnant metal (Fig. 5). On most of the sample the corrosion crust is uniform. In areas we see cracks appearing as brown lines separating the corrosion crust (Figs. 6 and 7). In bright field the corrosion crust appears grey containing dark-grey zones (Fig. 6). Under polarized light, the corrosion crust appears white with darker parts including remnant metal (Fig. 7). It contains Zn and O as well as S along some cracks (Fig. 9). The cracks appear in brown.

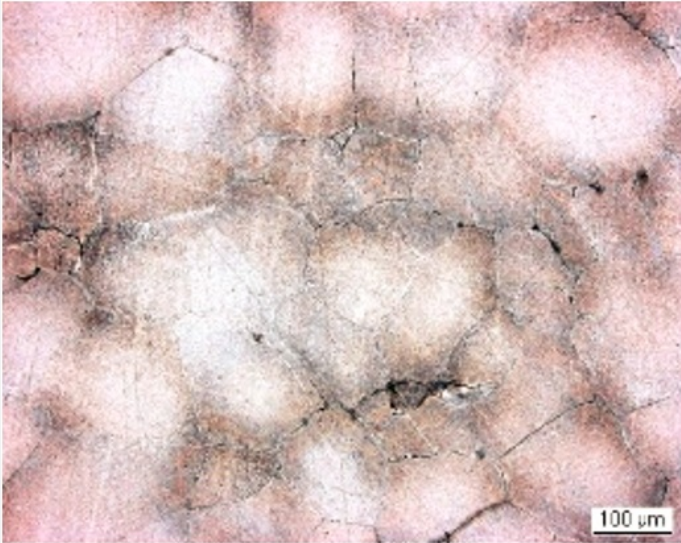
Fig. 5: Micrograph of the metal sample from Fig. 3 (detail), etched,

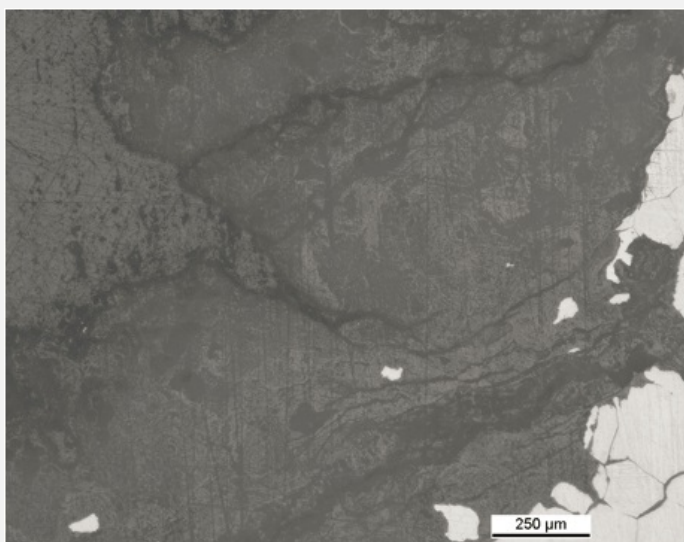
Table 2. Chemical composition (mass %) of the corrosion layer from Fig. 6. Method of analysis: SEM/EDX, Laboratory of Analytical Chemistry, Empa.

Fig. 6: Micrograph showing the metal - corrosion products interface from Fig. 4 (detail), unetched, bright field,

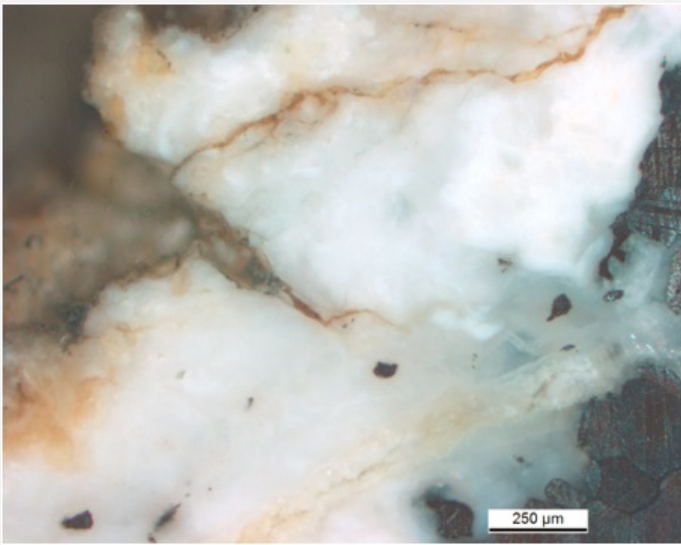
Fig. 7: Micrograph (same as Fig. 6), unetched, polarised light. We observe in dark-grey the metal, in white the corrosion crust separated by brown cracks including remnant metal,

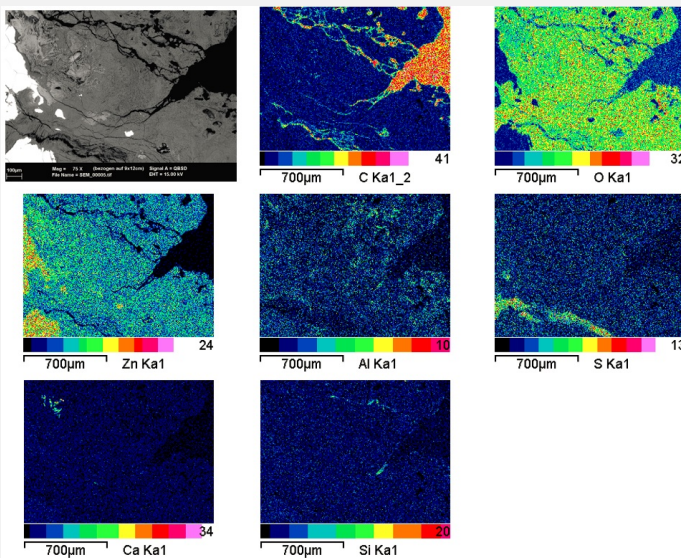
Fig. 8: SEM image, BSD-mode, and elemental chemical distribution of most of the area of Fig. 6 (reversed picture). Method of examination: SEM/EDX, Laboratory of Analytical Chemistry, Empa,
