SACRIFICIAL ANODE VHS-8339 - ZN ALLOY - MODERN TIMES

Artefact name Sacrificial anode VHS-8339

Authors Marianne. Senn (EMPA, Dübendorf, Zurich, Switzerland) & Christian. Degriigny (HE-Arc CR, Neuchâtel, Neuchâtel, Switzerland)

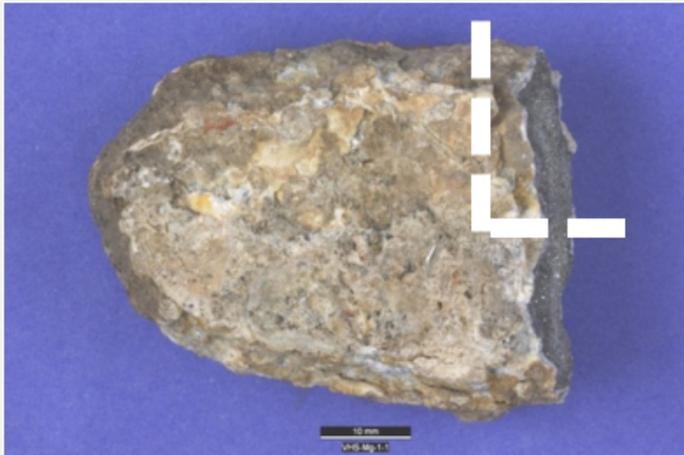
Fig. 2: Location of sampling area,

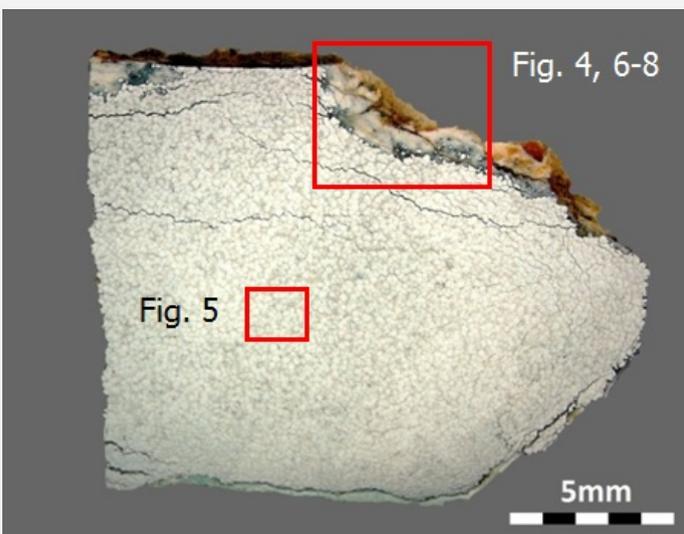
Fig. 3: Micrograph of the cross-section showing the locations of Figures 4 to 8,

The sample shows a cross-section from the sacrificial anode. The thickness of the corrosion crust is variable. Dimensions: L = 17mm; W = 14mm.

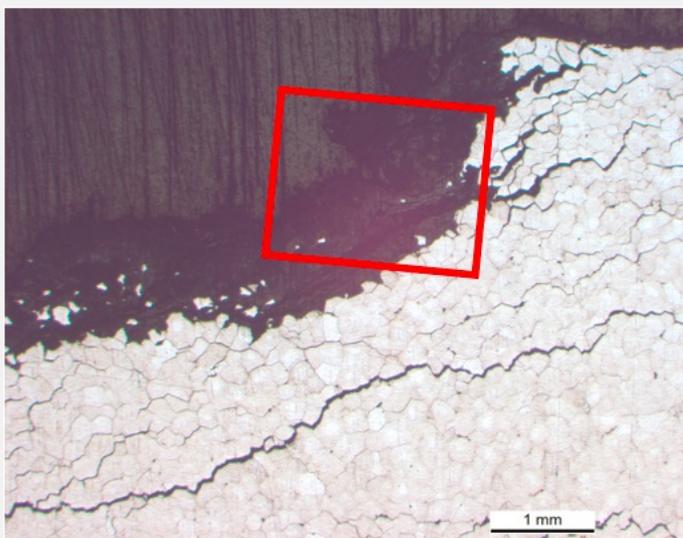
The remaining metal is an almost pure zinc alloy (Table 1). The oxygen content is not from the original alloy, but is due to secondary corrosion. The metal grains are visible without etching and present a polygonal structure (Figs. 4 and 5). The structure is recrystallised after annealing. The recrystallization of zinc alloys begins at room temperature.

Fig. 4: Micrograph of the metal sample from Fig. 3 (reversed picture, detail), unetched, bright field. Extensive intergranular corrosion is visible. The rectangle marks Fig. 6.

Extended intergranular corrosion has developed in the metal structure (Figs. 4, 5 & 6). The metal is covered by a corrosion crust that is hard to see in bright field and which contains remnant metal (Fig. 5). On most of the sample the corrosion crust is uniform. In areas we see cracks appearing as brown lines separating the corrosion crust (Figs. 6 and 7). In bright field the corrosion crust appears grey containing dark-grey zones (Fig. 6). Under polarized light, the corrosion crust appears white with darker parts including remnant metal (Fig. 7). It contains Zn and O as well as S along some cracks (Fig. 9). The cracks appear in brown.

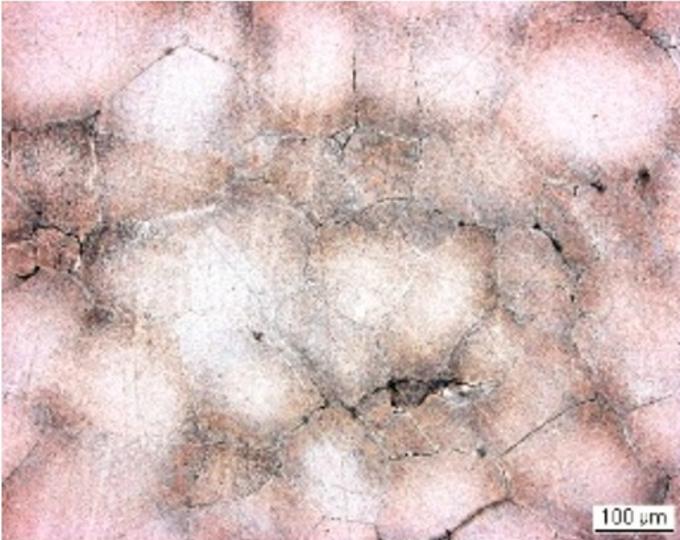
Fig. 5: Micrograph of the metal sample from Fig. 3 (detail), etched,

Microstructure Recrystallized structure (polygonal grains)

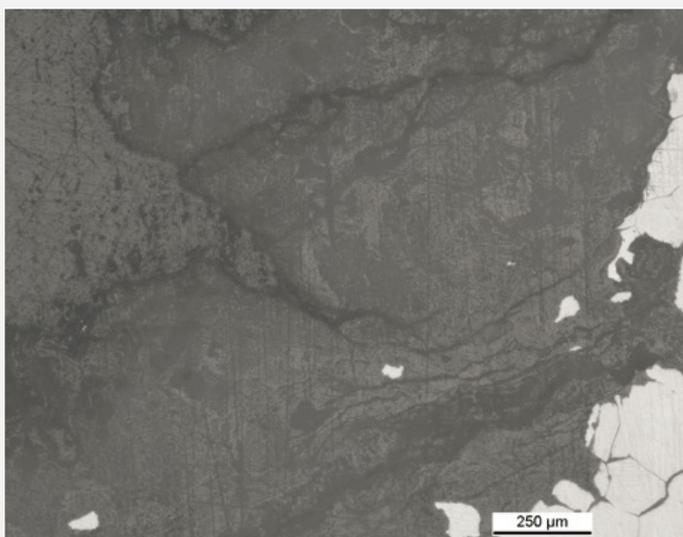
Elements	O	Al	Zn	Total
Light-grey corrosion part	23	<	77	98
Dark grey corrosion part	38	0.6	68	106

Table 2. Chemical composition (mass %) of the corrosion layer from Fig. 6. Method of analysis: SEM/EDX, Laboratory of Analytical Chemistry, Empa.

Fig. 6: Micrograph showing the metal - corrosion products interface from Fig. 4 (detail), unetched, bright field,

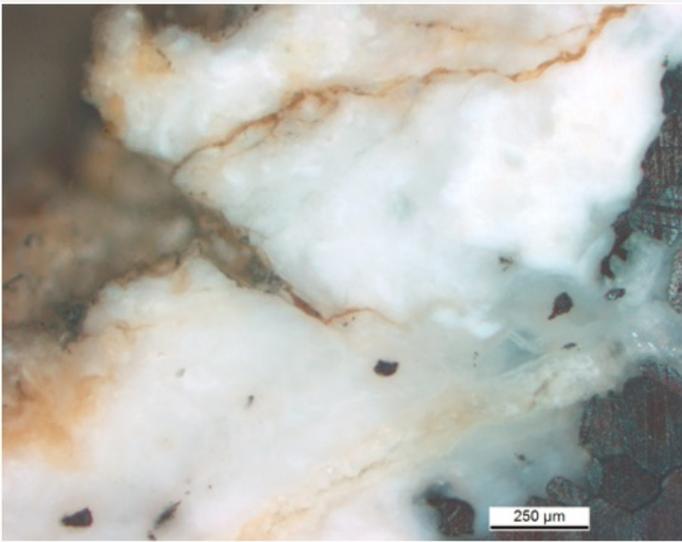
Fig. 7: Micrograph (same as Fig. 6), unetched, polarised light. We observe in dark-grey the metal, in white the corrosion crust separated by brown cracks including remnant metal,

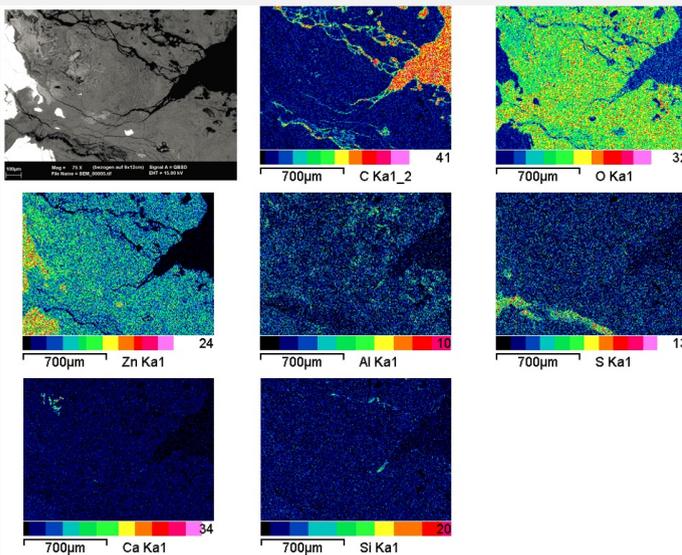
Fig. 8: SEM image, BSD-mode, and elemental chemical distribution of most of the area of Fig. 6 (reversed picture). Method of examination: SEM/EDX, Laboratory of Analytical Chemistry, Empa,
