SACRIFICIAL ANODE VHS-8339 – ZN ALLOY – MODERN TIMES

Artefact name Sacrificial anode VHS-8339

Authors Marianne. Senn (EMPA, Dübendorf, Zurich, Switzerland) & Christian. Degriy (HE-Arc CR, Neuchâtel, Neuchâtel, Switzerland)

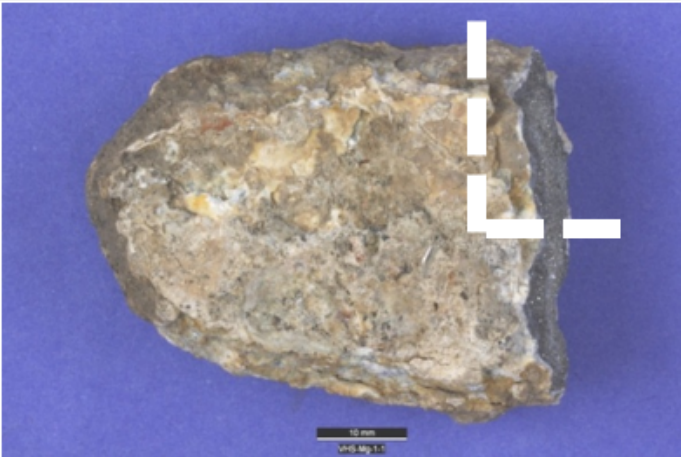
Fig. 2: Location of sampling area,

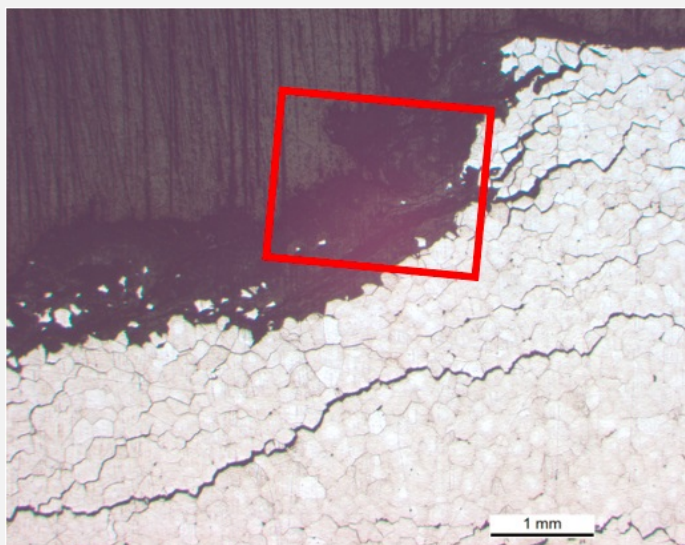
The remaining metal is an almost pure zinc alloy (Table 1). The oxygen content is not from the original alloy, but is due to secondary corrosion. The metal grains are visible without etching and present a polygonal structure (Figs. 4 and 5). The structure is recrystallised after annealing. The recrystallization of zinc alloys begins at room temperature.

Fig. 4: Micrograph of the metal sample from Fig. 3 (reversed picture, detail), unetched, bright field. Extensive intergranular corrosion is visible. The rectangle marks Fig. 6,

Extended intergranular corrosion has developed in the metal structure (Figs. 4, 5 & 6). The metal is covered by a corrosion crust that is hard to see in bright field and which contains remnant metal (Fig. 5). On most of the sample the corrosion crust is uniform. In areas we see cracks appearing as brown lines separating the corrosion crust (Figs. 6 and 7). In bright field the corrosion crust appears grey containing dark-grey zones (Fig. 6). Under polarized light, the corrosion crust appears white with darker parts including remnant metal (Fig. 7). It contains Zn and O as well as S along some cracks (Fig. 9). The cracks appear in brown.

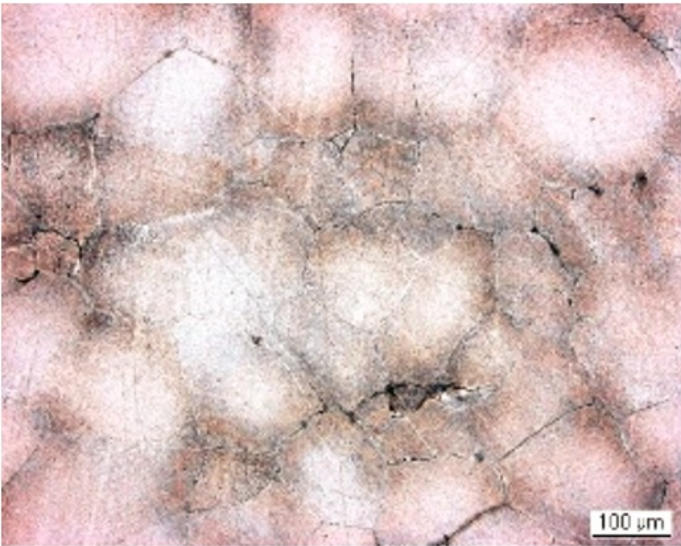
Fig. 5: Micrograph of the metal sample from Fig. 3 (detail), etched,

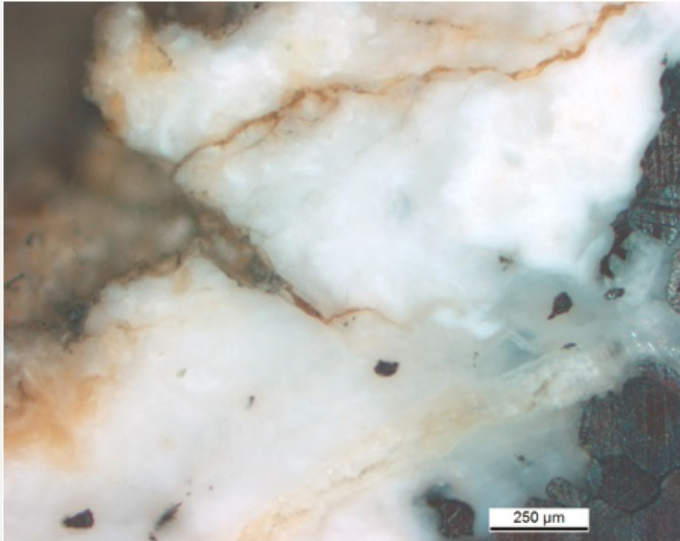
Fig. 7: Micrograph (same as Fig. 6), unetched, polarised light. We observe in dark-grey the metal, in white the corrosion crust separated by brown cracks including remnant metal,
