SHINGLE OF A ROOF - CU ALLOY - MODERN TIMES - SWITZERLAND

Authors Marianne. Senn (EMPA, Dübendorf, Zurich, Switzerland) & Christian. Degrigny (HE-Arc CR, Neuchâtel, Neuchâtel, Switzerland)

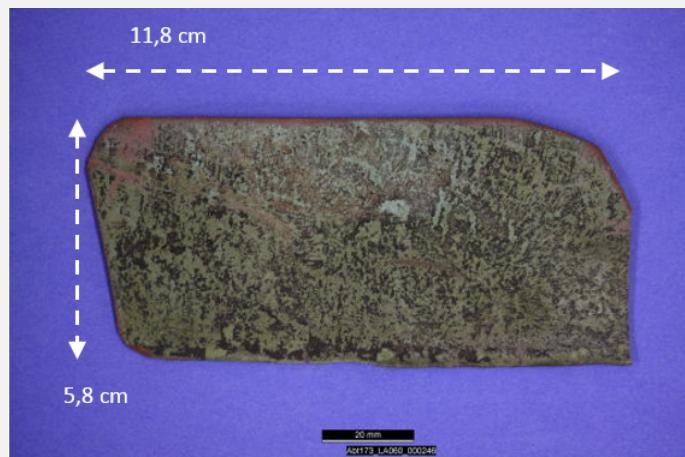
Fig. 1: Copper alloy shingle, internal side,

Shingle, slightly curved, the internal side is covered with green and black corrosion products distributed heterogeneously (Fig. 1). The external side shows a regular dark green corrosion crust. Dimensions: L = 11.8cm; W = 5.8cm.

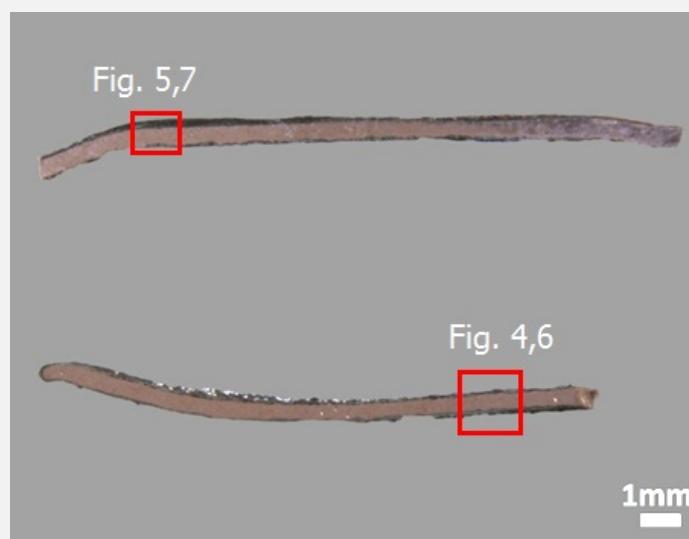
Fig. 3: Micrograph of the cross-sections showing the locations of Figures 4 to 7,

Description of sample	The polished samples show a well-preserved metal surface with a thin corrosion crust (Fig. 3). T = 0.5mm.
Alloy	Cu Alloy
Technology	Rolled (probably hot rolling) and annealed
Lab number of sample	MAH-98-257
Sample location	Empa (Marianne Senn)
Responsible institution	Conservation Department of the Musées d'art et d'histoire, Genève, Geneva
Date and aim of sampling	2009, integration of sample to the MIFAC-Métal project

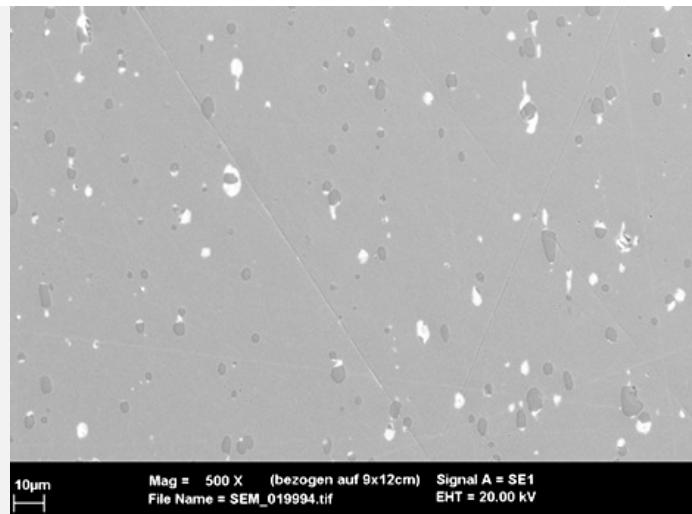
The remaining metal is a copper alloy (Table 1). The evenly distributed inclusions observed under SEM, SE-mode, are either light-grey or white (Fig. 4). The oval shape of the light-grey inclusions is due to deformation, probably hot rolling (common in the 18th century). Under polarised light they look red (Fig. 6) and their analysis reveals a composition similar to cuprite/Cu₂O (Table 2). The white inclusions are rich in Pb and are remnants of the refining process (Table 2). The etched copper shows a structure of polygonal and twinned grains (Fig. 5). The grain size is variable. The average hardness of the metal is about HV1 70.

Fig. 4: SEM image, SE-mode, of the metal sample from Fig. 3 (detail). Light-grey and white inclusions are distributed evenly,

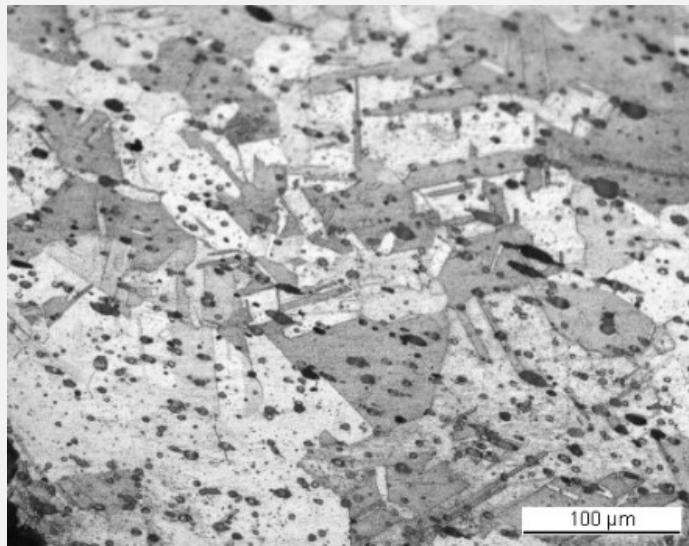
Fig. 5: Micrograph of the metal sample from Fig. 3 (detail), etched, bright field. The metal shows a structure of polygonal and twinned grains. Cuprite inclusions appear as dark spots,

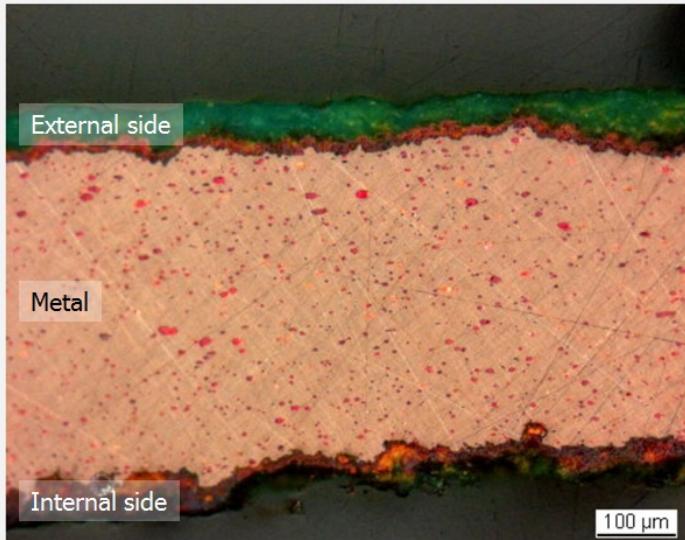
The corrosion crusts of the external and internal sides are distinctively different (Fig. 6). On the internal side an irregular red-orange corrosion layer has developed and pitting corrosion has occurred. The more uniform corrosion layers on the external side are composed of a red-orange layer, followed by a thicker green outer layer. In some areas, dark-red corrosion products can be observed between the green and red-orange sub-layers. The same dark-red sub-layer can be seen in areas on the internal side covering the red-orange corrosion products. The red-orange corrosion layer has a chemical composition similar to cuprite/Cu₂O, while the green layer contains Cu, S and O and is enriched on its upper surface with Si (Table 3 and Fig. 7). XRD analysis of the corrosion products on the external side of another shingle fragment from the same roof identified brochantite/Cu₄SO₄(OH)₆ and cuprite as corrosion products (Rapport d'analyse no MAH 98-257). These results are confirmed by Raman spectroscopy of the external side of this sample where the same compounds were clearly identified (Figs. 8 and 9).

Fig. 6: Micrograph of the metal sample from Fig. 3, polarised light. External side: the regular corrosion crust with outer green, inner red-orange corrosion products and intermediate dark-red corrosion products. Internal side: the irregular corrosion crust with inner red-orange and outer dark-red corrosion products,

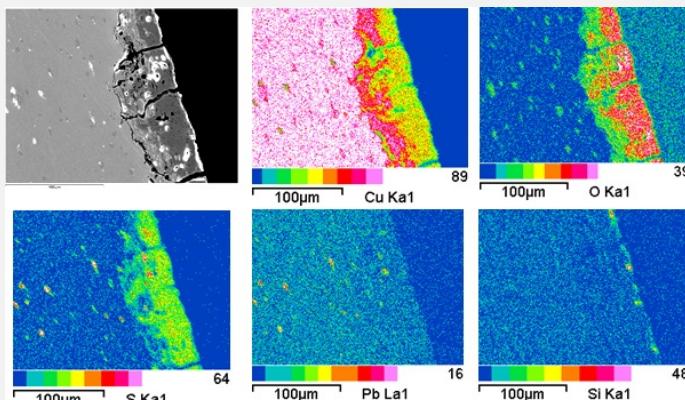
Fig. 7: SEM image, SE-mode, and elemental chemical distribution of the selected area of Fig. 3 (rotated image, detail). Method of examination: SEM/EDX, Laboratory of Analytical Chemistry, Empa,

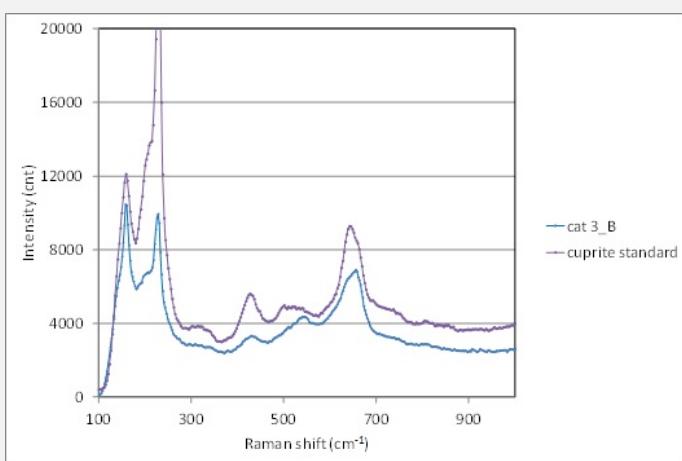
Fig. 8: Raman spectrum of the red-orange inner corrosion layer of the external side (cat3_B) compared to a cuprite standard spectrum. Settings: laser wavelength 532nm, acquisition time 100s, one accumulation, filter D2 (0.75-0.8 mW), hole 500, slit 80, grating 600. Method of analysis: Raman spectroscopy, Lab Swiss National Museum, Affoltern a. Albis ZH,

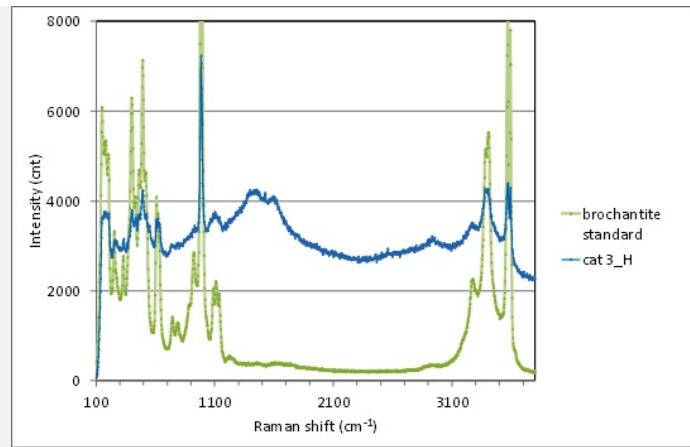
Fig. 9: Raman spectrum of the green outer corrosion layer of the external side (cat3_H) compared to a brochantite standard spectrum. Settings: laser wavelength 532nm, acquisition time 100s, one accumulation, filter D2 (0.75-0.8 mW), hole 500, slit 80, grating 600. The peak indicated with an arrow on the cat3_H spectrum is due to fluorescence. Method of analysis: Raman spectroscopy, Lab Swiss National Museum, Affoltern a. Albis ZH,

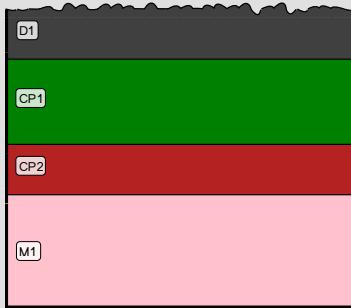
Fig. 4: Stratigraphic representation of the object in cross-section using the MiCorr application. This representation can be compared to Fig. 7.
