SHINGLE OF A ROOF - CU ALLOY - MODERN TIMES - SWITZERLAND

Artefact name Shingle of a roof

Authors Marianne. Senn (EMPA, Dübendorf, Zurich, Switzerland) & Christian. Degrigny (HE-Arc CR, Neuchâtel, Neuchâtel,

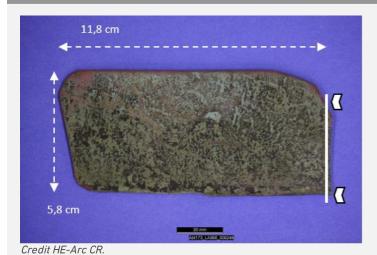
Fig. 2: showing the location of sampling area,

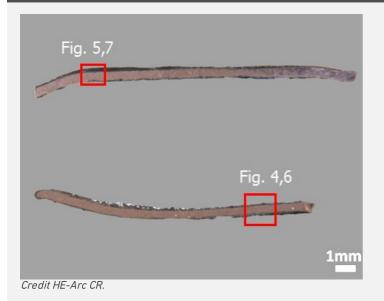
Fig. 3: Micrograph of the cross-sections showing the locations of Figures 4 to 7,

The polished samples show a well-preserved metal surface with a thin corrosion crust (Fig. 3). T = 0.5 mm.

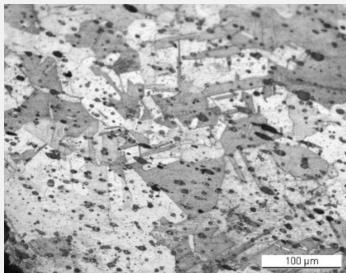
Fig. 5: Micrograph of the metal sample from Fig. 3 (detail), etched, bright field. The metal shows a structure of polygonal and twinned grains. Cuprite inclusions appear as dark spots,

Microstructure Polygonal and twinned grains, elongated inclusions

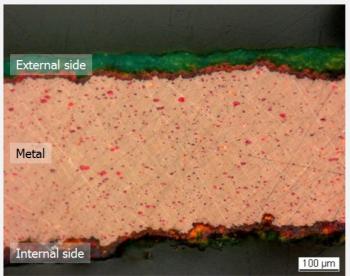
The corrosion crusts of the external and internal sides are distinctively different (Fig. 6). On the internal side an irregular red-orange corrosion layer has developed and pitting corrosion has occurred. The more uniform corrosion layers on the external side are composed of a red-orange layer, followed by a thicker green outer layer. In some areas, dark-red corrosion products can be observed between the green and red-orange sub-layers. The same dark-red sub-layer can be seen in areas on the internal side covering the red-orange corrosion products. The red-orange corrosion layer has a chemical composition similar to cuprite/Cu₂O, while the green layer contains Cu, S and O and is enriched on its upper surface with Si (Table 3 and Fig. 7). XRD analysis of the $corrosion\ products\ on\ the\ external\ side\ of\ another\ shingle\ fragment\ from\ the\ same\ roof\ identified\ brochantite/Cu_4SO_4(OH)_6\ and$ cuprite as corrosion products (Rapport d'analyse no MAH 98-257). These results are confirmed by Raman spectroscopy of the external side of this sample where the same compounds were clearly identified (Figs. 8 and 9).

Fig. 6: Micrograph of the metal sample from Fig. 3, polarised light. External side: the regular corrosion crust with outer green, inner redorange corrosion products and intermediate dark-red corrosion products. Internal side: the irregular corrosion crust with inner redorange and outer dark-red corrosion products,
