## SHINGLE OF A ROOF – CU ALLOY – MODERN TIMES – SWITZERLAND

<b>Artefact name</b>	Shingle of a roof
<b>Authors</b>	Marianne. Senn (EMPA, Dübendorf, Zurich, Switzerland) & Christian. Degriigny (HE-Arc CR, Neuchâtel, Neuchâtel, Switzerland)
<b>Url</b>	/artefacts/220/

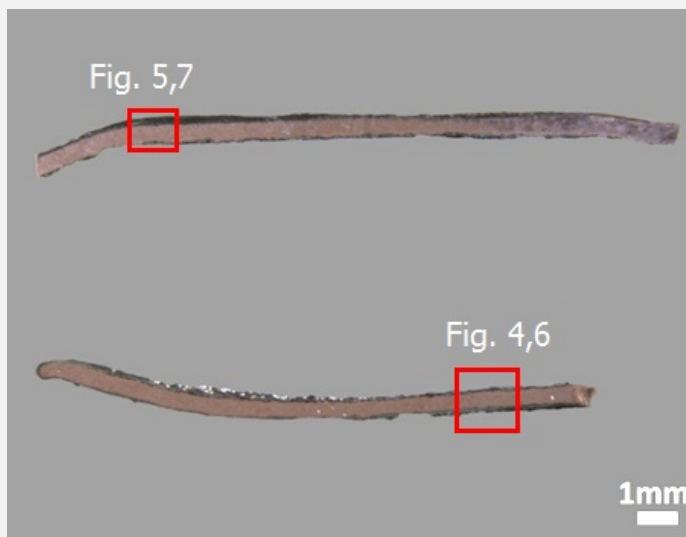
Fig. 3: Micrograph of the cross-sections showing the locations of Figures 4 to 7,

The polished samples show a well-preserved metal surface with a thin corrosion crust (Fig. 3). T = 0.5mm.

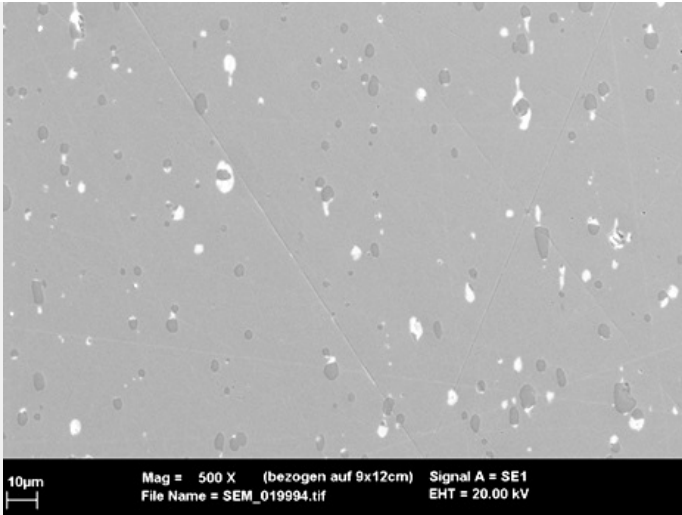
The remaining metal is a copper alloy (Table 1). The evenly distributed inclusions observed under SEM, SE-mode, are either light-grey or white (Fig. 4). The oval shape of the light-grey inclusions is due to deformation, probably hot rolling (common in the 18th century). Under polarised light they look red (Fig. 6) and their analysis reveals a composition similar to cuprite/Cu<sub>2</sub>O (Table 2). The white inclusions are rich in Pb and are remnants of the refining process (Table 2). The etched copper shows a structure of polygonal and twinned grains (Fig. 5). The grain size is variable. The average hardness of the metal is about HV1 70.

Fig. 4: SEM image, SE-mode, of the metal sample from Fig. 3 (detail). Light-grey and white inclusions are distributed evenly,

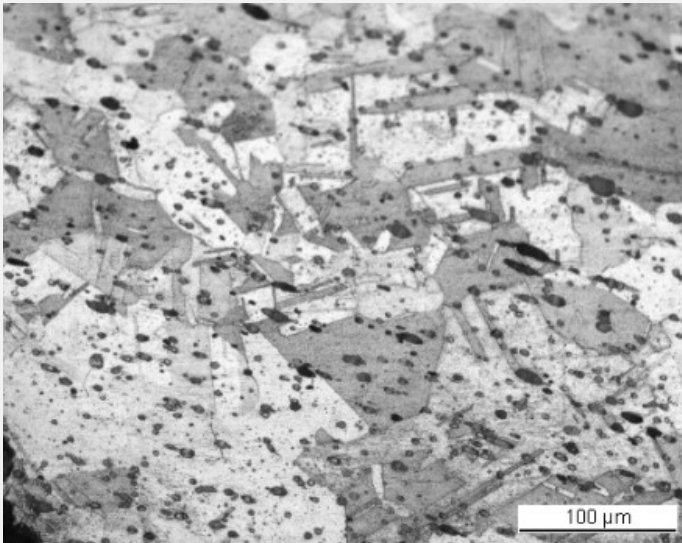
Fig. 5: Micrograph of the metal sample from Fig. 3 (detail), etched, bright field. The metal shows a structure of polygonal and twinned grains. Cuprite inclusions appear as dark spots,

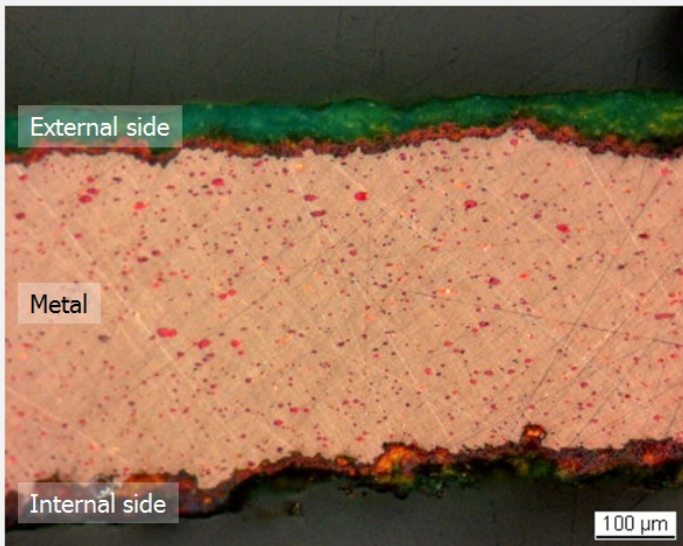
The corrosion crusts of the external and internal sides are distinctively different (Fig. 6). On the internal side an irregular red-orange corrosion layer has developed and pitting corrosion has occurred. The more uniform corrosion layers on the external side are composed of a red-orange layer, followed by a thicker green outer layer. In some areas, dark-red corrosion products can be observed between the green and red-orange sub-layers. The same dark-red sub-layer can be seen in areas on the internal side covering the red-orange corrosion products. The red-orange corrosion layer has a chemical composition similar to cuprite/ $\text{Cu}_2\text{O}$ , while the green layer contains Cu, S and O and is enriched on its upper surface with Si (Table 3 and Fig. 7). XRD analysis of the corrosion products on the external side of another shingle fragment from the same roof identified brochantite/ $\text{Cu}_4\text{SO}_4(\text{OH})_6$  and cuprite as corrosion products (Rapport d'analyse no MAH 98-257). These results are confirmed by Raman spectroscopy of the external side of this sample where the same compounds were clearly identified (Figs. 8 and 9).

Fig. 6: Micrograph of the metal sample from Fig. 3, polarised light. External side: the regular corrosion crust with outer green, inner red-orange corrosion products and intermediate dark-red corrosion products. Internal side: the irregular corrosion crust with inner red-orange and outer dark-red corrosion products,

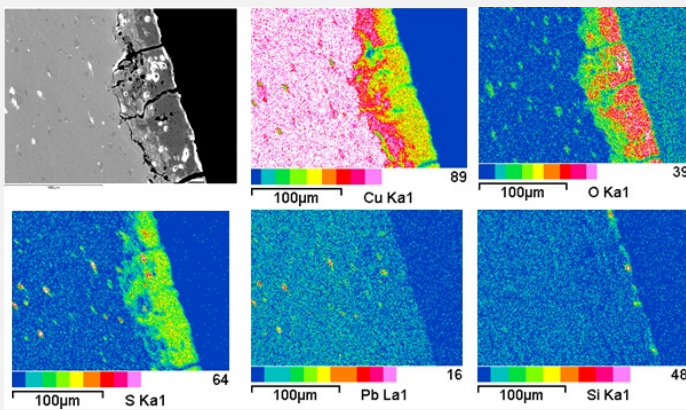
Fig. 7: SEM image, SE-mode, and elemental chemical distribution of the selected area of Fig. 3 (rotated image, detail). Method of examination: SEM/EDX, Laboratory of Analytical Chemistry, Empa.

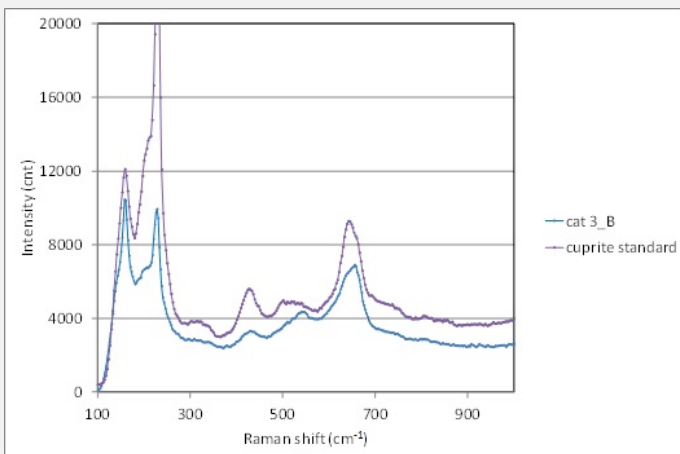
Fig. 8: Raman spectrum of the red-orange inner corrosion layer of the external side (cat3\_B) compared to a cuprite standard spectrum. Settings: laser wavelength 532nm, acquisition time 100s, one accumulation, filter D2 (0.75-0.8 mW), hole 500, slit 80, grating 600. Method of analysis: Raman spectroscopy, Lab Swiss National Museum, Affoltern a. Albis ZH,

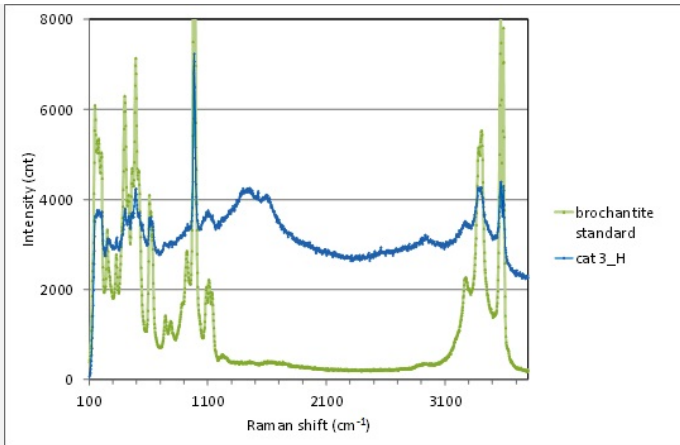
Fig. 9: Raman spectrum of the green outer corrosion layer of the external side (cat3\_H) compared to a brochantite standard spectrum. Settings: laser wavelength 532nm, acquisition time 100s, one accumulation, filter D2 (0.75-0.8 mW), hole 500, slit 80, grating 600. The peak indicated with an arrow on the cat3\_H spectrum is due to fluorescence. Method of analysis: Raman spectroscopy, Lab Swiss National Museum, Affoltern a. Albis ZH,

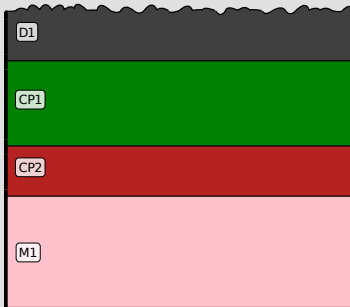
Fig. 4: Stratigraphic representation of the object in cross-section using the MiCorr application. This representation can be compared to Fig. 7.
