SHINGLE OF A ROOF – CU ALLOY – MODERN TIMES – SWITZERLAND

Artefact name	Shingle of a roof
Authors	Marianne. Senn (EMPA, Dübendorf, Zurich, Switzerland) & Christian. Degrieny (HE-Arc CR, Neuchâtel, Neuchâtel, Switzerland)
Url	/artefacts/220/

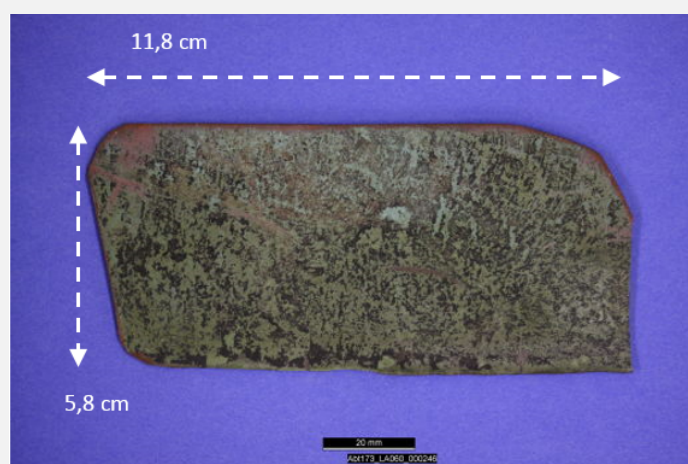
Fig. 1: Copper alloy shingle, internal side,

Description of the artefact	Shingle, slightly curved, the internal side is covered with green and black corrosion products distributed heterogeneously (Fig. 1). The external side shows a regular dark green corrosion crust. Dimensions: L = 11.8cm; W = 5.8cm.
Type of artefact	Architectural element
Origin	Roof of the abbey of St. Gallen, Sankt Gallen, Saint Gallen, Switzerland
Recovering date	None
Chronology category	Modern Times
chronology tpq	<input type="text" value="1780"/> A.D. ▼
chronology taq	<input type="text" value=""/> ---- ▼
Chronology comment	1780
Burial conditions / environment	Outdoor atmosphere
Artefact location	Conservation Department of the Musées d'art et d'histoire, Genève, Geneva
Owner	Abbey of St Gallen, Sankt Gallen, Saint Gallen

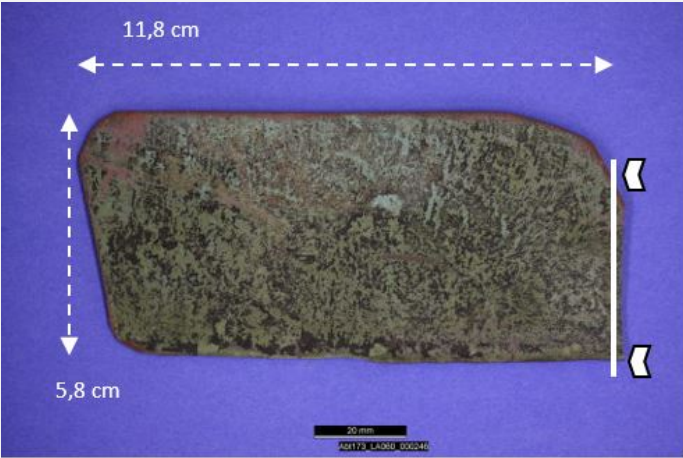
Fig. 2: showing the location of sampling area,

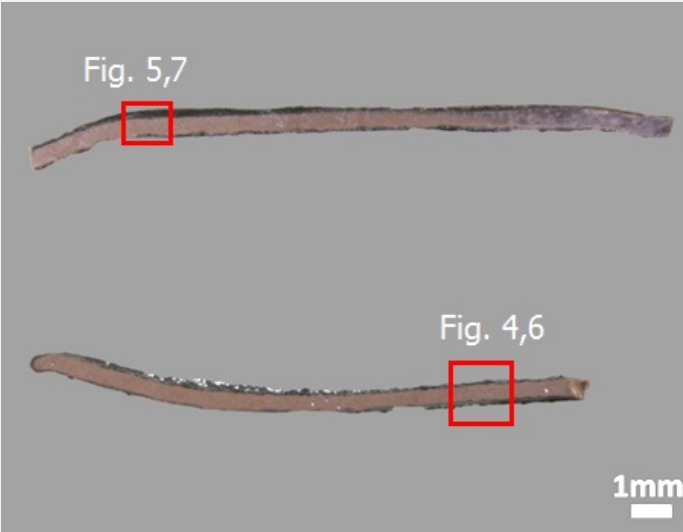
Fig. 3: Micrograph of the cross-sections showing the locations of Figures 4 to 7,

Description of sample
 The polished samples show a well-preserved metal surface with a thin corrosion crust (Fig. 3). T = 0.5mm.

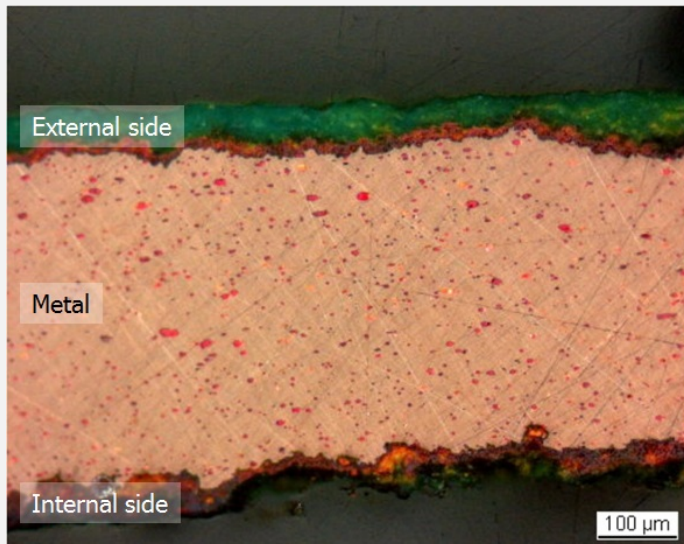
The corrosion crusts of the external and internal sides are distinctively different (Fig. 6). On the internal side an irregular red-orange corrosion layer has developed and pitting corrosion has occurred. The more uniform corrosion layers on the external side are composed of a red-orange layer, followed by a thicker green outer layer. In some areas, dark-red corrosion products can be observed between the green and red-orange sub-layers. The same dark-red sub-layer can be seen in areas on the internal side covering the red-orange corrosion products. The red-orange corrosion layer has a chemical composition similar to cuprite/ Cu_2O , while the green layer contains Cu, S and O and is enriched on its upper surface with Si (Table 3 and Fig. 7). XRD analysis of the corrosion products on the external side of another shingle fragment from the same roof identified brochantite/ $\text{Cu}_4\text{SO}_4(\text{OH})_6$ and cuprite as corrosion products (Rapport d'analyse no MAH 98-257). These results are confirmed by Raman spectroscopy of the external side of this sample where the same compounds were clearly identified (Figs. 8 and 9).

Fig. 6: Micrograph of the metal sample from Fig. 3, polarised light. External side: the regular corrosion crust with outer green, inner red-orange corrosion products and intermediate dark-red corrosion products. Internal side: the irregular corrosion crust with inner red-orange and outer dark-red corrosion products,

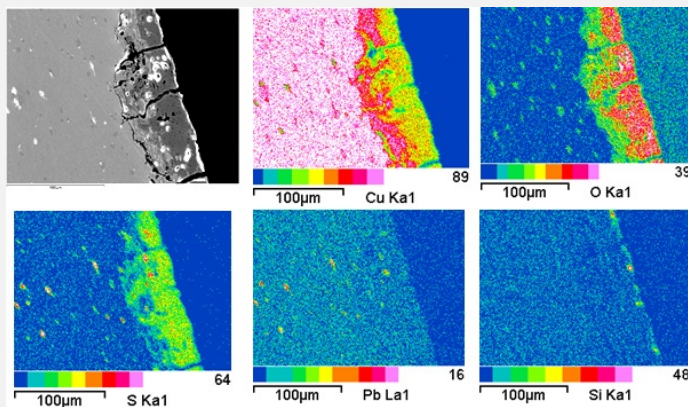
Fig. 7: SEM image, SE-mode, and elemental chemical distribution of the selected area of Fig. 3 (rotated image, detail). Method of examination: SEM/EDX, Laboratory of Analytical Chemistry, Empa,

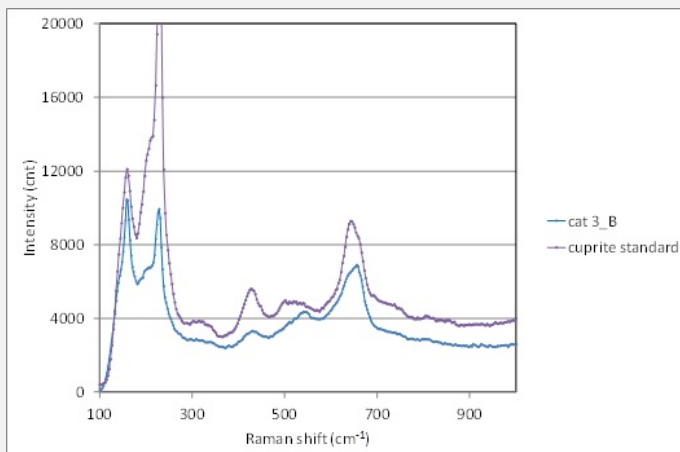
Fig. 8: Raman spectrum of the red-orange inner corrosion layer of the external side (cat3_B) compared to a cuprite standard spectrum. Settings: laser wavelength 532nm, acquisition time 100s, one accumulation, filter D2 (0.75-0.8 mW), hole 500, slit 80, grating 600. Method of analysis: Raman spectroscopy, Lab Swiss National Museum, Affoltern a. Albis ZH,

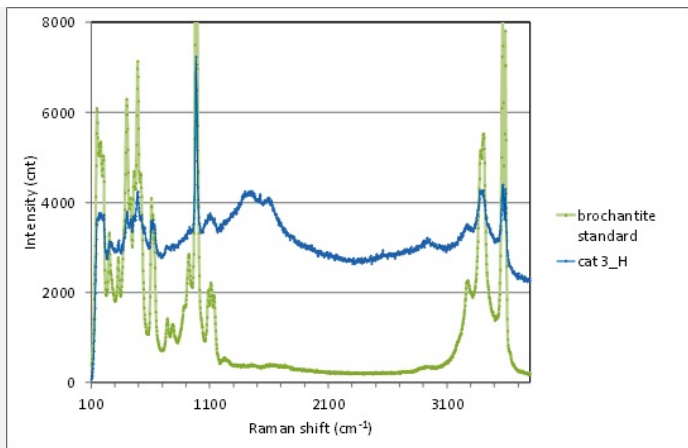
Fig. 9: Raman spectrum of the green outer corrosion layer of the external side (cat3_H) compared to a brochantite standard spectrum. Settings: laser wavelength 532nm, acquisition time 100s, one accumulation, filter D2 (0.75-0.8 mW), hole 500, slit 80, grating 600. The peak indicated with an arrow on the cat3_H spectrum is due to fluorescence. Method of analysis: Raman spectroscopy, Lab Swiss National Museum, Affoltern a. Albis ZH,

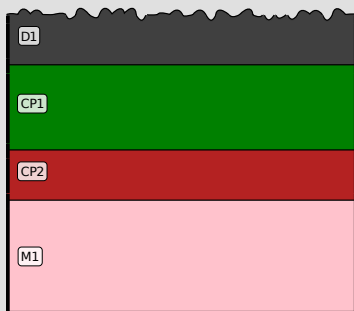
Fig. 4: Stratigraphic representation of the object in cross-section using the MiCorr application. This representation can be compared to Fig. 7.
