SHINGLE OF A ROOF – CU ALLOY – MODERN TIMES – SWITZERLAND

Artefact name	Shingle of a roof
Authors	Marianne. Senn (EMPA, Dübendorf, Zurich, Switzerland) & Christian. Degriy (HE-Arc CR, Neuchâtel, Neuchâtel, Switzerland)
Url	/artefacts/220/

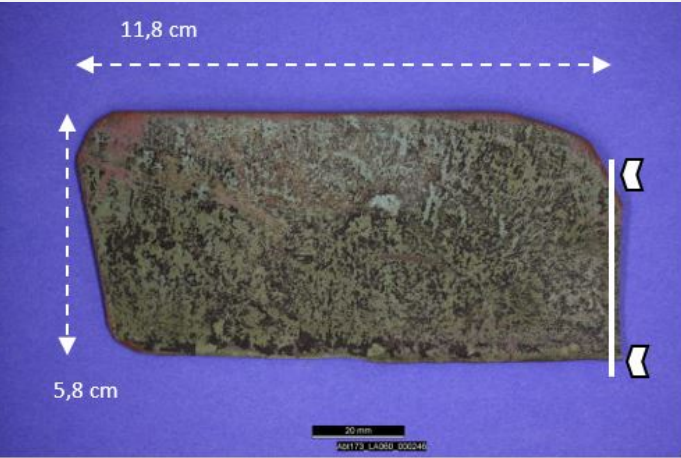
Fig. 2: showing the location of sampling area,

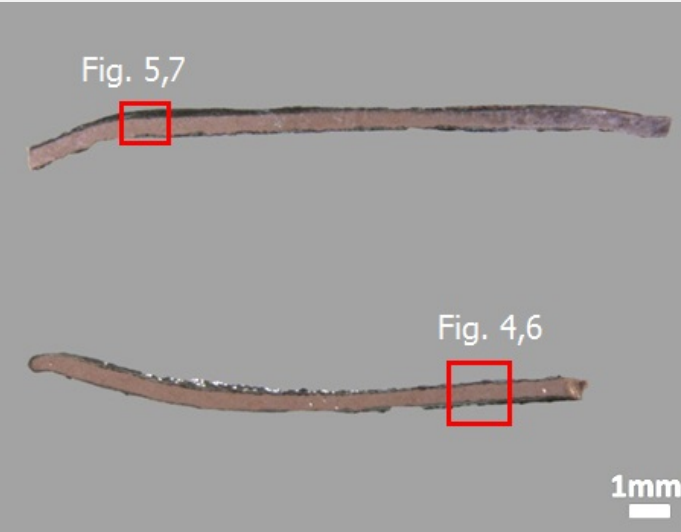
Fig. 3: Micrograph of the cross-sections showing the locations of Figures 4 to 7,

Description of sample
 The polished samples show a well-preserved metal surface with a thin corrosion crust (Fig. 3). T = 0.5mm.

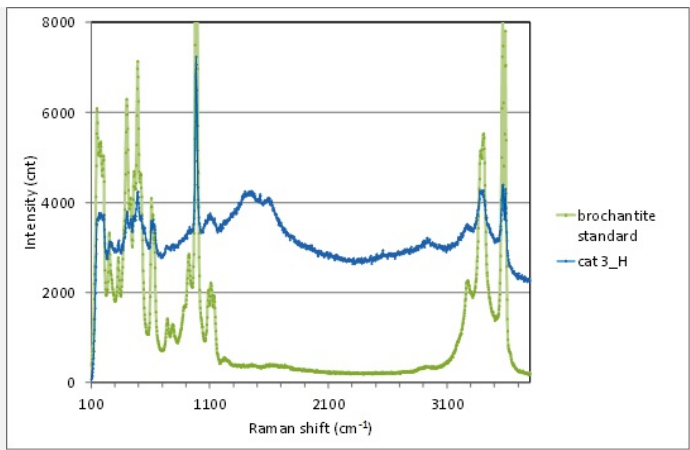
Fig. 9: Raman spectrum of the green outer corrosion layer of the external side (cat3_H) compared to a brochantite standard spectrum. Settings: laser wavelength 532nm, acquisition time 100s, one accumulation, filter D2 (0.75-0.8 mW), hole 500, slit 80, grating 600. The peak indicated with an arrow on the cat3_H spectrum is due to fluorescence. Method of analysis: Raman spectroscopy, Lab Swiss National Museum, Affoltern a. Albis ZH,

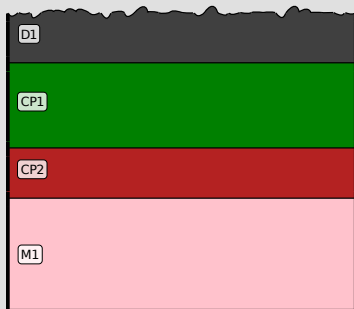
Fig. 4: Stratigraphic representation of the object in cross-section using the MiCorr application. This representation can be compared to Fig. 7.
