# SITULA EMT09-554.665 - TIN BRONZE - IRON AGE - SWITZERLAND

Artefact name Situla EMT09-554.665

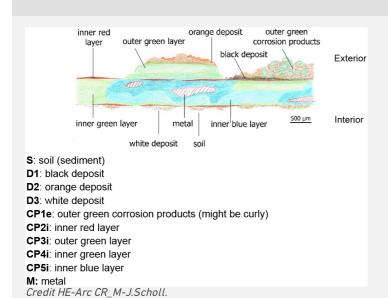
Fig. 3: Stratigraphic representation of the situla in cross-section by macroscopic observation,

The schematic representation below gives an overview of the corrosion layers encountered on the situla from a first visual macroscopic observation.

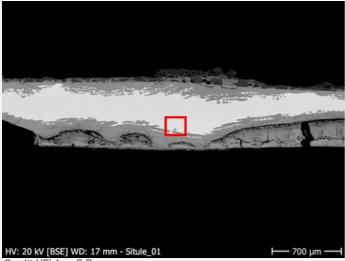
Fig. 5: SEM image, BSD-mode, of the metal sample from Fig. 4. Area of Fig. 6 is marked by a rectangle,

The remaining metal is a dense tin bronze (Fig. 5, Table 1), showing no inclusion. In bright field, the etched alloy shows a structure principally consisting of polygonal alpha phase grains (Fig. 6). Some of the grains include twin lines (Fig. 7). The presence of strain lines (slip lines) indicates a final cold work without annealing (Fig. 7).

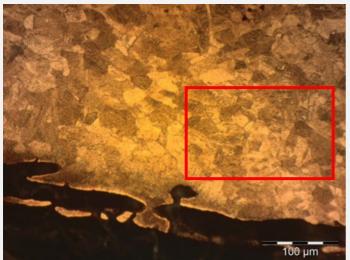
Fig. 6: Micrograph of the etched metal structure from Fig. 5 (detail), etched, bright field, 50x. The alpha phase of the alloy shows polygonal grains. Area of Fig. 7 is marked by a rectangle,

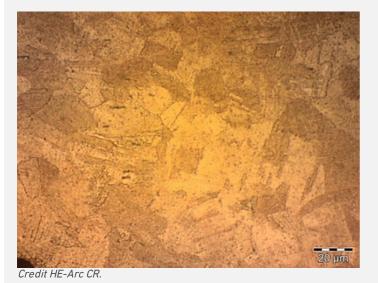
Fig. 7: Micrograph of the selected area of Fig. 6, etched, bright field, 500x. The grains show both twin and strain lines,

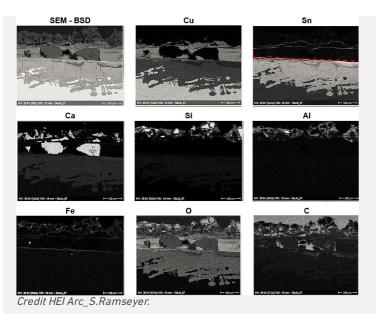
The inner layers are Sn and O-rich and depleted in Cu (Table 2). The outer layers are Cu and O-rich, contain no Sn, and are contaminated with Ca, Si, Al and Fe coming from the soil (Fig. 10). The colour of the corrosion crust varies according to the content of Sn (the more Sn, the darker green or blue the corrosion). FTIR and Raman spectra on the inner blue (Fig. 12) and outer green (Fig. 13) layers were difficult to interpret. Only malachite could be identified in both cases. XRD spectra could not be interpreted because of the deficiency of peaks.

Fig. 10: SEM image, SE-mode, and elemental chemical distribution of the selected area of Fig. 12. In red: the limit of the original surface

highlighted by the enriched tin layer. Method of examination: SEM-EDX, Lab of Electronic Microscopy and Microanalysis, IMA (Néode), HEI Arc.
