# SITULA EMT09-554.665 - TIN BRONZE - IRON AGE - SWITZERLAND

Artefact name Situla EMT09-554.665

Christian. Degrigny (HE-Arc CR, Neuchâtel, Neuchâtel, Switzerland) & Marie-Jeanne. Scholl (HE-Arc CR, Neuchâtel, **Authors**

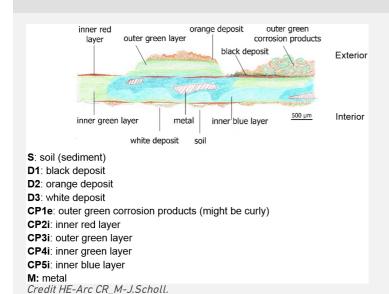
Fig. 3: Stratigraphic representation of the situla in cross-section by macroscopic observation,

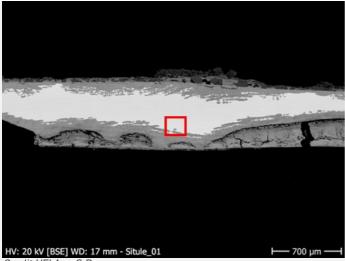
The remaining metal is a dense tin bronze (Fig. 5, Table 1), showing no inclusion. In bright field, the etched alloy shows a structure principally consisting of polygonal alpha phase grains (Fig. 6). Some of the grains include twin lines (Fig. 7). The presence of strain lines (slip lines) indicates a final cold work without annealing (Fig. 7).

Fig. 5: SEM image, BSD-mode, of the metal sample from Fig. 4. Area of Fig. 6 is marked by a rectangle,

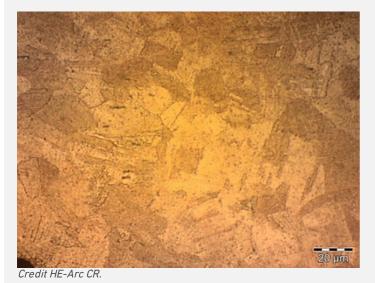
Fig. 7: Micrograph of the selected area of Fig. 6, etched, bright field, 500x. The grains show both twin and strain lines,

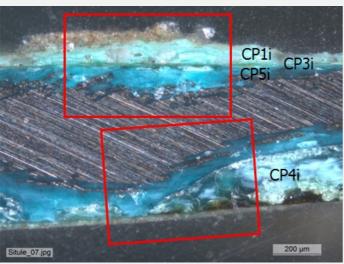
Fig. 8: Micrograph of the metal sample from Fig. 4, unetched, dark field, 50x. Areas of Fig. 9 (bottom) and Figs. 10 and 11 (top) are marked by a rectangle,

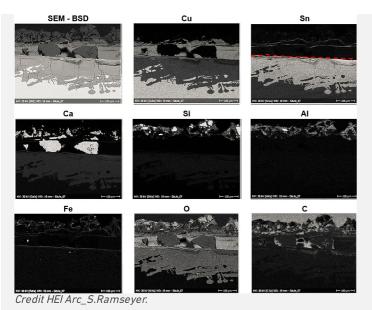
The inner layers are Sn and O-rich and depleted in Cu (Table 2). The outer layers are Cu and O-rich, contain no Sn, and are contaminated with Ca, Si, Al and Fe coming from the soil (Fig. 10). The colour of the corrosion crust varies according to the content of Sn (the more Sn, the darker green or blue the corrosion). FTIR and Raman spectra on the inner blue (Fig. 12) and outer green (Fig. 13) layers were difficult to interpret. Only malachite could be identified in both cases. XRD spectra could not be interpreted because of the deficiency of peaks.

Fig. 10: SEM image, SE-mode, and elemental chemical distribution of the selected area of Fig. 12. In red: the limit of the original surface

highlighted by the enriched tin layer. Method of examination: SEM-EDX, Lab of Electronic Microscopy and Microanalysis, IMA (Néode), HEI Arc.
