SITULA EMT09-554.665 - TIN BRONZE - IRON AGE - SWITZERLAND

Artefact name	Situla EMT09-554.665
Authors	Christian. Degriigny (HE-Arc CR, Neuchâtel, Neuchâtel, Switzerland) & Marie-Jeanne. Scholl (HE-Arc CR, Neuchâtel, Neuchâtel, Switzerland) & Valentin. Boissonnas (HE-Arc CR, Neuchâtel, Neuchâtel, Switzerland)
Url	/artefacts/221/

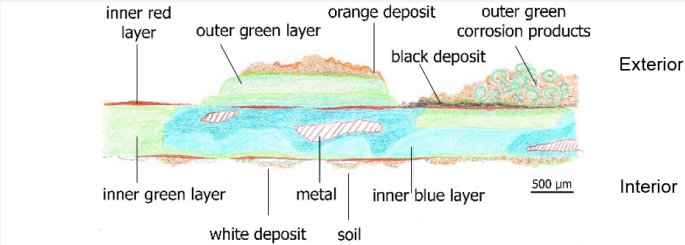
- S:** soil (sediment)
D1: black deposit
D2: orange deposit
D3: white deposit
CP1e: outer green corrosion products (might be curly)
CP2i: inner red layer
CP3i: outer green layer
CP4i: inner green layer
CP5i: inner blue layer
M: metal

Fig. 3: Stratigraphic representation of the situla in cross-section by macroscopic observation,

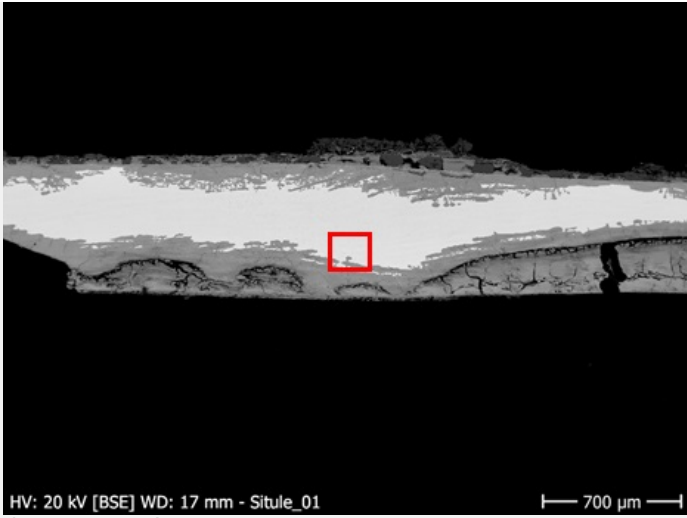
The remaining metal is a dense tin bronze (Fig. 5, Table 1), showing no inclusion. In bright field, the etched alloy shows a structure principally consisting of polygonal alpha phase grains (Fig. 6). Some of the grains include twin lines (Fig. 7). The presence of strain lines (slip lines) indicates a final cold work without annealing (Fig. 7).

Fig. 5: SEM image, BSD-mode, of the metal sample from Fig. 4. Area of Fig. 6 is marked by a rectangle,

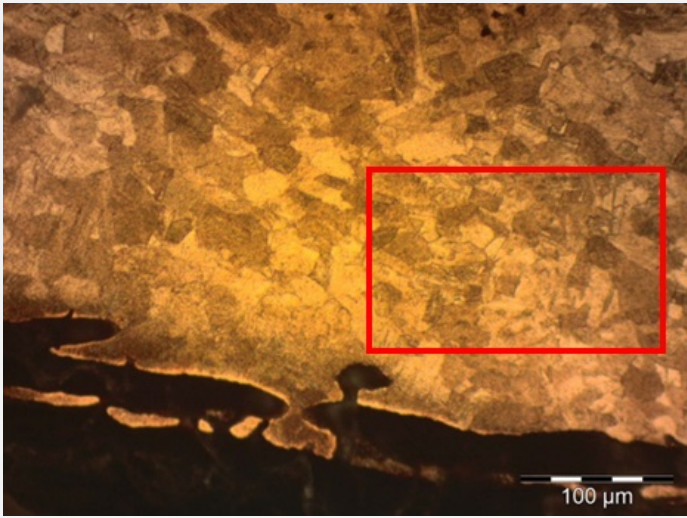
Fig. 6: Micrograph of the etched metal structure from Fig. 5 (detail), etched, bright field, 50x. The alpha phase of the alloy shows polygonal grains. Area of Fig. 7 is marked by a rectangle,

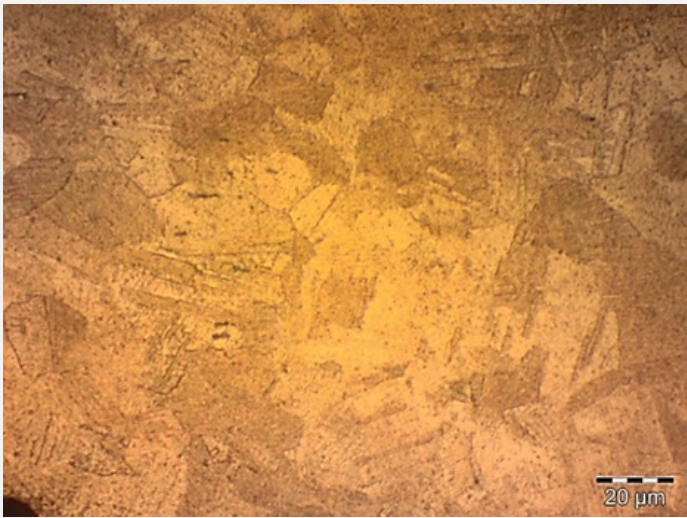
Fig. 7: Micrograph of the selected area of Fig. 6, etched, bright field, 500x. The grains show both twin and strain lines,

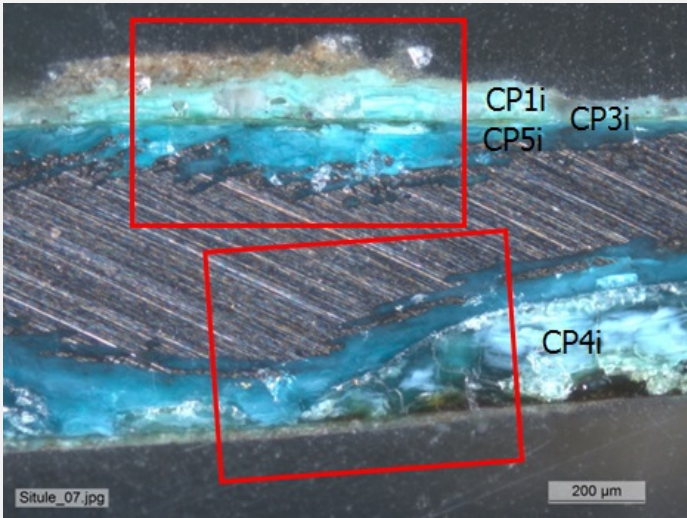
The corrosion crust is heterogeneous and has in places completely replaced the metal. The metal – corrosion products interface is irregular due to transgranular corrosion (Figs 5-6). In most cases, the corrosion crust can be divided in three main layers: an inner compact blue layer directly on the metal core. In areas of extensive corrosion this blue layer coexists with a friable green layer (Figs. 8 and 9). Depending on the area either a very fine dark green or red corrosion layer marks the limit of the original surface. It is followed by an external fourth layer, consisting of friable and sometimes curly pale green corrosion products intermingled with soil products (Fig. 8 & 11). In heavily worked and fragile parts of the object a cleavage between the inner layers of blue and green corrosion is present, rendering the green corrosion vulnerable to loss (Fig. 9).

Fig. 8: Micrograph of the metal sample from Fig. 4, unetched, dark field, 50x. Areas of Fig. 9 (bottom) and Figs. 10 and 11 (top) are marked by a rectangle,

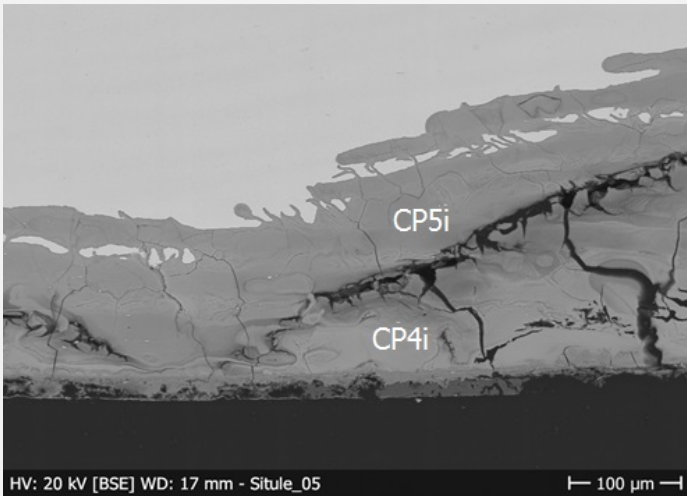
Fig. 9: SEM image, BSD-mode of the metal sample from Fig. 8 (detail) showing cleavage between the inner blue (CP5i) and green (CP4i) layers,

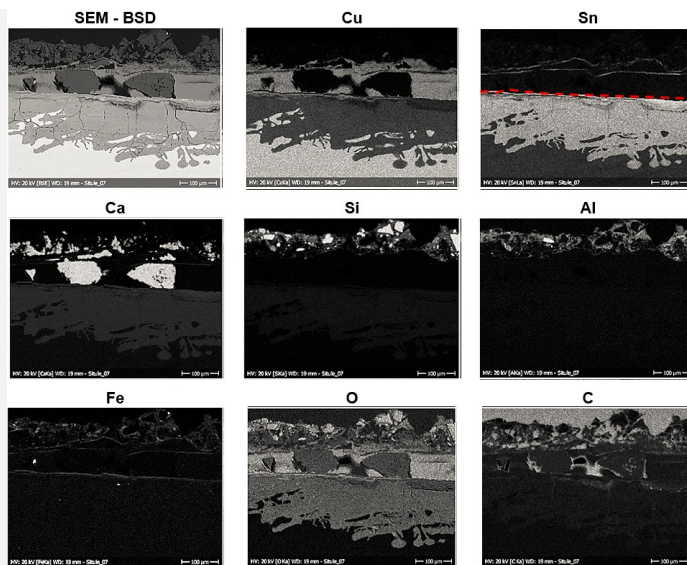
The inner layers are Sn and O-rich and depleted in Cu (Table 2). The outer layers are Cu and O-rich, contain no Sn, and are contaminated with Ca, Si, Al and Fe coming from the soil (Fig. 10). The colour of the corrosion crust varies according to the content of Sn (the more Sn, the darker green or blue the corrosion). FTIR and Raman spectra on the inner blue (Fig. 12) and outer green (Fig. 13) layers were difficult to interpret. Only malachite could be identified in both cases. XRD spectra could not be interpreted because of the deficiency of peaks.

Fig. 10: SEM image, SE-mode, and elemental chemical distribution of the selected area of Fig. 12. In red: the limit of the original surface highlighted by the enriched tin layer. Method of examination: SEM-EDX, Lab of Electronic Microscopy and Microanalysis, IMA (Néode), HEI Arc,

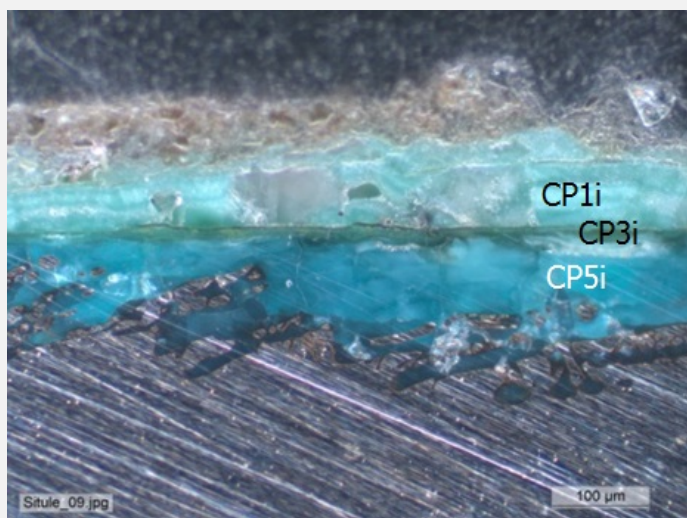
The limit of the original surface is well defined (interface of CP1i and CP3i) but due to the fragility of the inner corrosion layers it was difficult to uncover.

Fig. 11: Micrograph of the metal/corrosion interface (detail of Fig. 8) unetched, dark field, 100x. The outer layer (CP1i) incorporates soil material and the thin dark green layer (CP3i) highlights the limit of the original surface,

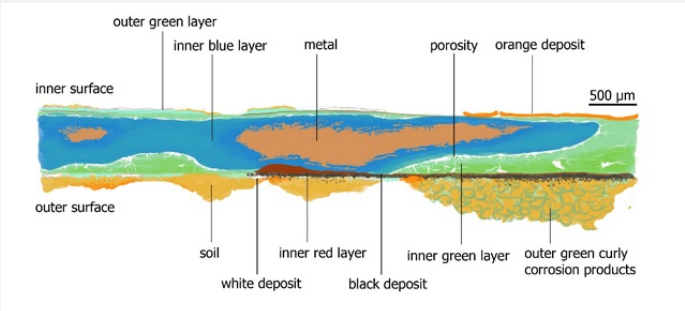
Fig. 14: Improved stratigraphic representation of the situla from visual observations and analyses,

Strata	Composition
Soil (S)	Ca, Si, Al, Fe
Black deposit (D1)	C
Orange deposit (D2)	Ferrous oxides
White deposit (D3)	Ca
Outer green curly corrosion product (CP1e)	Copper carbonates (curly malachite)
Inner red (CP2i)	Copper oxide (cuprite ?)
Outer green layer (CP3i)	Copper carbonates (malachite)
Inner green layer (CP4i)	Copper carbonates (?) + Sn
Inner blue layer (CP5i)	Copper carbonates (?) + Sn
Remnant metal phase (M)	Bronze (90%Cu, 10% Sn)
