# TANG FRAGMENT OF A KNIFE HR-6246 - TIN BRONZE - LATE BRONZE AGE - SWITZERLAND

<b>Artefact name</b>	Tang fragment of a knife HR-6246
<b>Authors</b>	Marianne. Senn (EMPA, Dübendorf, Zurich, Switzerland) & Christian. Degriigny (HE-Arc CR, Neuchâtel, Neuchâtel, Switzerland)
<b>Url</b>	/artefacts/224/

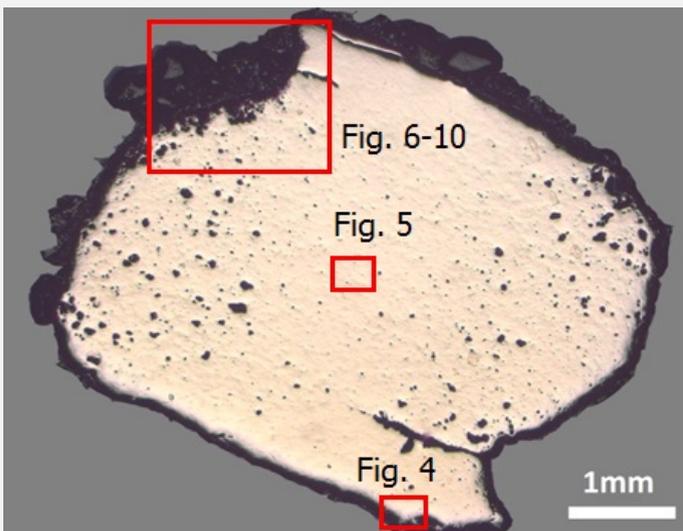
Fig. 3: Micrograph of the cross-section showing the locations of Figures 4 to 10,

The remaining metal is a tin bronze (Table 1) with high porosity and large cracks both on the left and right edges of the sample (Fig. 3). The metal contains small, elongated copper sulphide (Table 2) and Pb inclusions that are oriented parallel to the cracks. Near the metal surface, slip lines are outlined by the development of intergranular corrosion (Fig. 4). The etched metal shows small, elongated grains with slip lines (Fig. 5). Annealing is visible in areas near the surface. The average hardness of the metal is HV1 145, but significant variations are observed, depending on where the measurements are taken.

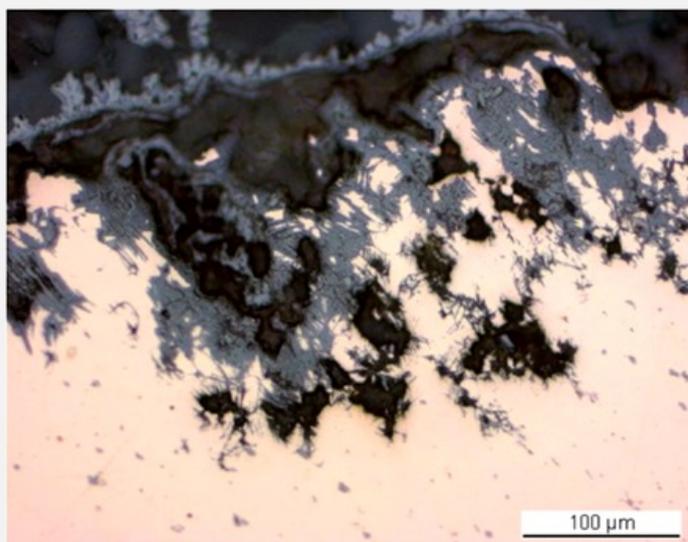
Fig. 4: Micrograph of the metal sample from Fig. 3 (inverted and reversed picture, detail), unetched, bright field. Corrosion products are in dark-grey whereas the metal is in pink. Slip lines are outlined by the development of intergranular corrosion,

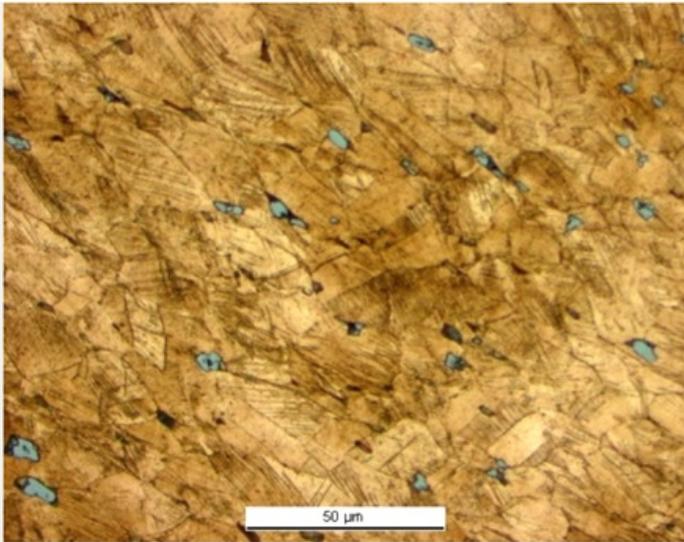
Fig. 5: Micrograph of the metal sample from Fig. 3 (detail), etched, bright field. We observe elongated grains with slip lines as well as grey copper sulphide inclusions,

<b>Microstructure</b>	Elongated grains + strain lines with pores
<b>First metal element</b>	Cu
<b>Other metal elements</b>	Sn

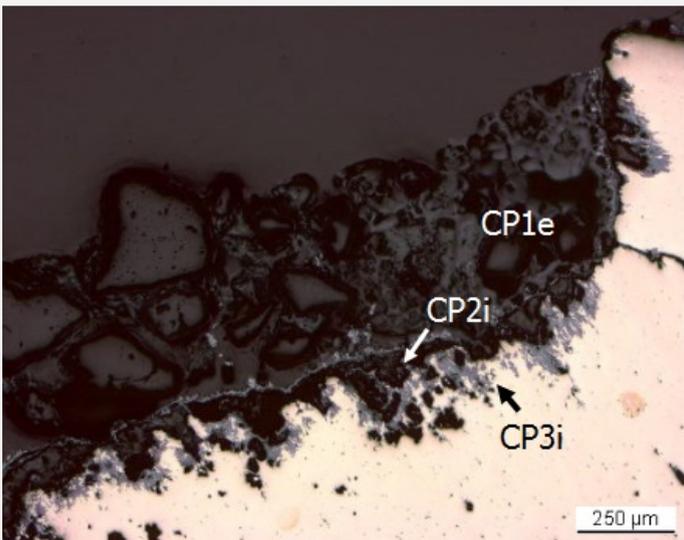
The corrosion crust has a thickness between 0.1mm and 0.7mm (Fig. 3). In bright field (Fig. 6), one can observe that the metal has been replaced by light-grey corrosion products. Adjacent to the metal is a thick, heterogeneous, dark-grey layer with a band of light-grey corrosion products. In polarised light (Fig. 7), all corrosion products which were previously light-grey appear brown-orange, the dark-grey layer turquoise. The elemental chemical distribution of the SEM image (Figs. 8 and 9) reveals that the inner corrosion products are Sn-rich whereas the adjacent band is Cu and S-rich (Fig. 10). The outer layer contains large inclusions (quartz and others, Si, Al and Na, see Figs. 9-10) and is most probably composed of malachite/ $\text{Cu}_2(\text{CO}_3)(\text{OH})_2$  (only Cu and O are detected – Fig. 10). S is distributed throughout this layer. XRD analyses indicated the presence of posnjakite/ $\text{Cu}_4\text{SO}_4(\text{OH})_6\text{H}_2\text{O}$ , chalcocite/ $\text{Cu}_2\text{S}$  and djurleite/ $\text{Cu}_3\text{S}$  (Schweizer 1994).

Fig. 6: Micrograph of the metal sample from Fig. 3 (detail), unetched, bright field. The inner light-grey corrosion products extend into the metal surface (in pink) and appear as a line within the dark-grey corrosion layer,

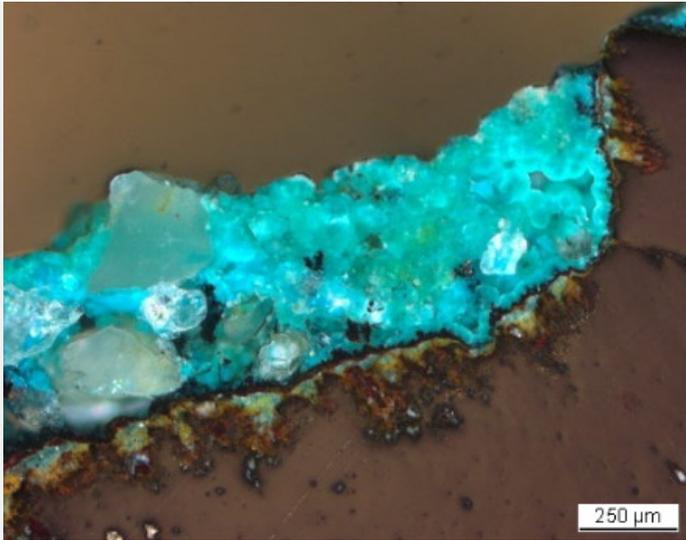
Fig. 7: Micrograph similar to Fig. 6, polarized light. One can see that large mineral features are incorporated only in the corrosion layers above the brown-orange corrosion band,

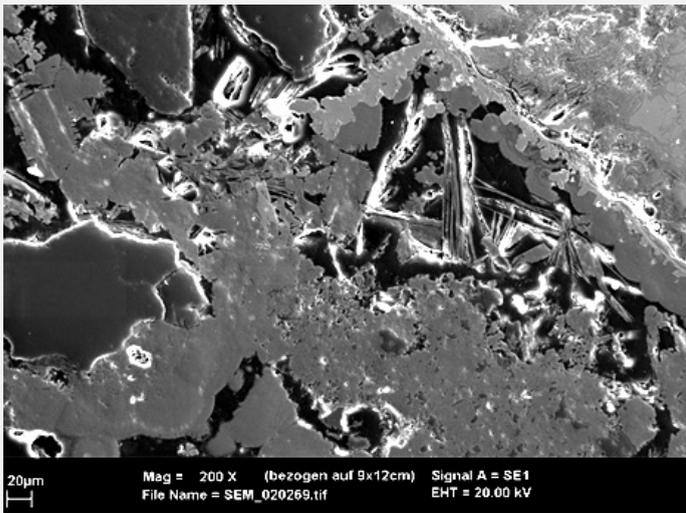
Fig. 8: SEM image (detail of Fig. 6), SE-mode. From bottom to top right: the thick, porous outer corrosion layer, the light-grey band and the remaining metal,

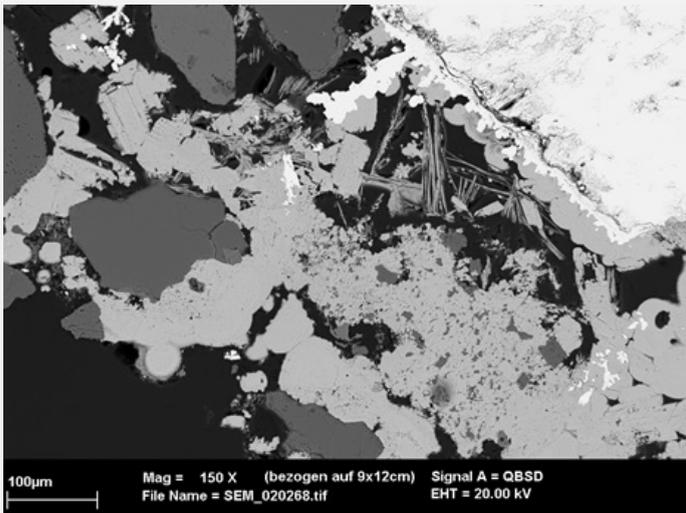
Fig. 9: SEM image, similar to Fig. 8, BSD-mode.

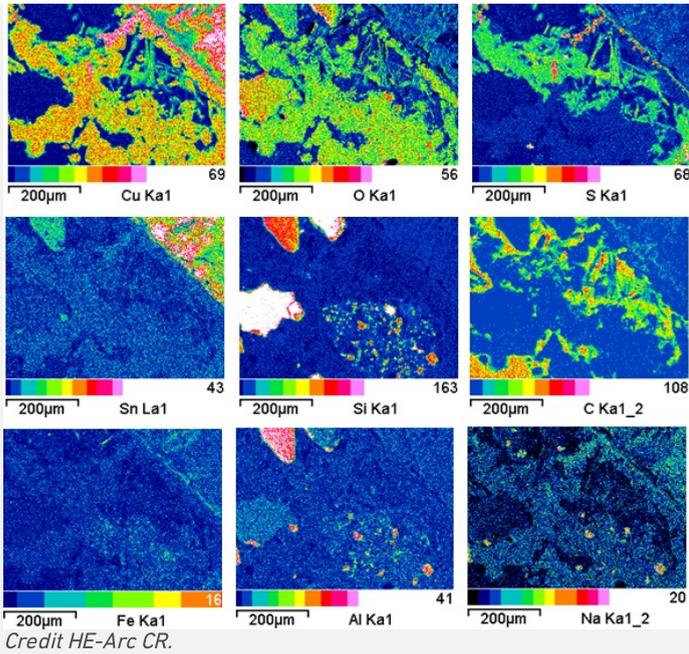
Fig. 10: EDX elemental chemical distribution of the SEM image of Fig. 8. Method of examination: SEM/EDX, Laboratory of Analytical Chemistry, Empa,

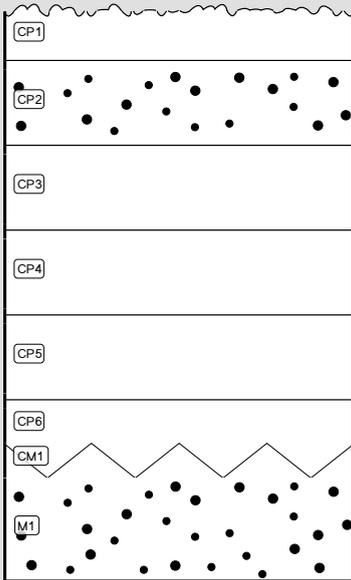
**Corrosion form** Uniform - transgranular

**Corrosion type** Type I (Robbiola)

Fig. 4: Stratigraphic representation of the object in cross-section using the MiCorr application. This representation can be compared to Fig. 8.
