TANG FRAGMENT OF A KNIFE HR-6246 - TIN BRONZE - LATE BRONZE AGE - SWITZERLAND

Artefact name	Tang fragment of a knife HR-6246
Authors	Marianne. Senn (EMPA, Dübendorf, Zurich, Switzerland) & Christian. Degrygn (HE-Arc CR, Neuchâtel, Neuchâtel, Switzerland)
Url	/artefacts/224/

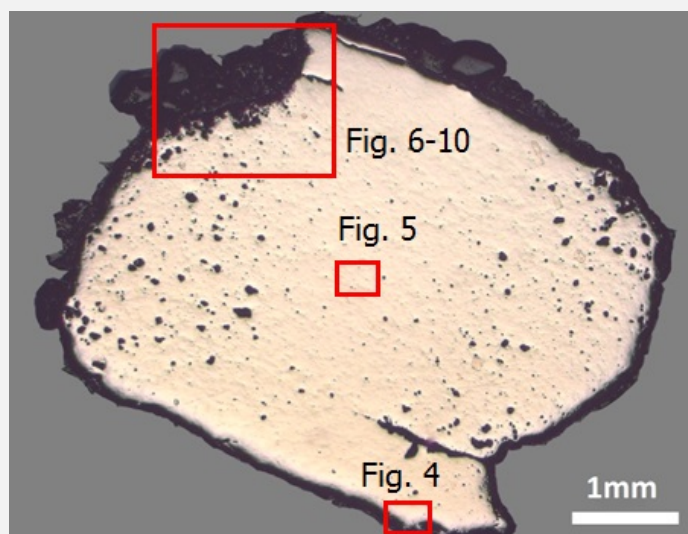
Fig. 3: Micrograph of the cross-section showing the locations of Figures 4 to 10,

Description of sample	The cross-section corresponds to a lateral cut. The surface is covered with a thick corrosion crust.
Alloy	Tin Bronze
Technology	Cold worked after annealing
Lab number of sample	MAH 87-197
Sample location	Musées d'art et d'histoire, Genève, Geneva
Responsible institution	Musées d'art et d'histoire, Genève, Geneva
Date and aim of sampling	1987, metallography and corrosion characterisation

The remaining metal is a tin bronze (Table 1) with high porosity and large cracks both on the left and right edges of the sample (Fig. 3). The metal contains small, elongated copper sulphide (Table 2) and Pb inclusions that are oriented parallel to the cracks. Near the metal surface, slip lines are outlined by the development of intergranular corrosion (Fig. 4). The etched metal shows small, elongated grains with slip lines (Fig. 5). Annealing is visible in areas near the surface. The average hardness of the metal is HV1 145, but significant variations are observed, depending on where the measurements are taken.

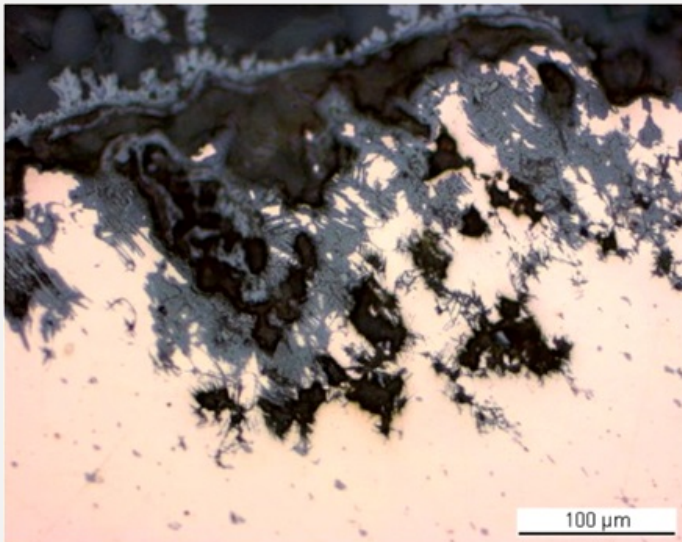
Fig. 4: Micrograph of the metal sample from Fig. 3 (inverted and reversed picture, detail), unetched, bright field. Corrosion products are in dark-grey whereas the metal is in pink. Slip lines are outlined by the development of intergranular corrosion,

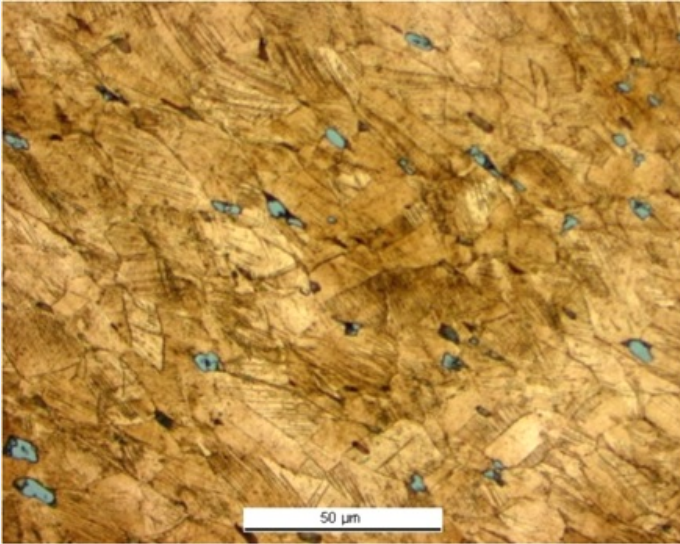
Fig. 5: Micrograph of the metal sample from Fig. 3 (detail), etched, bright field. We observe elongated grains with slip lines as well as grey copper sulphide inclusions,

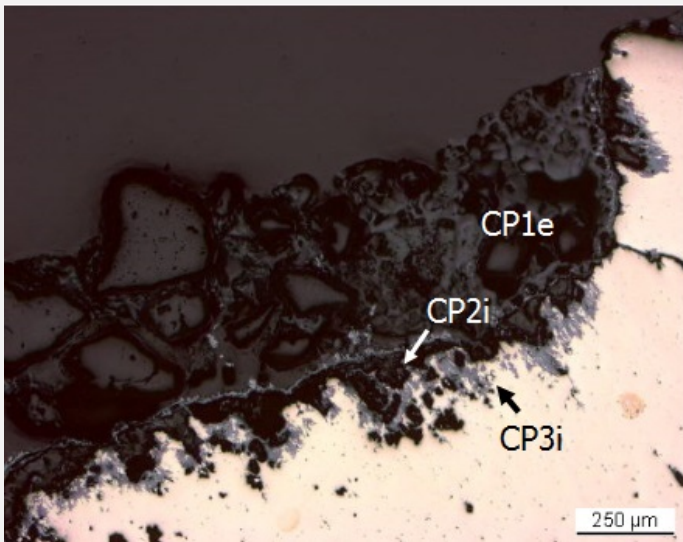
The corrosion crust has a thickness between 0.1mm and 0.7mm (Fig. 3). In bright field (Fig. 6), one can observe that the metal has been replaced by light-grey corrosion products. Adjacent to the metal is a thick, heterogeneous, dark-grey layer with a band of light-grey corrosion products. In polarised light (Fig. 7), all corrosion products which were previously light-grey appear brown-orange, the dark-grey layer turquoise. The elemental chemical distribution of the SEM image (Figs. 8 and 9) reveals that the inner corrosion products are Sn-rich whereas the adjacent band is Cu and S-rich (Fig. 10). The outer layer contains large inclusions (quartz and others, Si, Al and Na, see Figs. 9-10) and is most probably composed of malachite/ $\text{Cu}_2(\text{CO}_3)(\text{OH})_2$ (only Cu and O are detected – Fig. 10). S is distributed throughout this layer. XRD analyses indicated the presence of posnjakite/ $\text{Cu}_4\text{SO}_4(\text{OH})_6\text{H}_2\text{O}$, chalcocite/ Cu_2S and djurleite/ $\text{Cu}_{1.93}\text{S}$ (Schweizer 1994).

Fig. 6: Micrograph of the metal sample from Fig. 3 (detail), unetched, bright field. The inner light-grey corrosion products extend into the metal surface (in pink) and appear as a line within the dark-grey corrosion layer,

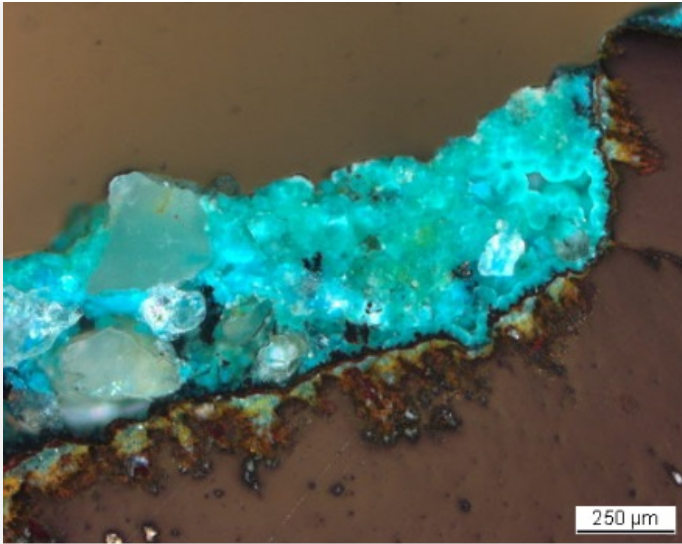
Fig. 7: Micrograph similar to Fig. 6, polarized light. One can see that large mineral features are incorporated only in the corrosion layers above the brown-orange corrosion band,

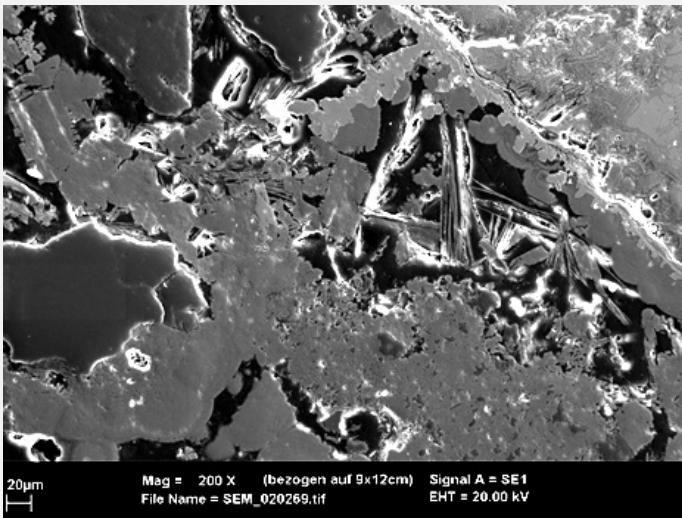
Fig. 8: SEM image (detail of Fig. 6), SE-mode. From bottom to top right: the thick, porous outer corrosion layer, the light-grey band and the remaining metal,

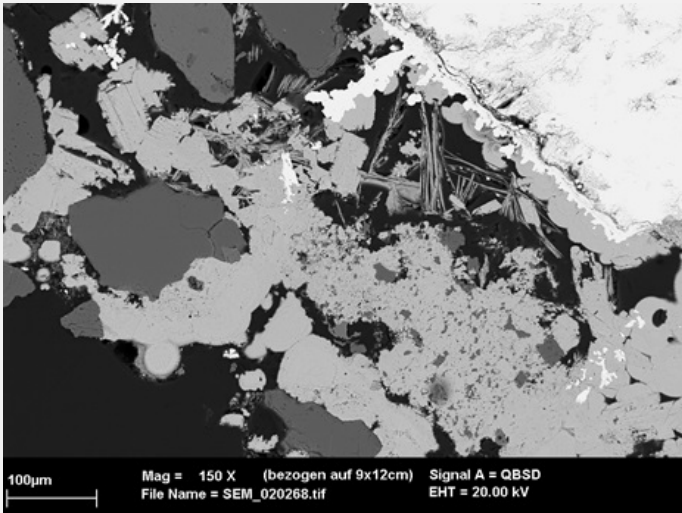
Fig. 9: SEM image, similar to Fig. 8, BSD-mode.

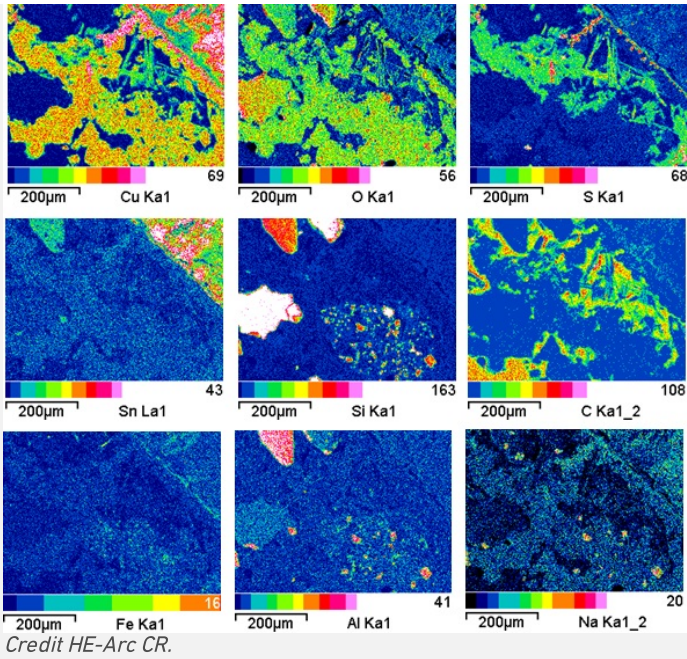
Fig. 10: EDX elemental chemical distribution of the SEM image of Fig. 8. Method of examination: SEM/EDX, Laboratory of Analytical Chemistry, Empa,

Corrosion form Uniform - transgranular
Corrosion type Type I (Robbiola)

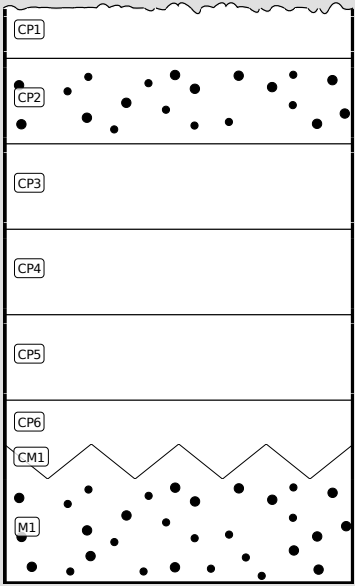
Fig. 4: Stratigraphic representation of the object in cross-section using the MiCorr application. This representation can be compared to Fig. 8.
