TANG FRAGMENT OF A KNIFE HR-6246 - TIN BRONZE - LATE BRONZE AGE - SWITZERLAND

| Artefact name | Tang fragment of a knife HR-6246 |
| Authors | Marianne. Senn (EMPA, Dübendorf, Zurich, Switzerland) & Christian. Degriigny (HE-Arc CR, Neuchâtel, Neuchâtel, Switzerland) |

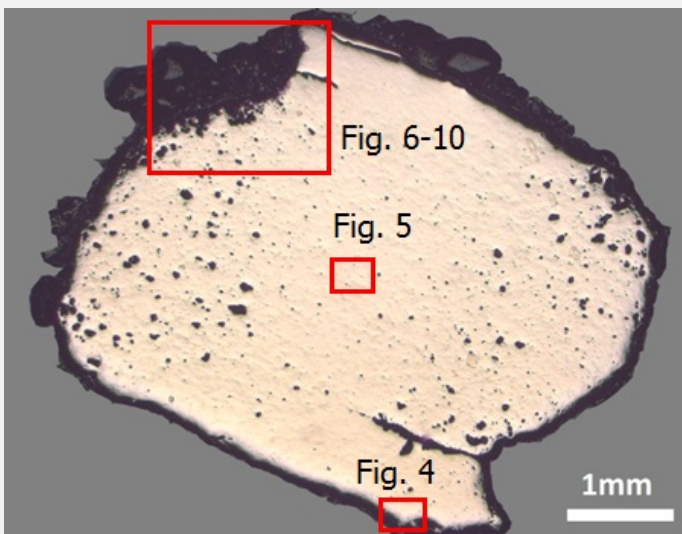
Fig. 3: Micrograph of the cross-section showing the locations of Figures 4 to 10,

The remaining metal is a tin bronze (Table 1) with high porosity and large cracks both on the left and right edges of the sample (Fig. 3). The metal contains small, elongated copper sulphide (Table 2) and Pb inclusions that are oriented parallel to the cracks. Near the metal surface, slip lines are outlined by the development of intergranular corrosion (Fig. 4). The etched metal shows small, elongated grains with slip lines (Fig. 5). Annealing is visible in areas near the surface. The average hardness of the metal is HV1 145, but significant variations are observed, depending on where the measurements are taken.

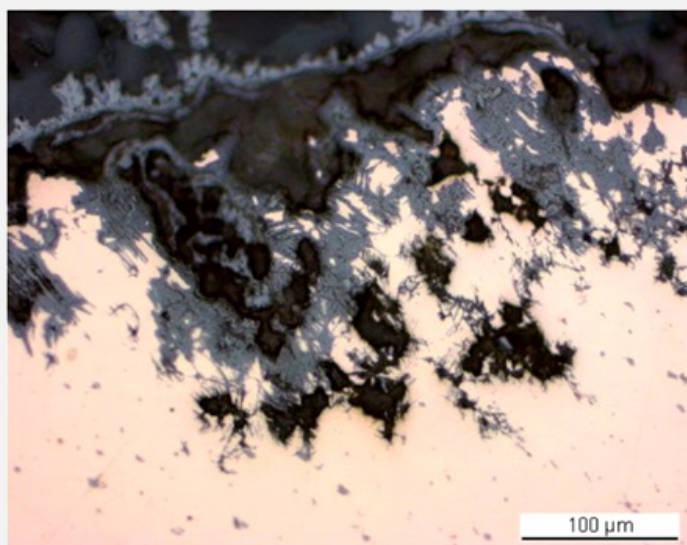
Fig. 4: Micrograph of the metal sample from Fig. 3 (inverted and reversed picture, detail), unetched, bright field. Corrosion products are in dark-grey whereas the metal is in pink. Slip lines are outlined by the development of intergranular corrosion,

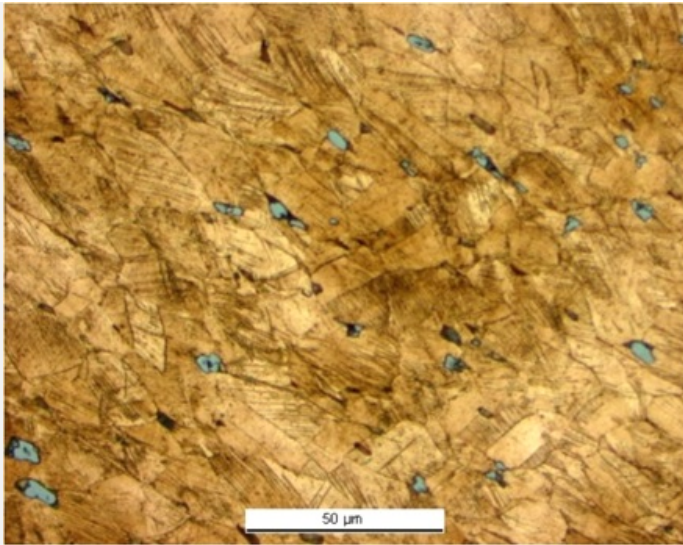
Fig. 5: Micrograph of the metal sample from Fig. 3 (detail), etched, bright field. We observe elongated grains with slip lines as well as grey copper sulphide inclusions,

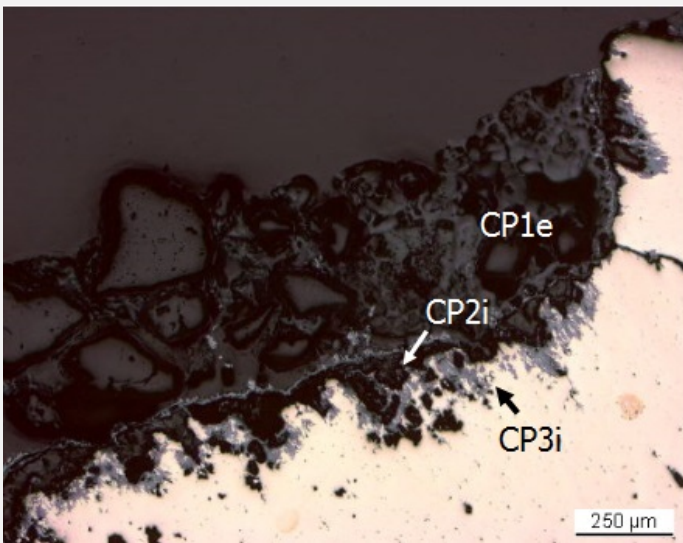
The corrosion crust has a thickness between 0.1mm and 0.7mm (Fig. 3). In bright field (Fig. 6), one can observe that the metal has been replaced by light-grey corrosion products. Adjacent to the metal is a thick, heterogeneous, dark-grey layer with a band of light-grey corrosion products. In polarised light (Fig. 7), all corrosion products which were previously light-grey appear brown-orange, the dark-grey layer turquoise. The elemental chemical distribution of the SEM image (Figs. 8 and 9) reveals that the inner corrosion products are Sn-rich whereas the adjacent band is Cu and S-rich (Fig. 10). The outer layer contains large inclusions (quartz and others, Si, Al and Na, see Figs. 9-10) and is most probably composed of malachite/ $\text{Cu}_2(\text{CO}_3)(\text{OH})_2$ (only Cu and O are detected – Fig. 10). S is distributed throughout this layer. XRD analyses indicated the presence of posnjakite/ $\text{Cu}_4\text{SO}_4(\text{OH})_6\text{H}_2\text{O}$, chalcocite/ Cu_2S and djurleite/ Cu_3S_2 (Schweizer 1994).

Fig. 6: Micrograph of the metal sample from Fig. 3 (detail), unetched, bright field. The inner light-grey corrosion products extend into the metal surface (in pink) and appear as a line within the dark-grey corrosion layer,

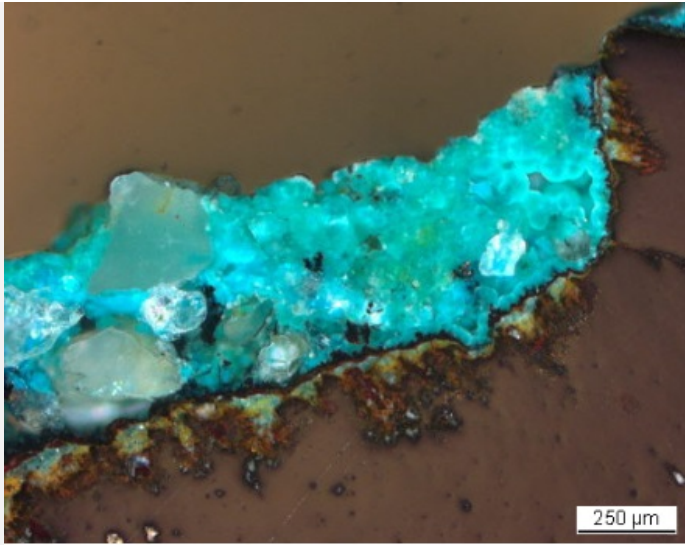
Fig. 7: Micrograph similar to Fig. 6, polarized light. One can see that large mineral features are incorporated only in the corrosion layers above the brown-orange corrosion band,

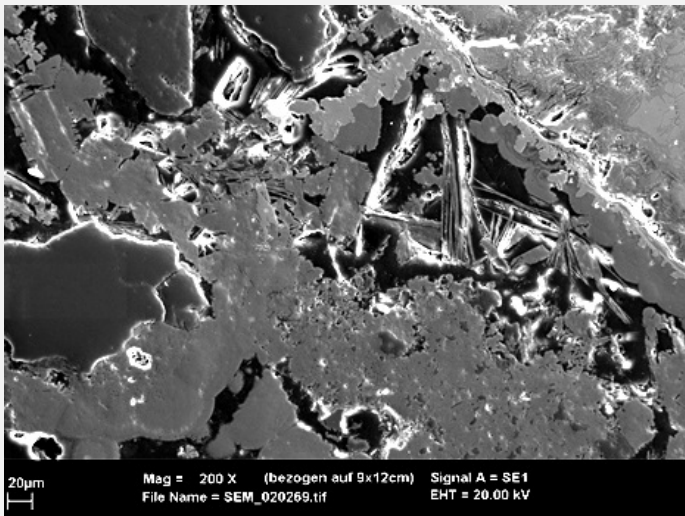
Fig. 8: SEM image (detail of Fig. 6), SE-mode. From bottom to top right: the thick, porous outer corrosion layer, the light-grey band and the remaining metal,

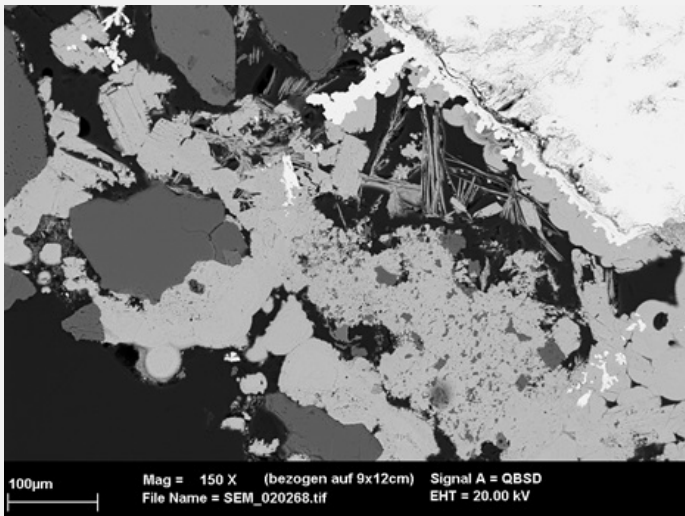
Fig. 9: SEM image, similar to Fig. 8, BSD-mode.

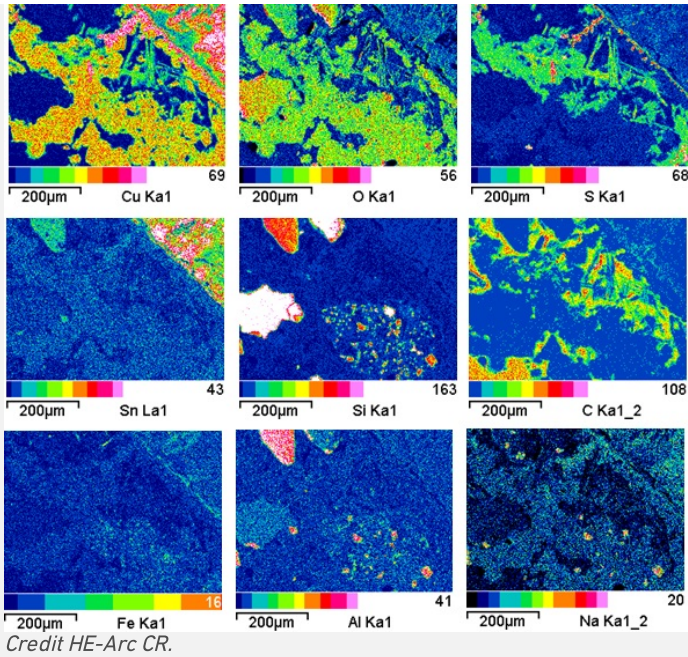
Fig. 10: EDX elemental chemical distribution of the SEM image of Fig. 8. Method of examination: SEM/EDX, Laboratory of Analytical Chemistry, Empa,

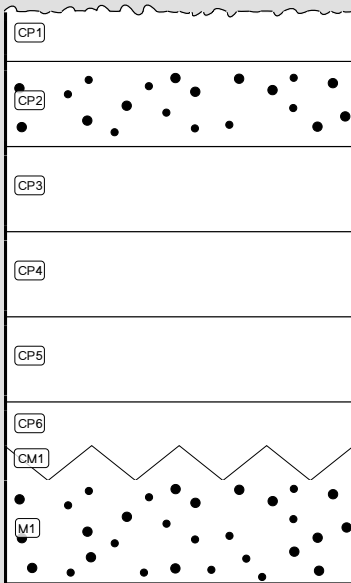
Corrosion form Uniform - transgranular
Corrosion type Type I (Robbiola)

Fig. 4: Stratigraphic representation of the object in cross-section using the MiCorr application. This representation can be compared to Fig. 8.
