VOTIVE FIGURE OF A BAT IVB4168 - GILDED BRASS

Votive figure of a bat IVb4168 Artefact name

Authors Christian. Degrigny (HE-Arc CR, Neuchâtel, Neuchâtel, Switzerland) & Naima. Gutknecht (HE-Arc CR,

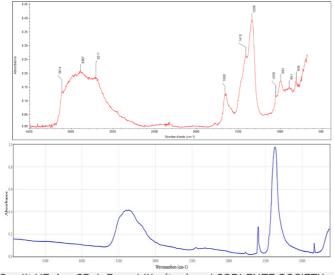
The light green to white corrosion product (CP1) has a waxy consistency and is thin, translucent, non-magnetic, powdery and very soft. It is very loosely bound. It is distributed on the whole object (front and back) as disparate clumps. It is mainly located on the cavities and irregularities of the surface. Its FTIR analysis (ATR mode) (Fig. 11) was

Fig. 11: FTIR spectrum (ATR mode) of the white corrosion product product (top), and of synthesized copper nitrate (Cu(NO3)2 * 3H2O) (bottom),

FTIR analysis of the green/white corrosion product suggests that it is a copper nitrate, a highly water soluble corrosion product that cannot be found in an archaeological context. However, it has been recorded on artificially patinated copper alloys (Scott, D. (2000) p. 250-251; Craddock, P. (2009) p. 365).
