CORRODED METAL SHEET FN 655.13.01 – FE ALLOY – MODERN TIMES – SWITZERLAND

Artefact name	Corroded metal sheet FN 655.13.01
Authors	Marianne. Senn (EMPA, Dübendorf, Zurich, Switzerland) & Christian. Degriigny (HE-Arc CR, Neuchâtel, Neuchâtel, Switzerland)
Url	/artefacts/317/

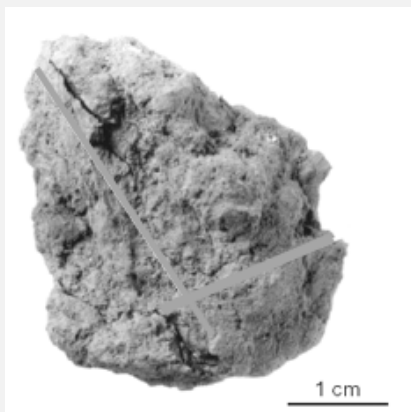
Fig. 1: Iron (and steel) sheet (after Senn Bischofberger 2005, 137),

Description of the artefact	Iron sheet with middle rib. The shape is no longer discernible (Fig. 1). The metal is covered by a thick corrosion crust. Dimensions: L = 4.5cm; WT = 35g.
Type of artefact	Iron (and steel) sheet
Origin	Steinmöri, Neftenbach / Dorf Neftenbach, Zurich, Switzerland
Recovering date	Excavation of the Roman villa, 1986-1990, phase S2, Stbl.2 (2nd/3rd century AD)
Chronology category	Modern Times
chronology tpq	1986 A.D. ▼
chronology taq	1990 A.D. ▼
Chronology comment	20th century (1986 _ 1990)
Burial conditions / environment	Soil
Artefact location	Kantonsarchäologie, Dübendorf, Zurich
Owner	Kantonsarchäologie, Dübendorf, Zurich

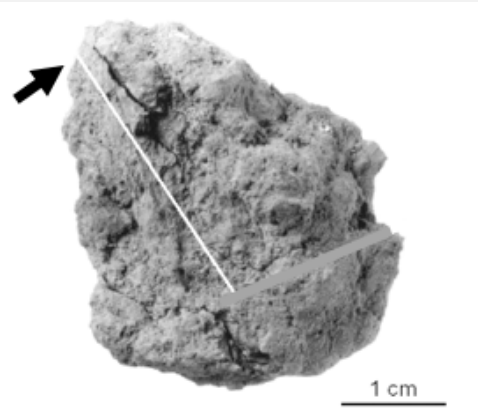
Fig. 2: Location of sampling area,

Description of sample	A longitudinal cut has been made through the sheet (Fig. 2). Large parts of the corrosion crust fell off during sampling (Fig. 3).
Alloy	Fe Alloy
Technology	Forged with final cold work
Lab number of sample	NEF 655
Sample location	Empa (Marianne Senn)
Responsible institution	Kantonsarchäologie, Dübendorf, Zurich
Date and aim of sampling	2000, metallography

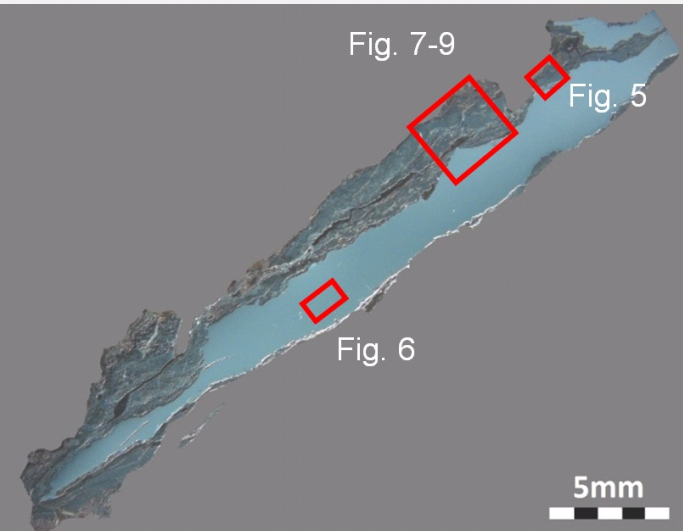
Fig. 3: Micrograph of the cross-section showing the location of Figs. 5 to 9,

The corrosion is massive and large parts of the outer corrosion layers have been lost during the sample preparation. The heavily cracked corrosion crust represents about one third of the thickness of the sample (Fig. 3) and is located on one side of the metal (the rest having been lost during the cutting process). It does not show well defined layers. Despite this, three areas can be distinguished (Figs. 7 and 8). Adhering to the metal (area 1), we find an orange-red-brown layer enriched in Cl (CP3 in Fig. 4, Fig. 9 and Table 3). The dark or violet middle area 2 is richer in Fe (CP2 in Fig. 4). The outer area 3 is red-brown (CP1 in Fig. 4) and strongly contaminated by soil material (rock fragment inclusion and elements like Si, Al, P etc.). This layer is enriched in O (Fig. 9).

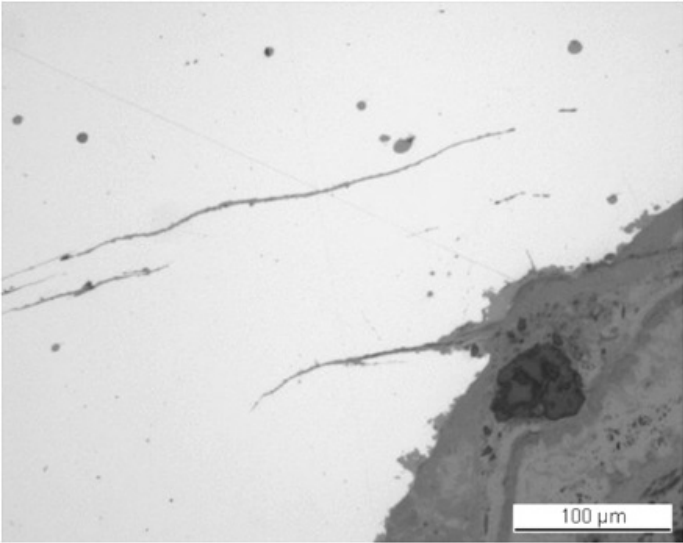
The remaining metal is an iron containing elevated (more than 1g/kg) concentrations of Co and Ni (Table 1), small round slag inclusions and cracks resulting from corrosion and deformation (Fig. 5). The composition of the round, elongated slag inclusions is similar to wüstite-FeO (Table 2). Iron reduced in the direct smelting process never contains such pure compounds and only FeO inclusions. In modern steels FeO occurs in low carbon alloys and Armco-iron (Schumann 1991, 474). After etching, the cross-section shows a heavily deformed ferritic microstructure from cold working (Fig. 6). The cracks have the same orientation as the deformation. The average hardness of the metal is HV1 195.

Fig. 5: Micrograph of metal sample from Fig. 3 (inverted picture, detail), unetched, bright field. In white the metal with round slag inclusions as well as cracks filled with corrosion products,

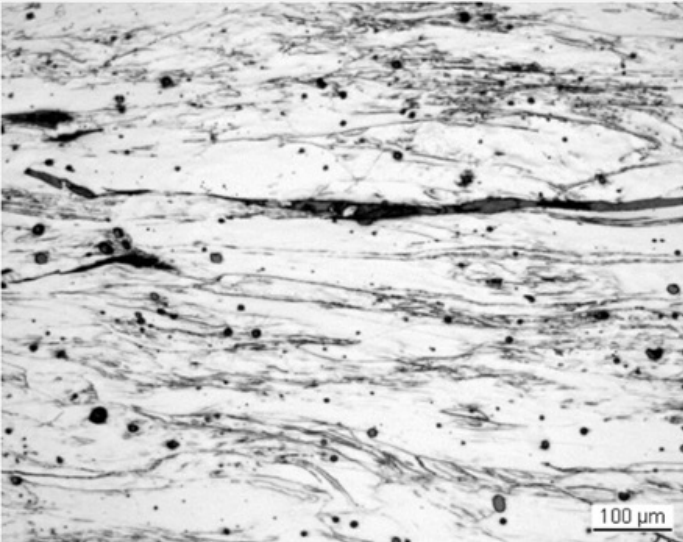
Fig. 6: Micrograph of metal sample from Fig. 3 (detail), etched, bright field. The heavily cold worked metal shows elongated grains with nearly invisible grain boundaries and cracks parallel to the grains,

Microstructure	Heavily deformed ferritic microstructure
First metal element	Fe
Other metal elements	Ni

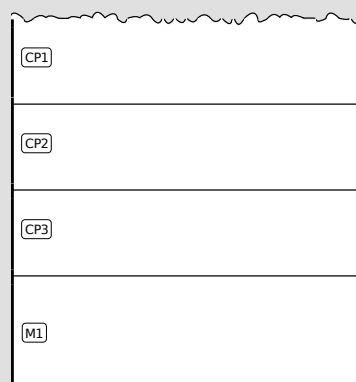
Fig. 4: Stratigraphic representation of the object in cross-section using the MiCorr application. This representation can be compared to Figs. 7 and 8.

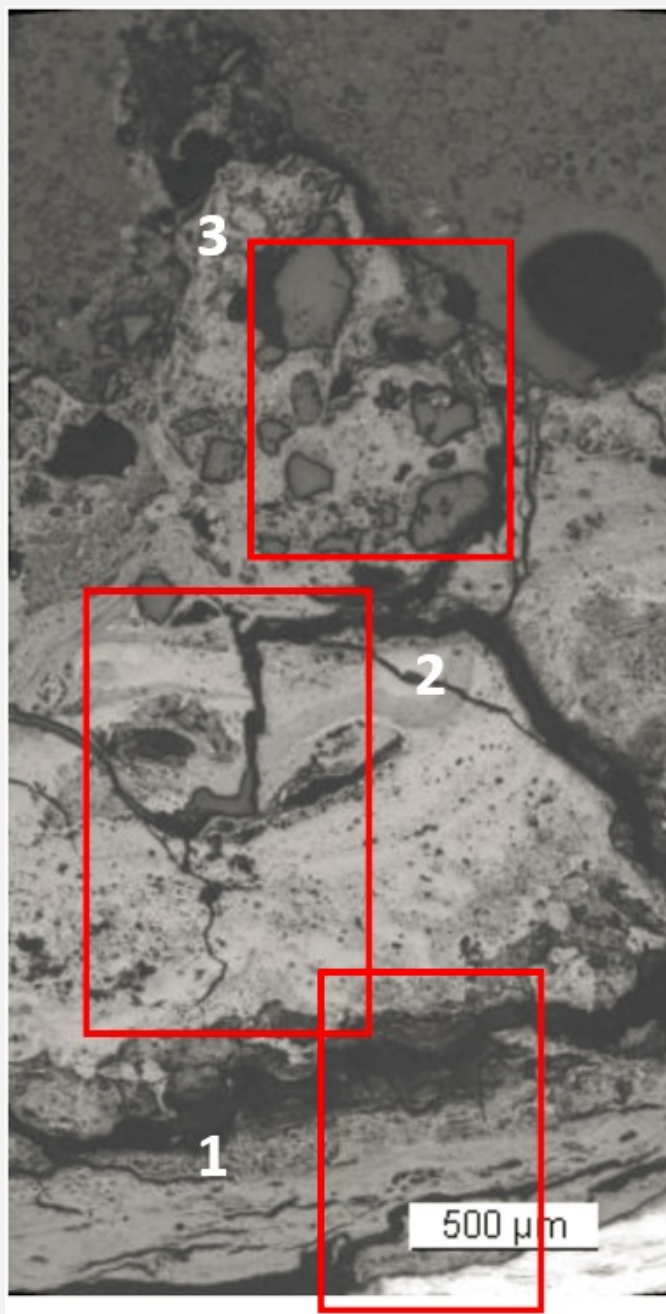
Fig. 7: Micrograph of the corrosion layer from Fig. 3 showing the metal - corrosion crust interface (detail, rotated by 45°) and corresponding to the stratigraphy of Fig. 4, unetched, bright field. Areas 1 (inner layer, CP3) to 3 (outer layer, CP1) are indicated,

Fig. 8: Micrograph (same as Fig.7) and corresponding to the stratigraphy of Fig. 4, polarised light. The inner layer (CP3) is red-brown, area 2 is brown-violet (CP2) and the outer pale brown area contains rock fragment inclusions (CP1),

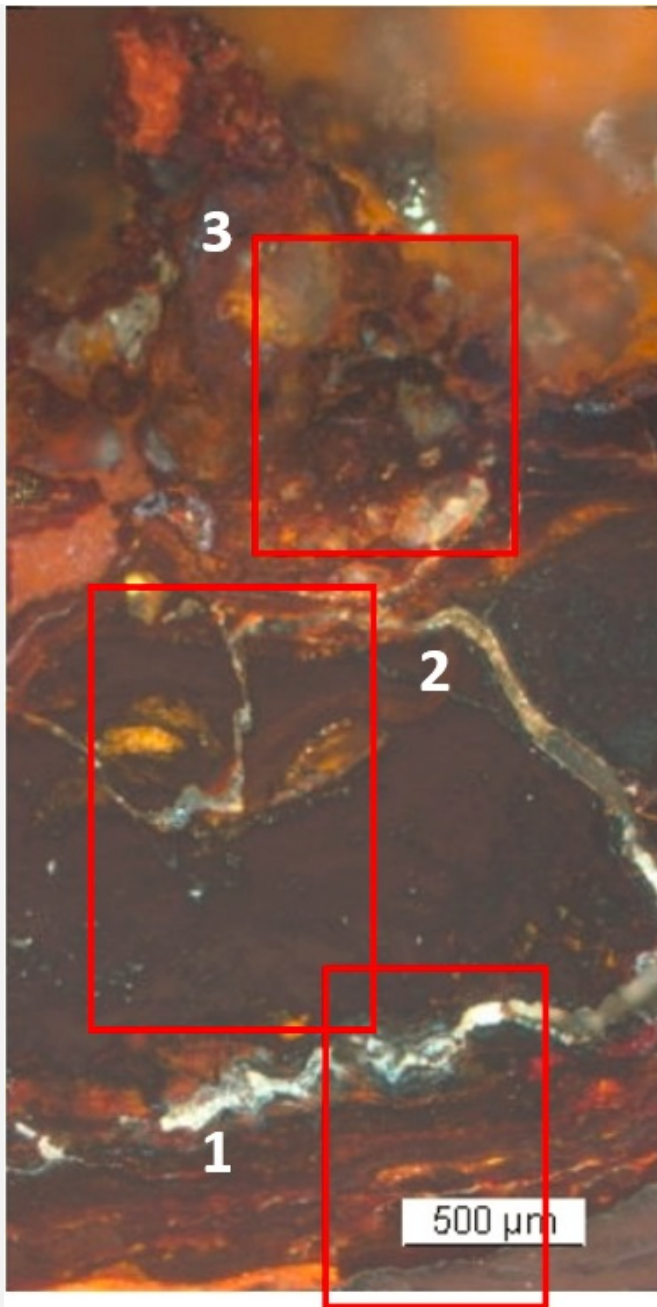
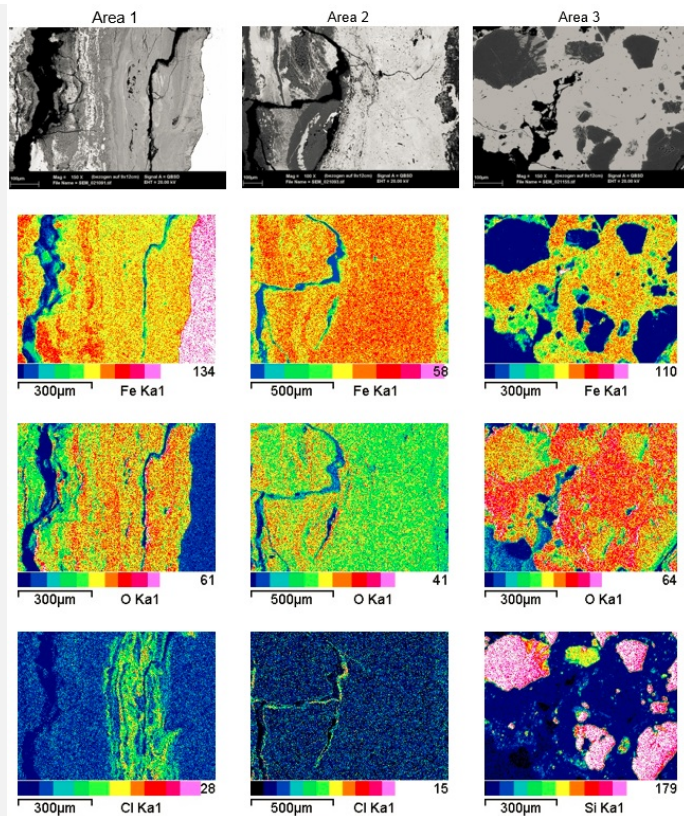
Fig. 9: SEM images, BSE-mode, and elemental chemical distribution of the selected areas from Fig. 8 (reversed picture rotated by 270°, details). First column: mapping on area 1 (CP3) where an inner layer enriched in Cl appears near the metal surface. 2nd column: area 2 (CP2) where iron oxides prevail. 3rd column: area 3 (CP1) where the outer O-rich layer includes rock fragments rich in Si. Method of examination: SEM/EDS, Lab. Anal. Chem. Empa,

This iron sheet is entirely cold worked and hard compared to an annealed metal. The corrosion is massive and masks the shape of the object. The presence of Cl adjacent to the metal surface indicates that the corrosion front is potentially active. The very thick top corrosion layers may have slowed down the corrosion. The object was mentioned as being Roman in Senn Bischofberger 2005, however the chemical composition of the slag inclusions shows that it is a product of the 20th century AD which has been accidentally introduced into a Roman layer.
