CORRODED METAL SHEET FN 655.13.01 – FE ALLOY – MODERN TIMES – SWITZERLAND

Artefact name Corroded metal sheet FN 655.13.01

Authors Marianne. Senn (EMPA, Dübendorf, Zurich, Switzerland) & Christian. Degriigny (HE-Arc CR, Neuchâtel, Neuchâtel, Switzerland)

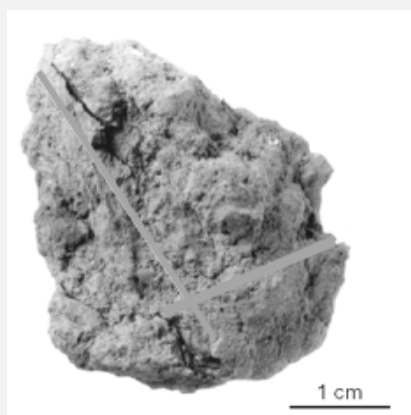
Fig. 1: Iron (and steel) sheet (after Senn Bischofberger 2005, 137),

Description of the artefact	Iron sheet with middle rib. The shape is no longer discernible (Fig. 1). The metal is covered by a thick corrosion crust. Dimensions: L = 4.5cm; WT = 35g.
Type of artefact	Iron (and steel) sheet
Origin	Steinmöri, Neftenbach / Dorf Neftenbach, Zurich, Switzerland
Recovering date	Excavation of the Roman villa, 1986-1990, phase S2, StbII.2 (2nd/3rd century AD)
Chronology category	Modern Times
chronology tpq	<input type="text" value="1986"/> A.D. ▾
chronology taq	<input type="text" value="1990"/> A.D. ▾
Chronology comment	20th century (1986 _ 1990)
Burial conditions / environment	Soil
Artefact location	Kantonsarchäologie, Dübendorf, Zurich
Owner	Kantonsarchäologie, Dübendorf, Zurich

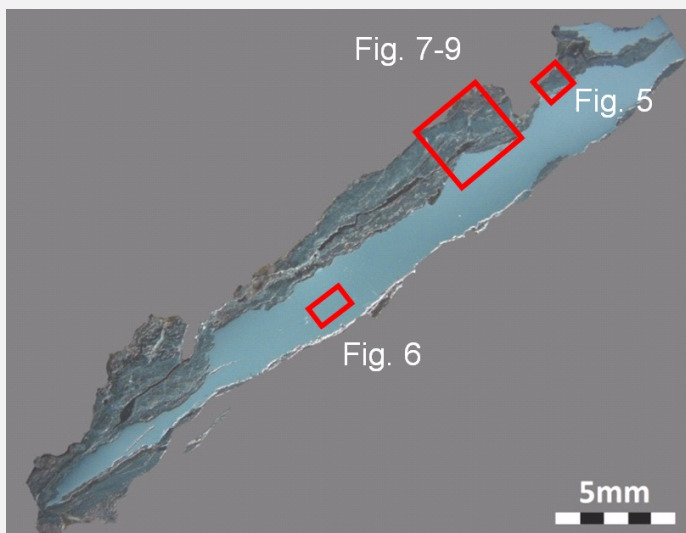
Fig. 3: Micrograph of the cross-section showing the location of Figs. 5 to 9,

Description of sample	A longitudinal cut has been made through the sheet (Fig. 2). Large parts of the corrosion crust fell off during sampling (Fig. 3).
Alloy	Fe Alloy
Technology	Forged with final cold work
Lab number of sample	NEF 655
Sample location	Empa (Marianne Senn)
Responsible institution	Kantonsarchäologie, Dübendorf, Zurich
Date and aim of sampling	2000, metallography

The corrosion is massive and large parts of the outer corrosion layers have been lost during the sample preparation. The heavily cracked corrosion crust represents about one third of the thickness of the sample (Fig. 3) and is located on one side of the metal

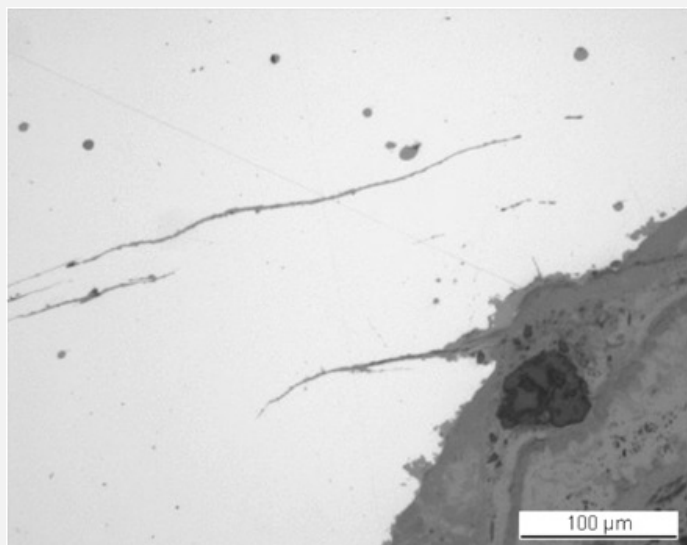
The remaining metal is an iron containing elevated (more than 1g/kg) concentrations of Co and Ni (Table 1), small round slag inclusions and cracks resulting from corrosion and deformation (Fig. 5). The composition of the round, elongated slag inclusions is similar to wüstite-FeO (Table 2). Iron reduced in the direct smelting process never contains such pure compounds and only FeO inclusions. In modern steels FeO occurs in low carbon alloys and Armco-iron (Schumann 1991, 474). After etching, the cross-section shows a heavily deformed ferritic microstructure from cold working (Fig. 6). The cracks have the same orientation as the deformation. The average hardness of the metal is HV1 195.

Fig. 5: Micrograph of metal sample from Fig. 3 (inverted picture, detail), unetched, bright field. In white the metal with round slag inclusions as well as cracks filled with corrosion products,

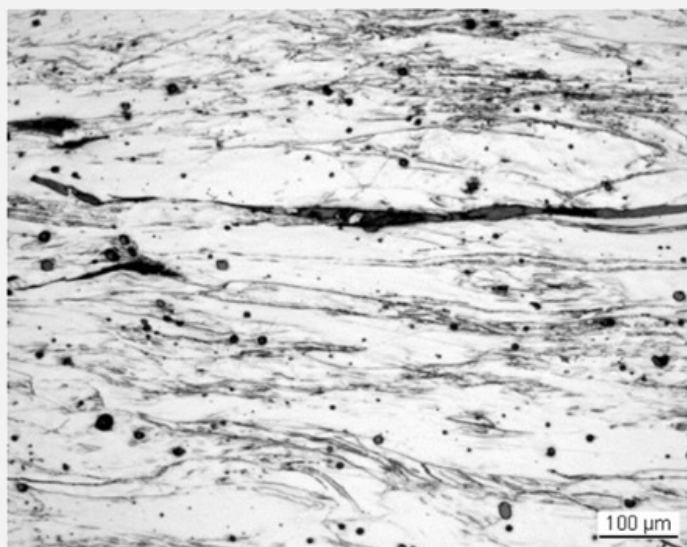
Fig. 6: Micrograph of metal sample from Fig. 3 (detail), etched, bright field. The heavily cold worked metal shows elongated grains with nearly invisible grain boundaries and cracks parallel to the grains,

Microstructure	Heavily deformed ferritic microstructure
First metal element	Fe
Other metal elements	Ni

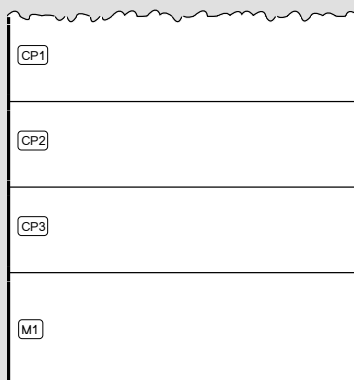
Fig. 4: Stratigraphic representation of the object in cross-section using the MiCorr application. This representation can be compared to Figs. 7 and 8.
