CORRODED METAL SHEET FN 655.13.01 – FE ALLOY – MODERN TIMES – SWITZERLAND

Artefact name	Corroded metal sheet FN 655.13.01
Authors	Marianne. Senn (EMPA, Dübendorf, Zurich, Switzerland) & Christian. Degriigny (HE-Arc CR, Neuchâtel, Neuchâtel, Switzerland)
Url	/artefacts/317/

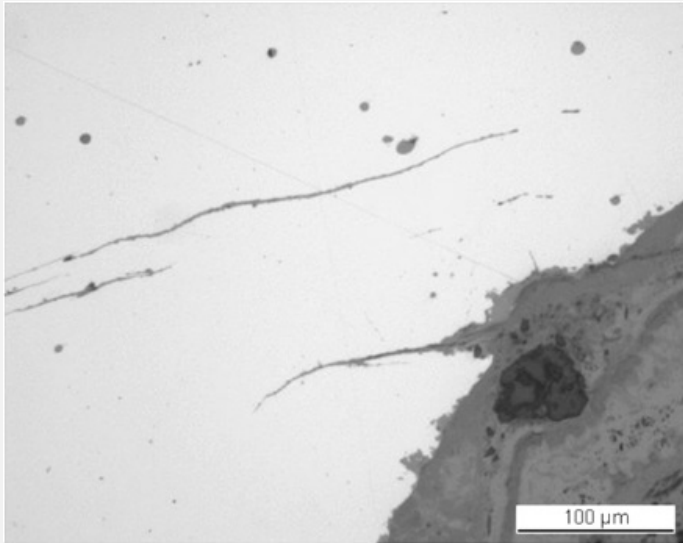
The remaining metal is an iron containing elevated (more than 1g/kg) concentrations of Co and Ni (Table 1), small round slag inclusions and cracks resulting from corrosion and deformation (Fig. 5). The composition of the round, elongated slag inclusions is similar to wüstite-FeO (Table 2). Iron reduced in the direct smelting process never contains such pure compounds and only FeO inclusions. In modern steels FeO occurs in low carbon alloys and Armco-iron (Schumann 1991, 474). After etching, the cross-section shows a heavily deformed ferritic microstructure from cold working (Fig. 6). The cracks have the same orientation as the deformation. The average hardness of the metal is HV1 195.

Fig. 5: Micrograph of metal sample from Fig. 3 (inverted picture, detail), unetched, bright field. In white the metal with round slag inclusions as well as cracks filled with corrosion products,

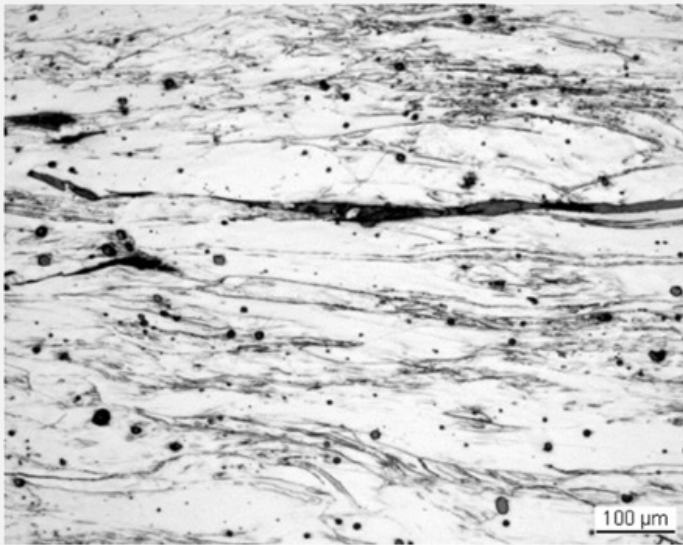
Fig. 6: Micrograph of metal sample from Fig. 3 (detail), etched, bright field. The heavily cold worked metal shows elongated grains with nearly invisible grain boundaries and cracks parallel to the grains,

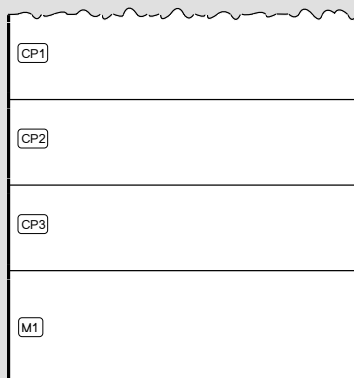
Fig. 4: Stratigraphic representation of the object in cross-section using the MiCorr application. This representation can be compared to Figs. 7 and 8.
