# CORRODED METAL SHEET FN 655.13.01 – FE ALLOY – MODERN TIMES – SWITZERLAND

**Artefact name** Corroded metal sheet FN 655.13.01

**Authors** Marianne. Senn (EMPA, Dübendorf, Zurich, Switzerland) & Christian. Degrigny (HE-Arc CR, Neuchâtel, Neuchâtel, Switzerland)

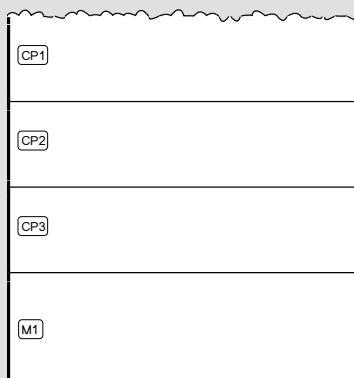
Fig. 4: Stratigraphic representation of the object in cross-section using the MiCorr application. This representation can be compared to Figs. 7 and 8.
