SHINGLE OF A ROOF – CU ALLOY – MODERN TIMES – SWITZERLAND

Artefact name Shingle of a roof

Authors Marianne. Senn (EMPA, Dübendorf, Zurich, Switzerland) & Christian. Degryny (HE-Arc CR, Neuchâtel, Neuchâtel, Switzerland)

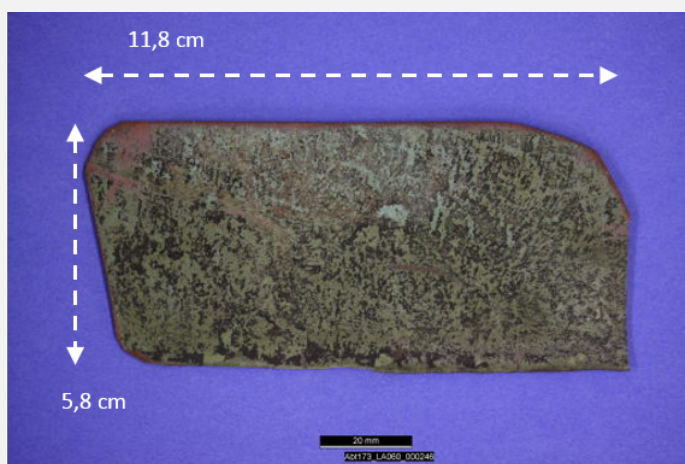
Fig. 1: Copper alloy shingle, internal side,

| Description of the artefact | Shingle, slightly curved, the internal side is covered with heterogeneously distributed green and black corrosion products (Fig. 1). The external side shows a regular dark green corrosion crust. Dimensions: L = 11.8cm; W = 5.8cm. |

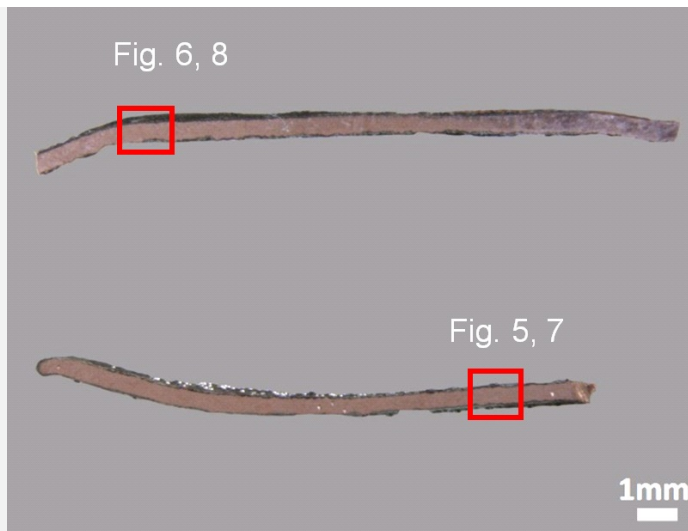
Fig. 3: Micrograph of the cross-sections showing the location of Figs. 5 to 8,

| Description of sample | Two samples were taken (Fig. 2). The polished samples show a well-preserved metal surface with a thin corrosion crust (Fig. 3). T = 0.5mm. |

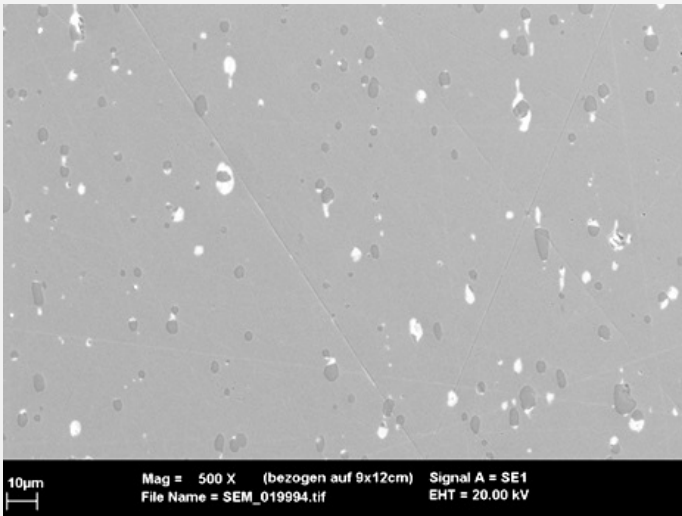
The remaining metal is a copper alloy (Table 1). The evenly distributed inclusions observed under SEM, SE-mode, are either light-grey or white (Fig. 5). The oval shape of the light-grey inclusions is due to deformation, probably by hot rolling (a common technique in the 18th century). Under polarised light they look red (Fig. 7) and their analysis reveals a composition similar to cuprite/Cu₂O (Table 2). The white inclusions are rich in Pb and are remnants of the refining process (Table 2). The etched copper shows a structure of polygonal and twinned grains (Fig. 6). The grain size is variable. The average hardness of the metal is about HV1 70.

Fig. 5: SEM image, SE-mode, of the metal sample from Fig. 3 (detail). Light-grey and white inclusions are distributed evenly,

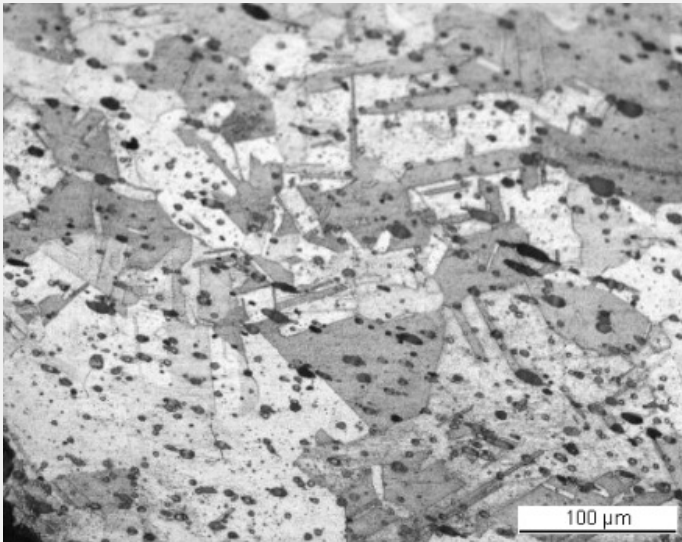
Fig. 6: Micrograph of the metal sample from Fig. 3 (detail), etched, bright field. The metal shows a structure of polygonal and twinned grains. Cuprite inclusions appear as dark spots,

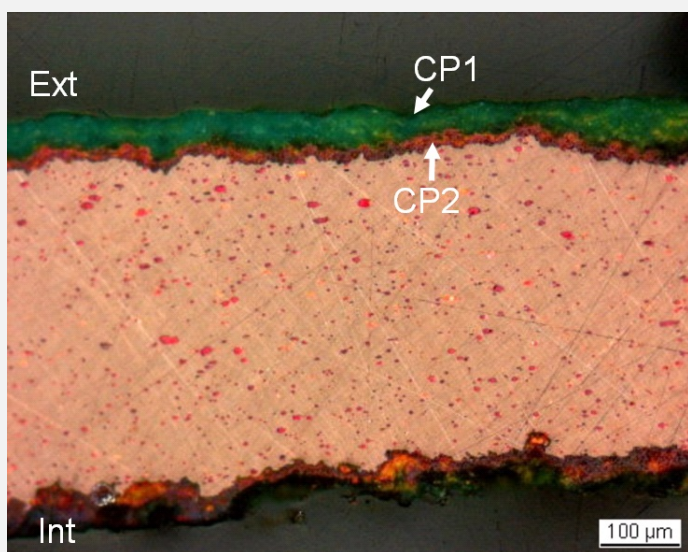
The corrosion crusts of the external and internal sides are distinctively different (Fig. 7). On the internal side an irregular red-orange corrosion layer has developed, and pitting corrosion has occurred. The more uniform corrosion layers on the external side are composed of a red-orange layer, followed by a thicker green outer layer. In some areas, dark-red corrosion products can be observed between the green and red-orange sub-layers. The same dark-red sub-layer can be seen in areas on the internal side covering the red-orange corrosion products. The red-orange corrosion layer on both sides (CP2) has a chemical composition similar to cuprite/ Cu_2O , while the green layer on the external side (CP1) contains Cu, S and O and is enriched on its upper surface with Si (Table 3 and Fig. 8). XRD analysis of the corrosion products on the external side of another shingle fragment from the same roof identified brochantite/ $\text{Cu}_4\text{SO}_4(\text{OH})_6$ and cuprite as corrosion products (Rapport d'analyse no. MAH 98-257). These results are confirmed by Raman spectroscopy of the external side of this sample where the same compounds were clearly identified (Figs. 9 and 10).

Fig. 7: Micrograph of the metal sample from Fig. 3 and corresponding to the stratigraphy of Fig. 4, polarised light. External side: the regular corrosion crust with outer green, inner red-orange corrosion products and intermediate dark-red corrosion products. Internal side: the irregular corrosion crust with inner red-orange and outer dark-red corrosion products,

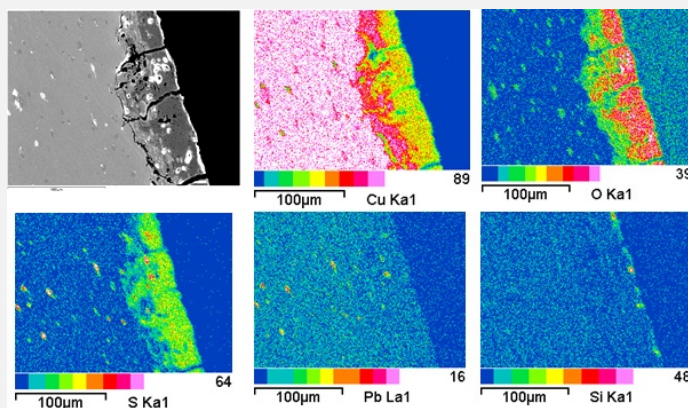
Fig. 8: SEM image, SE-mode, and elemental chemical distribution of the selected area of Fig. 3 (rotated image, detail). Method of examination: SEM/EDS, Laboratory of Analytical Chemistry, Empa,

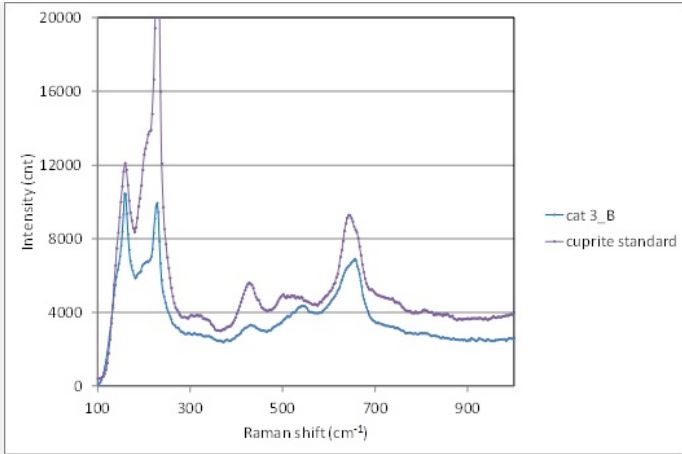
Fig. 9: Raman spectrum of the red-orange inner corrosion layer (CP2) of the external side (cat3_B) compared to a cuprite standard spectrum. Settings: laser wavelength 532nm, acquisition time 100s,

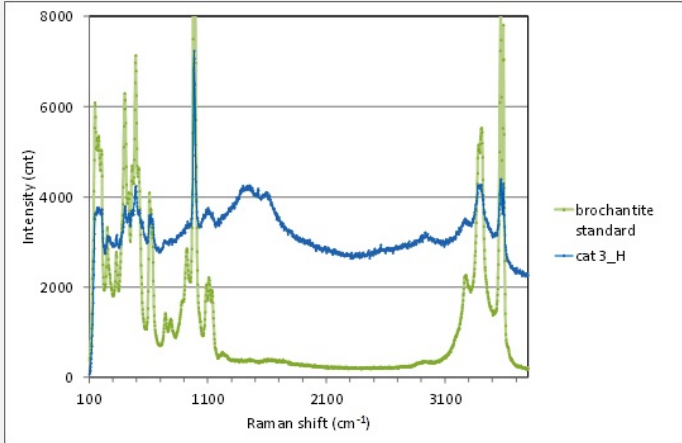
Fig. 10: Raman spectrum of the green outer corrosion layer (CP1) of the external side (cat3_H) compared to a brochantite standard spectrum. Settings: laser wavelength 532nm, acquisition time 100s, one accumulation, filter D2 (0.75-0.8 mW), hole 500, slit 80, grating 600. The peak indicated with an arrow on the cat3_H spectrum is due to fluorescence. Method of analysis: Raman spectroscopy, Lab Swiss National Museum, Affoltern a. Albis ZH,

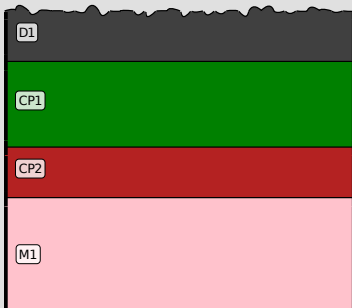
Fig. 4: Stratigraphic representation of the object in cross-section using the MiCorr application. This representation can be compared to Fig. 7.
