# SHINGLE OF A ROOF – CU ALLOY – MODERN TIMES – SWITZERLAND

| <b>Artefact name</b> | Shingle of a roof |
| <b>Authors</b> | Marianne. Senn (EMPA, Dübendorf, Zurich, Switzerland) & Christian. Degriigny (HE-Arc CR, Neuchâtel, Neuchâtel, Switzerland) |

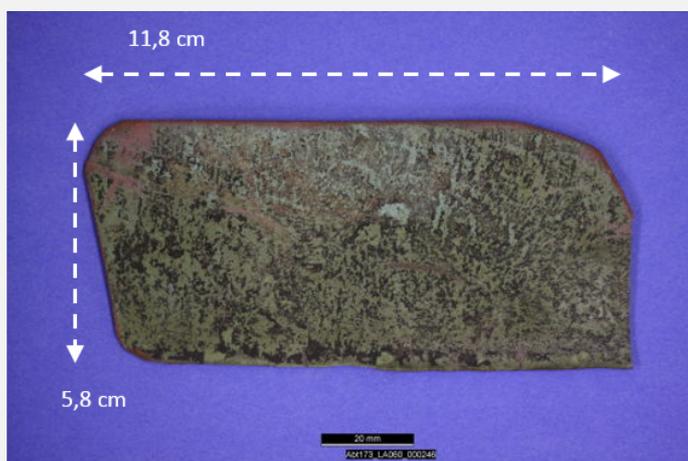
Fig. 1: Copper alloy shingle, internal side,

| <b>Description of the artefact</b> | Shingle, slightly curved, the internal side is covered with heterogeneously distributed green and black corrosion products (Fig. 1). The external side shows a regular dark green corrosion crust. Dimensions: L = 11.8cm; W = 5.8cm. |

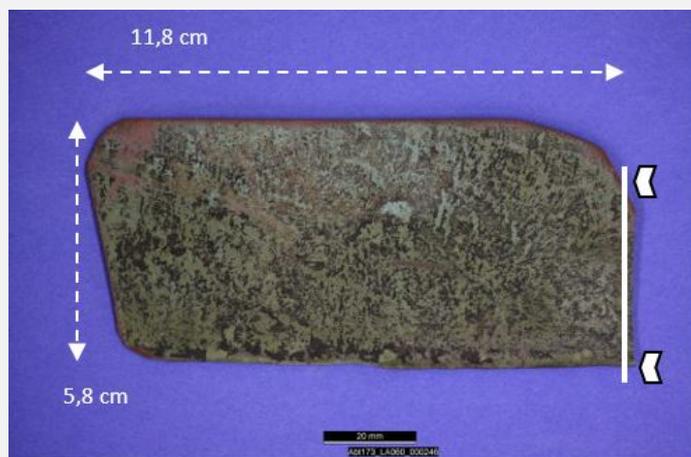
Fig. 2: showing the location of sampling area,

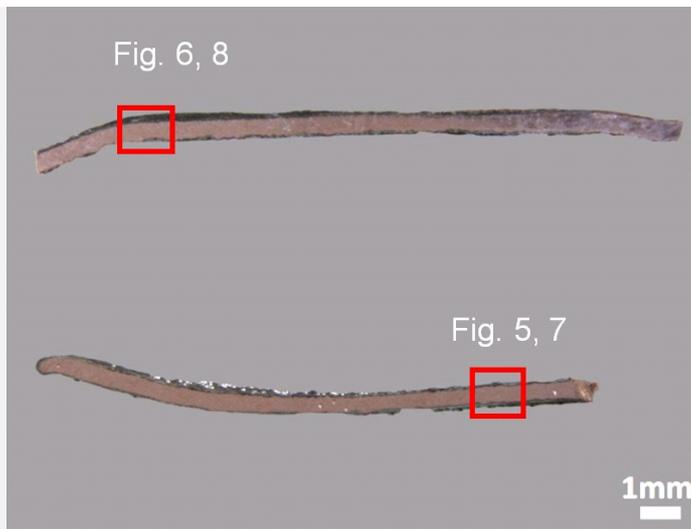
Fig. 3: Micrograph of the cross-sections showing the location of Figs. 5 to 8,

| <b>Description of sample</b> | Two samples were taken (Fig. 2). The polished samples show a well-preserved metal surface with a thin corrosion crust (Fig. 3). T = 0.5mm. |

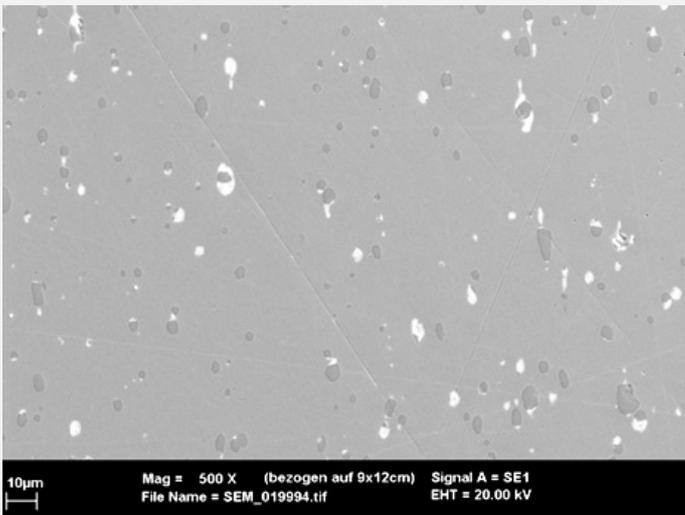
The remaining metal is a copper alloy (Table 1). The evenly distributed inclusions observed under SEM, SE-mode, are either light-grey or white (Fig. 5). The oval shape of the light-grey inclusions is due to deformation, probably by hot rolling (a common technique in the 18th century). Under polarised light they look red (Fig. 7) and their analysis reveals a composition similar to cuprite/Cu<sub>2</sub>O (Table 2). The white inclusions are rich in Pb and are remnants of the refining process (Table 2). The etched copper shows a structure of polygonal and twinned grains (Fig. 6). The grain size is variable. The average hardness of the metal is about HV1 70.

Table 2: Chemical composition (mass %) of the inclusions in the metal (from Fig. 5). Method of analysis: SEM/EDS, Laboratory of Analytical Chemistry, Empa.

Fig. 5: SEM image, SE-mode, of the metal sample from Fig. 3 (detail). Light-grey and white inclusions are distributed evenly,

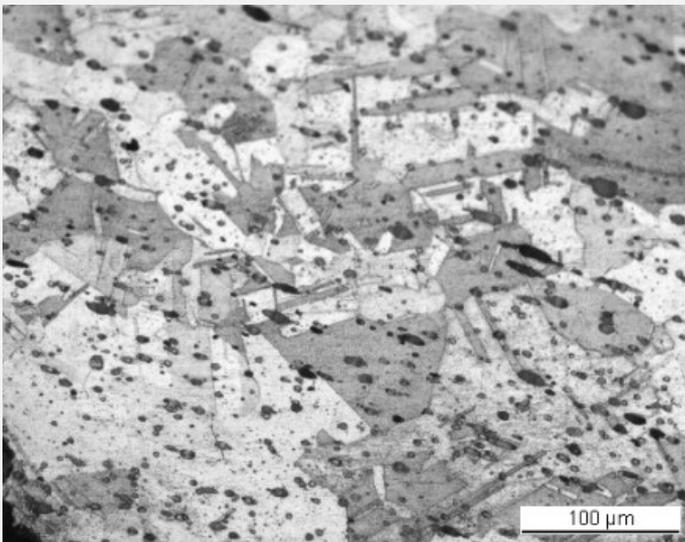
Fig. 6: Micrograph of the metal sample from Fig. 3 (detail), etched, bright field. The metal shows a structure of polygonal and twinned grains. Cuprite inclusions appear as dark spots,

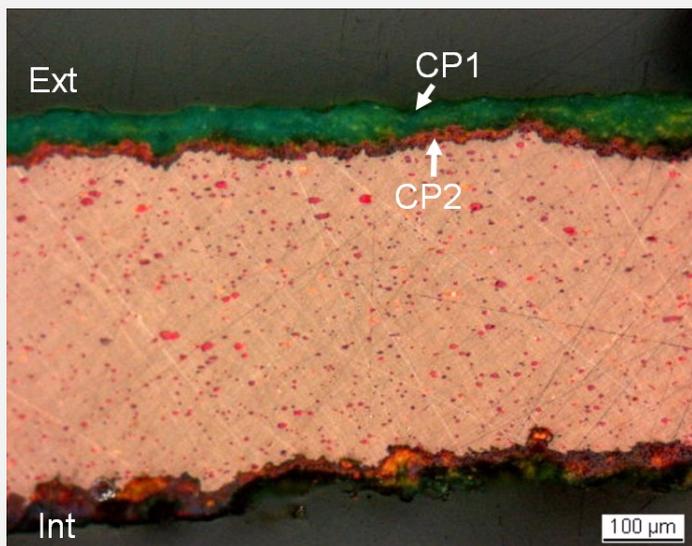
The corrosion crusts of the external and internal sides are distinctively different (Fig. 7). On the internal side an irregular red-orange corrosion layer has developed, and pitting corrosion has occurred. The more uniform corrosion layers on the external side are composed of a red-orange layer, followed by a thicker green outer layer. In some areas, dark-red corrosion products can be observed between the green and red-orange sub-layers. The same dark-red sub-layer can be seen in areas on the internal side covering the red-orange corrosion products. The red-orange corrosion layer on both sides (CP2) has a chemical composition similar to cuprite/Cu<sub>2</sub>O, while the green layer on the external side (CP1) contains Cu, S and O and is enriched on its upper surface with Si (Table 3 and Fig. 8). XRD analysis of the corrosion products on the external side of another shingle fragment from the same roof identified brochantite/Cu<sub>4</sub>SO<sub>4</sub>(OH)<sub>6</sub> and cuprite as corrosion products (Rapport d'analyse no. MAH 98-257). These results are confirmed by Raman spectroscopy of the external side of this sample where the same compounds were clearly identified (Figs. 9 and 10).

Fig. 7: Micrograph of the metal sample from Fig. 3 and corresponding to the stratigraphy of Fig. 4, polarised light. External side: the regular corrosion crust with outer green, inner red-orange corrosion products and intermediate dark-red corrosion products. Internal side: the irregular corrosion crust with inner red-orange and outer dark-red corrosion products,

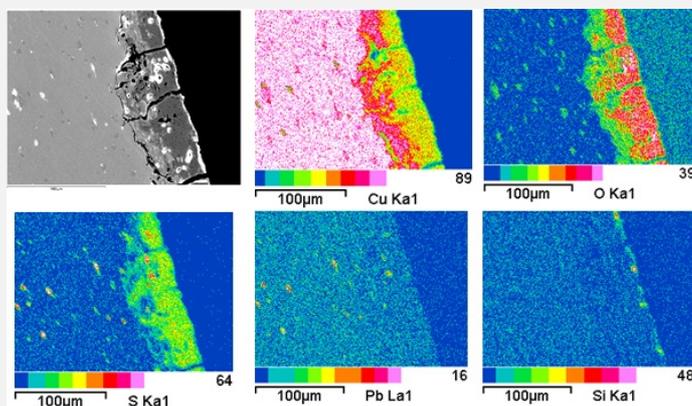
Fig. 8: SEM image, SE-mode, and elemental chemical distribution of the selected area of Fig. 3 (rotated image, detail). Method of examination: SEM/EDS, Laboratory of Analytical Chemistry, Empa,

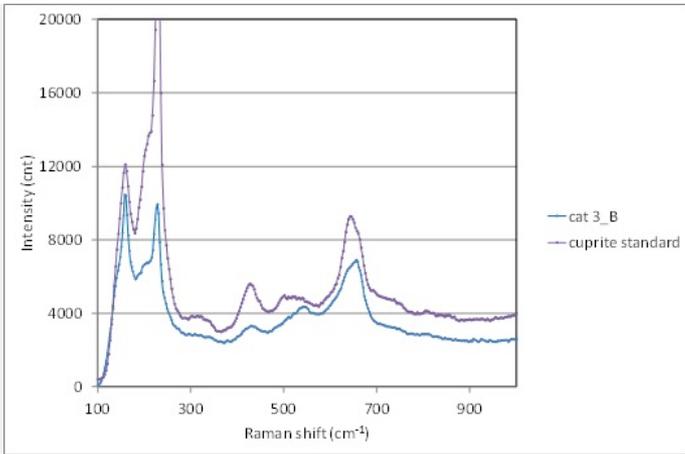
Fig. 9: Raman spectrum of the red-orange inner corrosion layer (CP2) of the external side (cat3\_B) compared to a cuprite standard spectrum. Settings: laser wavelength 532nm, acquisition time 100s,

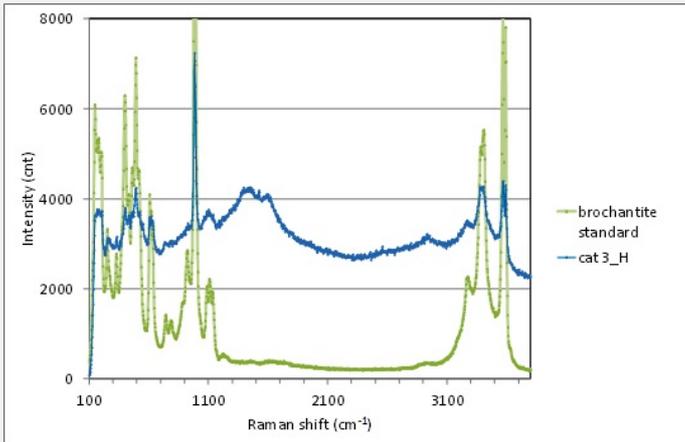
Fig. 10: Raman spectrum of the green outer corrosion layer (CP1) of the external side (cat3\_H) compared to a brochantite standard spectrum. Settings: laser wavelength 532nm, acquisition time 100s, one accumulation, filter D2 (0.75-0.8 mW), hole 500, slit 80, grating 600. The peak indicated with an arrow on the cat3\_H spectrum is due to fluorescence. Method of analysis: Raman spectroscopy, Lab Swiss National Museum, Affoltern a. Albis ZH,

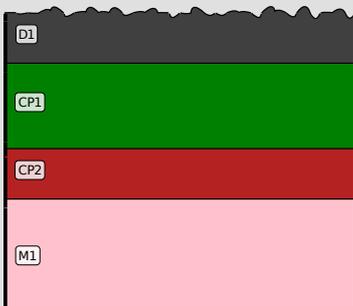
Fig. 4: Stratigraphic representation of the object in cross-section using the MiCorr application. This representation can be compared to Fig. 7.
