# SHINGLE OF A ROOF – CU ALLOY – MODERN TIMES – SWITZERLAND

Artefact name	Shingle of a roof
Authors	Marianne. Senn (EMPA, Dübendorf, Zurich, Switzerland) & Christian. Degrieny (HE-Arc CR, Neuchâtel, Neuchâtel, Switzerland)
Url	/artefacts/318/

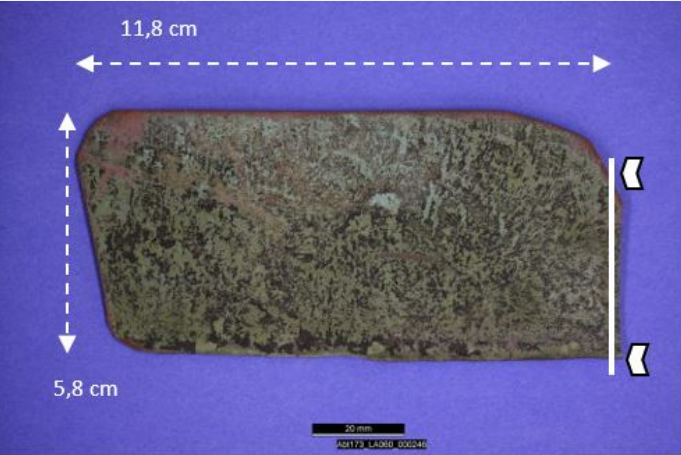
Fig. 2: showing the location of sampling area,

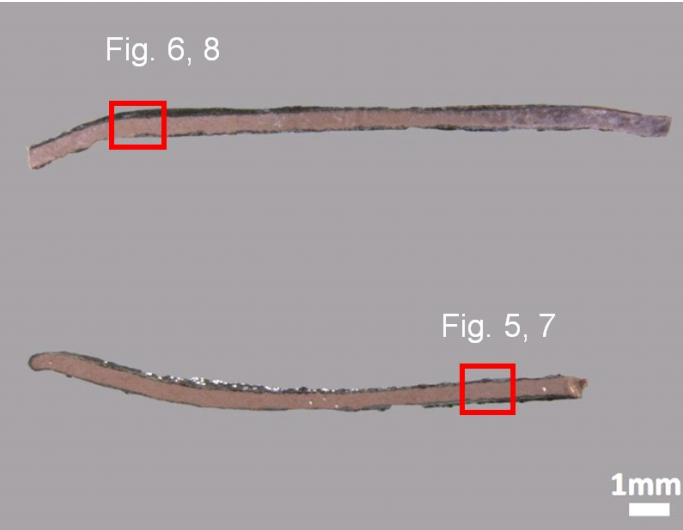
Fig. 3: Micrograph of the cross-sections showing the location of Figs. 5 to 8,

Description of sample	Two samples were taken (Fig. 2). The polished samples show a well-preserved metal surface with a thin corrosion crust (Fig. 3). T = 0.5mm.
Alloy	Cu Alloy
Technology	Rolled (probably hot rolling) and annealed
Lab number of sample	MAH-98-257
Sample location	Empa (Marianne Senn)
Responsible institution	Conservation Department of the Musées d'art et d'histoire, Genève, Geneva
Date and aim of sampling	2009, integration of sample to the MIFAC-Métal project

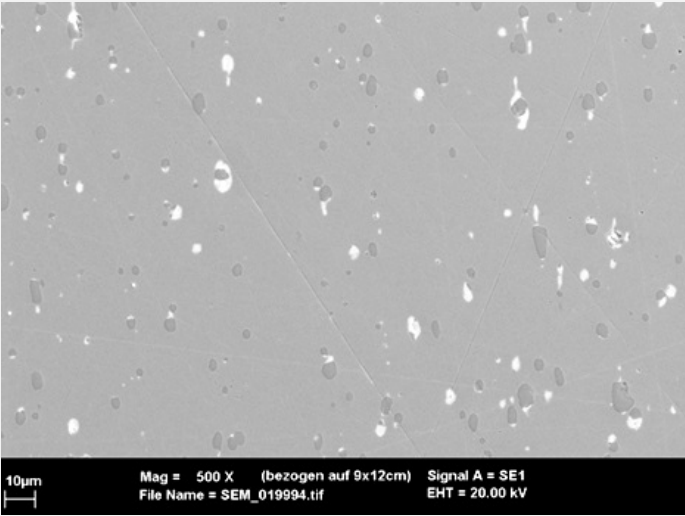
The remaining metal is a copper alloy (Table 1). The evenly distributed inclusions observed under SEM, SE-mode, are either light-grey or white (Fig. 5). The oval shape of the light-grey inclusions is due to deformation, probably by hot rolling (a common technique in the 18th century). Under polarised light they look red (Fig. 7) and their analysis reveals a composition similar to cuprite/Cu<sub>2</sub>O (Table 2). The white inclusions are rich in Pb and are remnants of the refining process (Table 2). The etched copper shows a structure of polygonal and twinned grains (Fig. 6). The grain size is variable. The average hardness of the metal is about HV1 70.

Fig. 5: SEM image, SE-mode, of the metal sample from Fig. 3 (detail). Light-grey and white inclusions are distributed evenly,

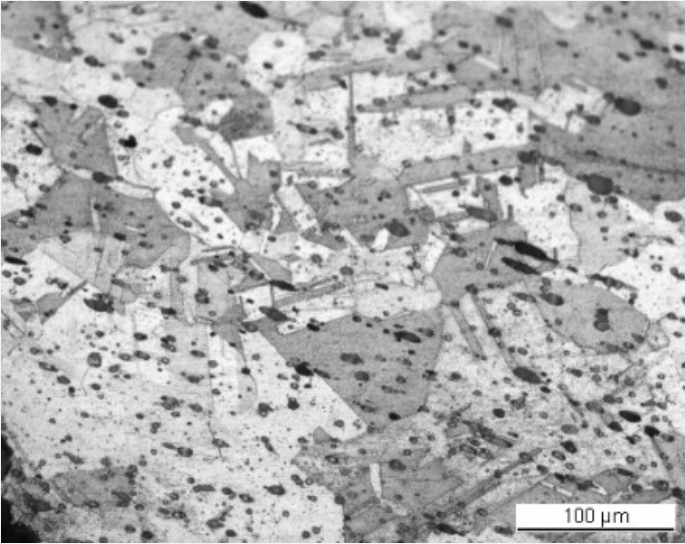
Fig. 6: Micrograph of the metal sample from Fig. 3 (detail), etched, bright field. The metal shows a structure of polygonal and twinned grains. Cuprite inclusions appear as dark spots,

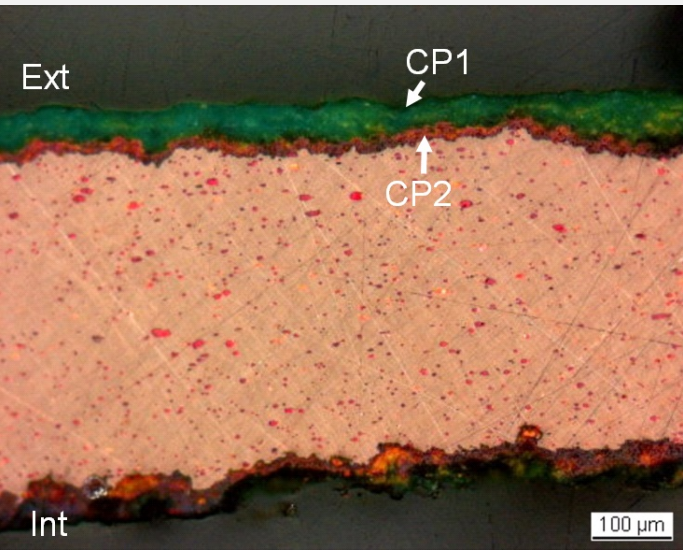
The corrosion crusts of the external and internal sides are distinctively different (Fig. 7). On the internal side an irregular red-orange corrosion layer has developed, and pitting corrosion has occurred. The more uniform corrosion layers on the external side are composed of a red-orange layer, followed by a thicker green outer layer. In some areas, dark-red corrosion products can be observed between the green and red-orange sub-layers. The same dark-red sub-layer can be seen in areas on the internal side covering the red-orange corrosion products. The red-orange corrosion layer on both sides (CP2) has a chemical composition similar to cuprite/ $\text{Cu}_2\text{O}$ , while the green layer on the external side (CP1) contains Cu, S and O and is enriched on its upper surface with Si (Table 3 and Fig. 8). XRD analysis of the corrosion products on the external side of another shingle fragment from the same roof identified brochantite/ $\text{Cu}_4\text{SO}_4(\text{OH})_6$  and cuprite as corrosion products (Rapport d'analyse no. MAH 98-257). These results are confirmed by Raman spectroscopy of the external side of this sample where the same compounds were clearly identified (Figs. 9 and 10).

Fig. 7: Micrograph of the metal sample from Fig. 3 and corresponding to the stratigraphy of Fig. 4, polarised light. External side: the regular corrosion crust with outer green, inner red-orange corrosion products and intermediate dark-red corrosion products. Internal side: the irregular corrosion crust with inner red-orange and outer dark-red corrosion products,

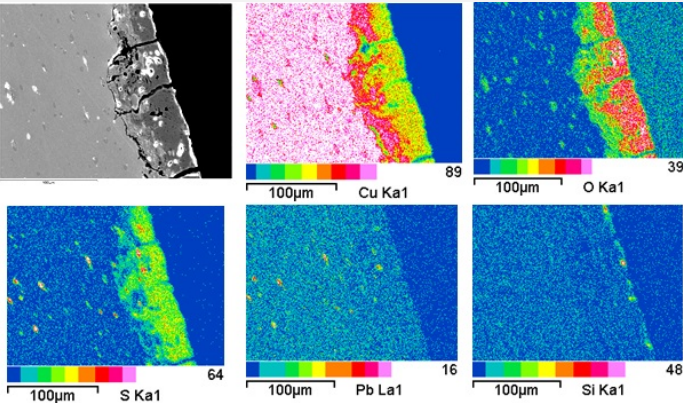
Fig. 8: SEM image, SE-mode, and elemental chemical distribution of the selected area of Fig. 3 (rotated image, detail). Method of examination: SEM/EDS, Laboratory of Analytical Chemistry, Empa,

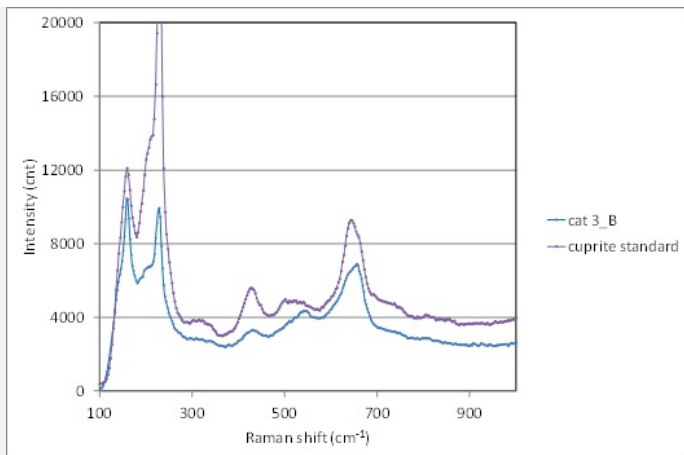
Fig. 9: Raman spectrum of the red-orange inner corrosion layer (CP2) of the external side (cat3\_B) compared to a cuprite standard spectrum. Settings: laser wavelength 532nm, acquisition time 100s,

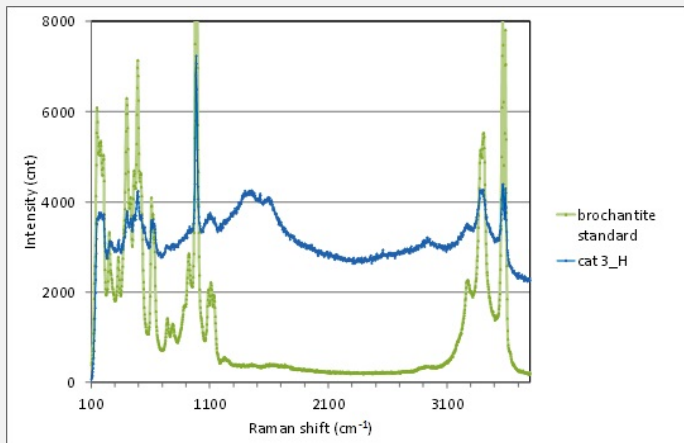
Fig. 10: Raman spectrum of the green outer corrosion layer (CP1) of the external side (cat3\_H) compared to a brochantite standard spectrum. Settings: laser wavelength 532nm, acquisition time 100s, one accumulation, filter D2 (0.75-0.8 mW), hole 500, slit 80, grating 600. The peak indicated with an arrow on the cat3\_H spectrum is due to fluorescence. Method of analysis: Raman spectroscopy, Lab Swiss National Museum, Affoltern a. Albis ZH,

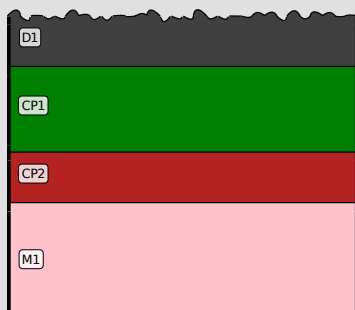
Fig. 4: Stratigraphic representation of the object in cross-section using the MiCorr application. This representation can be compared to Fig. 7.
