# SACRIFICIAL ANODE VHS-8339 - ZN ALLOY - MODERN TIMES

**Artefact name** Sacrificial anode VHS-8339

**Authors** Marianne. Senn (EMPA, Dübendorf, Zurich, Switzerland) & Christian. Degrieny (HE-Arc CR, Neuchâtel, Neuchâtel, Switzerland)

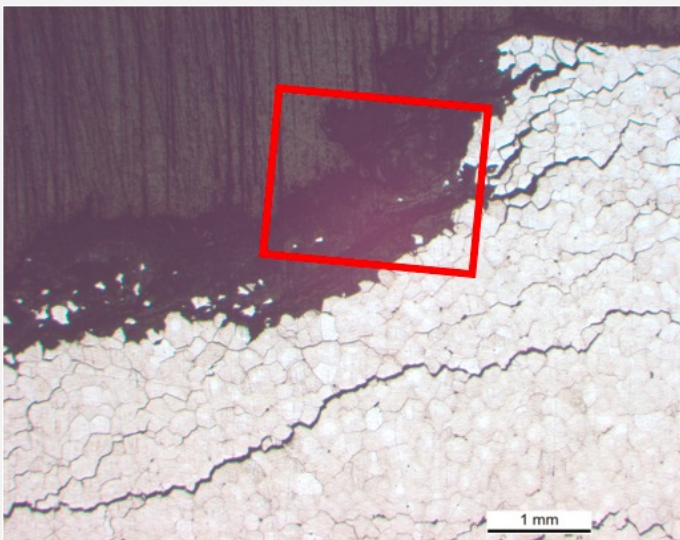
The remaining metal is an almost pure zinc alloy (Table 1). The oxygen content is not from the original alloy, but is due to secondary corrosion. The metal grains are visible without etching and present a polygonal structure (Figs. 5 and 6). The structure is recrystallised after annealing. The recrystallization of zinc alloys begins at room temperature.

Fig. 5: Micrograph of the metal sample from Fig. 3 (reversed picture, detail), unetched, bright field. Extensive intergranular corrosion is visible. The rectangle marks Fig. 7,

Extended intergranular corrosion has developed in the metal structure (Figs. 5, 6). The metal is covered by a corrosion crust that is hardly visible in bright field and which contains remnant metal (Fig. 5). On most of the sample the corrosion crust is uniform. In areas we see cracks (Fig. 7) appearing as brown lines separating the corrosion crust (Fig. 8). In bright field the corrosion crust appears grey containing dark-grey zones (Fig. 7). Under polarized light, the corrosion crust appears white with darker parts including remnant metal (Fig. 8). It contains Zn and O as well as S along some cracks (Table 2 and Fig. 9).

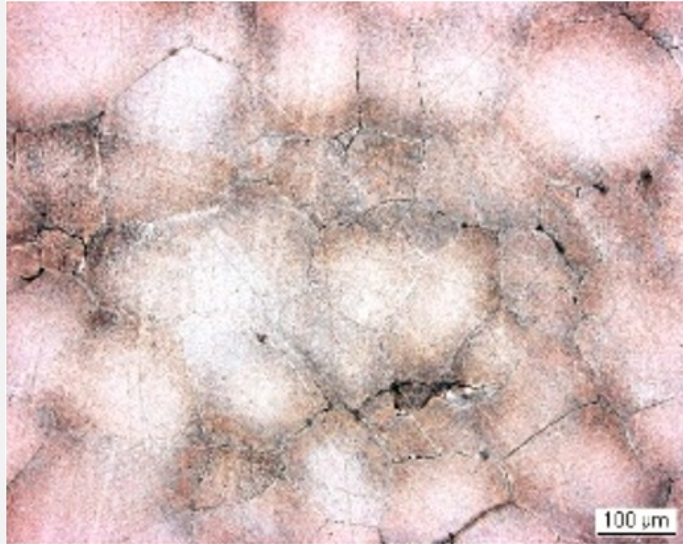
Fig. 6: Micrograph of the metal sample from Fig. 3 (detail), etched,

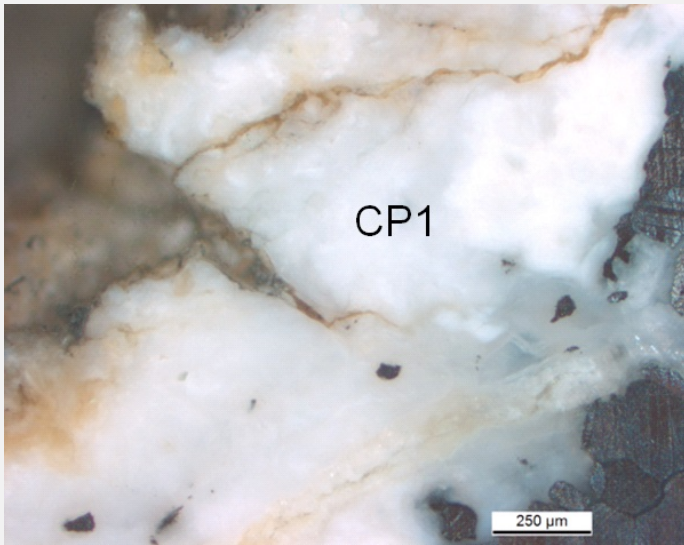
Fig. 8: Micrograph (same as Fig. 7) corresponding to the stratigraphy of Fig. 4, unetched, polarised light. We observe in dark-grey the metal, in white the corrosion crust separated by brown cracks including remnant metal,
