SACRIFICIAL ANODE VHS-8339 - ZN ALLOY - MODERN TIMES

Artefact name Sacrificial anode VHS-8339

Authors Marianne. Senn (EMPA, Dübendorf, Zurich, Switzerland) & Christian. Degrigny (HE-Arc CR, Neuchâtel, Neuchâtel,

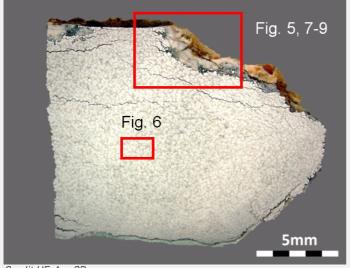
Fig. 3: Micrograph of the cross-section showing the location of Figs. 5

The sample (Fig. 3) shows a cross-section from the sacrificial anode (Fig. 2). The thickness of the corrosion crust is variable. Dimensions: L = 17mm; W = 14mm.

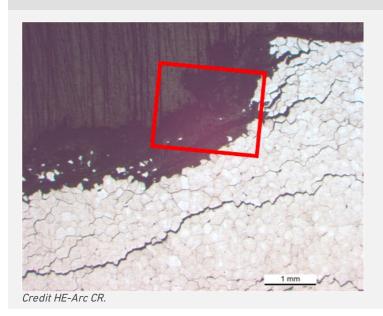
The remaining metal is an almost pure zinc alloy (Table 1). The oxygen content is not from the original alloy, but is due to secondary corrosion. The metal grains are visible without etching and present a polygonal structure (Figs. 5 and 6). The structure is recrystallised after annealing. The recrystallization of zinc alloys begins at room temperature.

Fig. 5: Micrograph of the metal sample from Fig. 3 (reversed picture, detail), unetched, bright field. Extensive intergranular corrosion is visible. The rectangle marks Fig. 7,

Extended intergranular corrosion has developed in the metal structure (Figs. 5, 6). The metal is covered by a corrosion crust that is hardly visible in bright field and which contains remnant metal (Fig. 5). On most of the sample the corrosion crust is uniform. In areas we see cracks (Fig. 7) appearing as brown lines separating the corrosion crust (Fig. 8). In bright field the corrosion crust appears grey containing dark-grey zones (Fig. 7). Under polarized light, the corrosion crust appears white with darker parts including remnant metal (Fig. 8). It contains Zn and O as well as S along some cracks (Table 2 and Fig. 9).

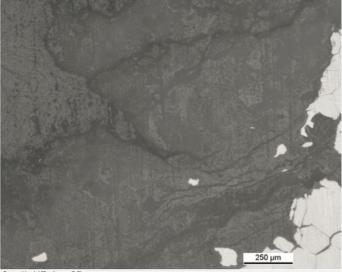
Fig. 7: Micrograph showing the metal - corrosion products interface from Fig. 5 (detail), unetched, bright field,

Table 2. Chemical composition (mass %) of the corrosion layer from Figs. 7 and 9. Method of analysis: SEM/EDS, Laboratory of Analytical Chemistry, Empa.

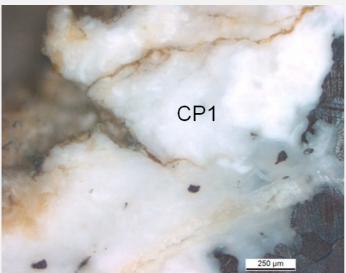
Fig. 8: Micrograph (same as Fig. 7) corresponding to the stratigraphy of Fig. 4, unetched, polarised light. We observe in dark-grey the metal, in white the corrosion crust separated by brown cracks including remnant metal,

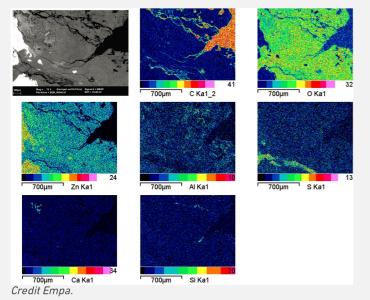
Fig. 9: SEM image, BSE-mode, and elemental chemical distribution of $\,$ most of the area of Fig. 7 (reversed picture). Method of examination: SEM/EDS, Laboratory of Analytical Chemistry, Empa,
