# SACRIFICIAL ANODE VHS-8339 - ZN ALLOY - MODERN TIMES

**Artefact name** Sacrificial anode VHS-8339

**Authors** Marianne. Senn (EMPA, Dübendorf, Zurich, Switzerland) & Christian. Degrigny (HE-Arc CR, Neuchâtel, Neuchâtel, Switzerland)

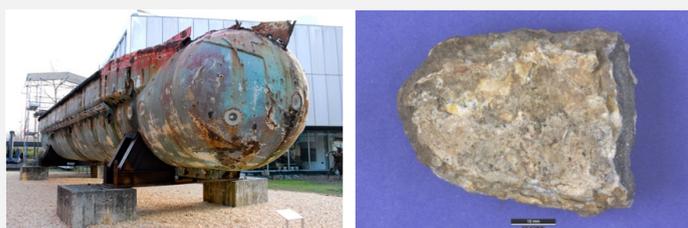
Fig. 1: The submarine and the anode (www.verkehrshaus.ch),

<b>Description of the artefact</b>	The artefact could be a weight or sacrificial anode of a submarine (Fig. 1). It is surrounded by a whitish brown-grey corrosion crust. The broken metal has a greyish shiny colour, whereas the metal part that is cut has a silvery appearance. Dimensions: L = 4.9cm ; WT = 95g.
<b>Type of artefact</b>	Submarine part
<b>Origin</b>	Submarine "Mesoscaph" from Auguste Piccard
<b>Recovering date</b>	The sacrificial anodes (?) might have been added when the submarine was used in the sea.
<b>Chronology category</b>	Modern Times
<b>chronology tpq</b>	<input type="text" value="1970"/> A.D. ▼
<b>chronology taq</b>	<input type="text" value="1974"/> A.D. ▼
<b>Chronology comment</b>	1970 _ 1974
<b>Burial conditions / environment</b>	Outdoor atmosphere
<b>Artefact location</b>	Swiss Museum of Transport, Luzern, Lucerne
<b>Owner</b>	Swiss Museum of Transport, Luzern, Lucerne
<b>Inv. number</b>	VHS-8339

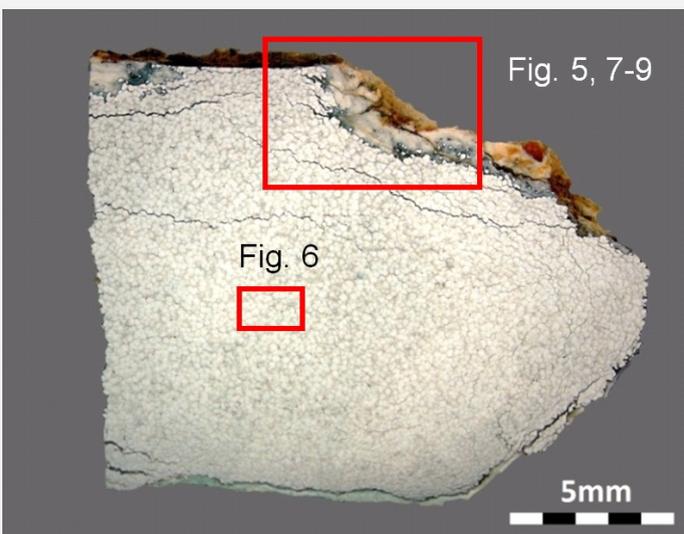
Fig. 3: Micrograph of the cross-section showing the location of Figs. 5 to 9,

The sample (Fig. 3) shows a cross-section from the sacrificial anode (Fig. 2). The thickness of the corrosion crust is variable. Dimensions: L = 17mm; W = 14mm.

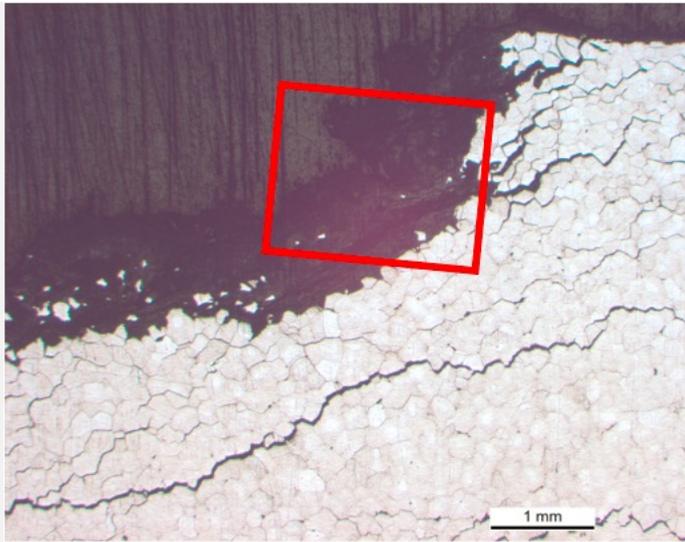
The remaining metal is an almost pure zinc alloy (Table 1). The oxygen content is not from the original alloy, but is due to secondary corrosion. The metal grains are visible without etching and present a polygonal structure (Figs. 5 and 6). The structure is recrystallised after annealing. The recrystallization of zinc alloys begins at room temperature.

Fig. 5: Micrograph of the metal sample from Fig. 3 (reversed picture, detail), unetched, bright field. Extensive intergranular corrosion is visible. The rectangle marks Fig. 7,

Extended intergranular corrosion has developed in the metal structure (Figs. 5, 6). The metal is covered by a corrosion crust that is hardly visible in bright field and which contains remnant metal (Fig. 5). On most of the sample the corrosion crust is uniform. In areas we see cracks (Fig. 7) appearing as brown lines separating the corrosion crust (Fig. 8). In bright field the corrosion crust appears grey containing dark-grey zones (Fig. 7). Under polarized light, the corrosion crust appears white with darker parts including remnant metal (Fig. 8). It contains Zn and O as well as S along some cracks (Table 2 and Fig. 9).

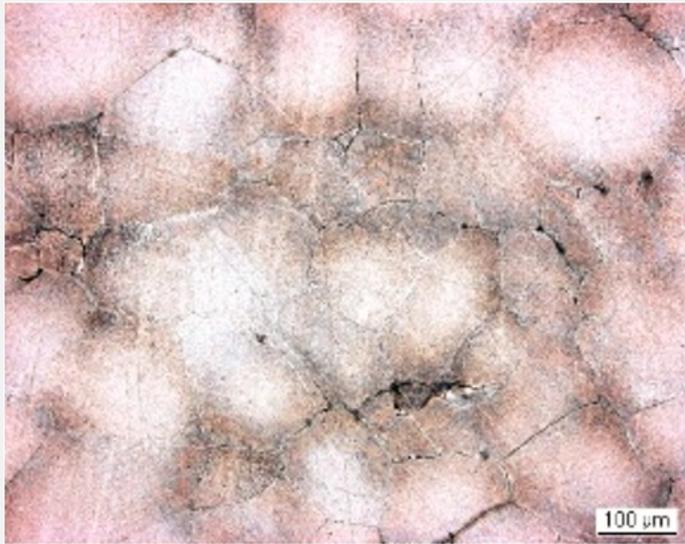
Fig. 6: Micrograph of the metal sample from Fig. 3 (detail), etched,

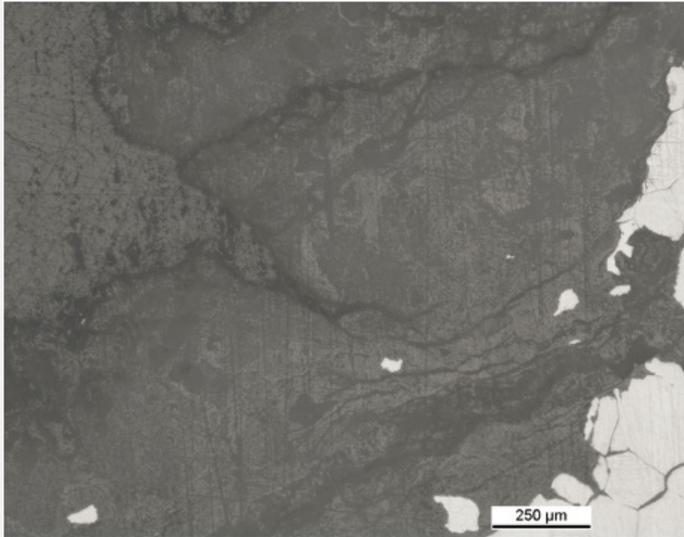
Table 2. Chemical composition (mass %) of the corrosion layer from Figs. 7 and 9. Method of analysis: SEM/EDS, Laboratory of Analytical Chemistry, Empa.

Fig. 7: Micrograph showing the metal - corrosion products interface from Fig. 5 (detail), unetched, bright field,

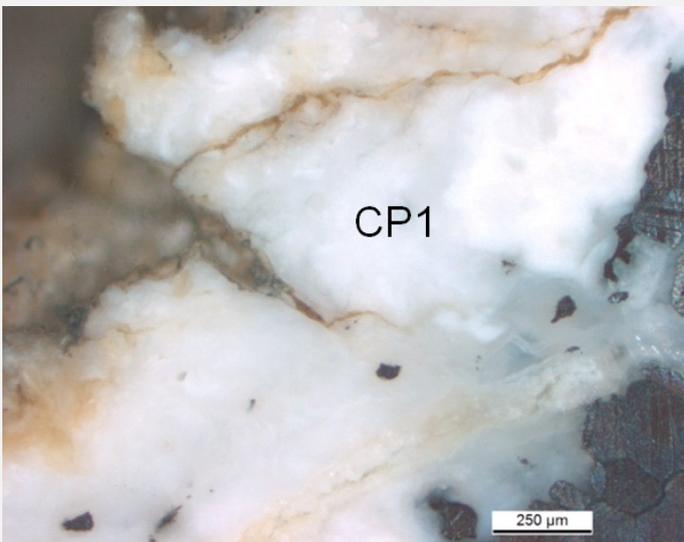
Fig. 8: Micrograph (same as Fig. 7) corresponding to the stratigraphy of Fig. 4, unetched, polarised light. We observe in dark-grey the metal, in white the corrosion crust separated by brown cracks including remnant metal,

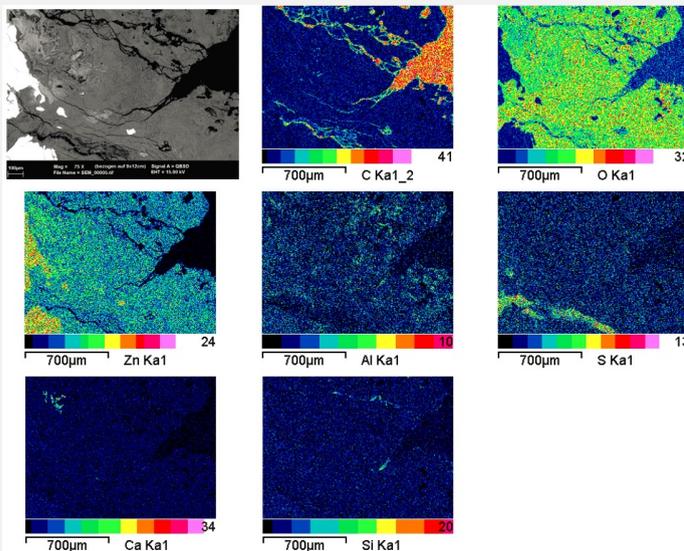
Fig. 9: SEM image, BSE-mode, and elemental chemical distribution of most of the area of Fig. 7 (reversed picture). Method of examination: SEM/EDS, Laboratory of Analytical Chemistry, Empa,
