TANG FRAGMENT OF A KNIFE HR-6246 - TIN BRONZE - LATE BRONZE AGE - SWITZERLAND

Artefact name	Tang fragment of a knife HR-6246
Authors	Marianne. Senn (EMPA, Dübendorf, Zurich, Switzerland) & Christian. Degriigny (HE-Arc CR, Neuchâtel, Neuchâtel, Switzerland)
Url	/artefacts/322/

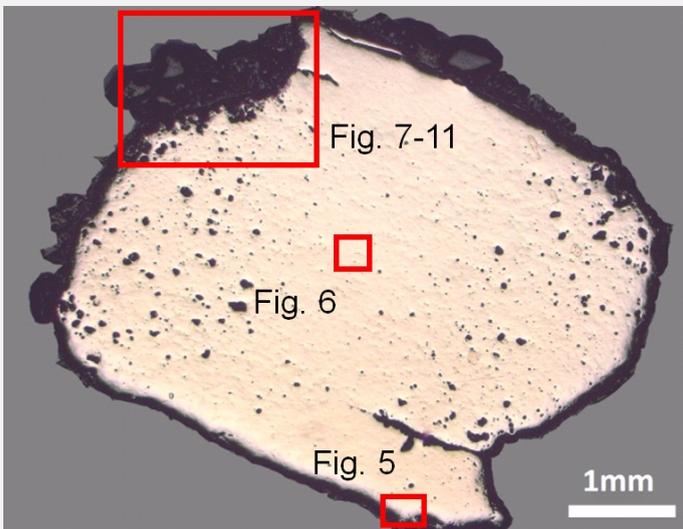
Fig. 3: Micrograph of the cross-section showing the location of Figs. 5 to 11,

The cross-section corresponds to a lateral cut (Fig. 2). The surface is covered with a thick corrosion crust (Fig. 3).

The remaining metal is a tin bronze (Table 1) with high porosity and large cracks both on the left and right edges of the sample (Fig. 3). The metal contains small, elongated copper sulphide (Table 2) and Pb inclusions that are oriented parallel to the cracks. Near the metal surface, slip lines are outlined by the development of intergranular corrosion (Fig. 5). The etched metal shows small, elongated grains with slip lines (Fig. 6). Annealing is visible in areas near the surface. The average hardness of the metal is HV1 145, but significant variations are observed, depending on where the measurements are taken.

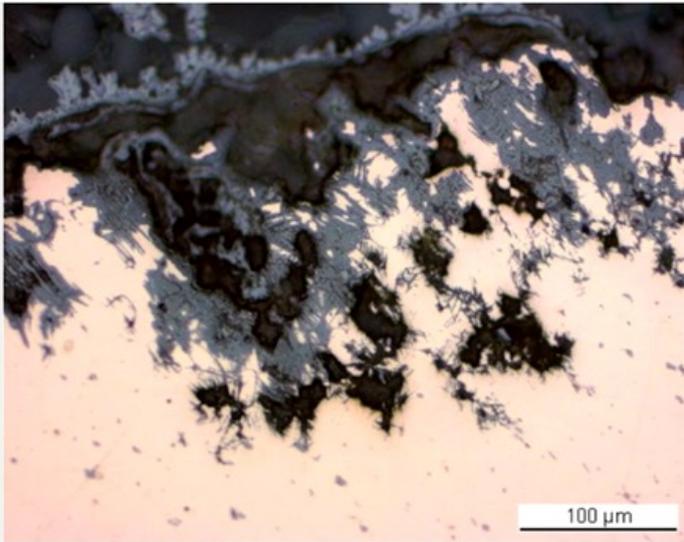
Fig. 5: Micrograph of the metal sample from Fig. 3 (inverted and reversed picture, detail), unetched, bright field. Corrosion products are in dark-grey whereas the metal is in pink. Slip lines are outlined by the development of intergranular corrosion,

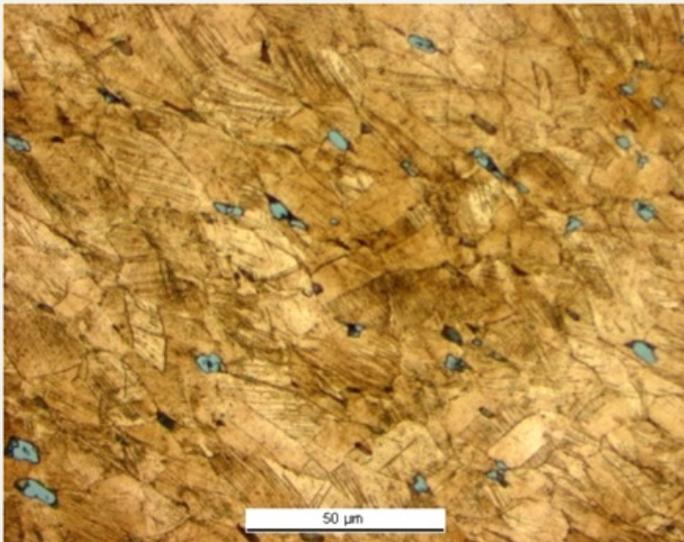
Fig. 6: Micrograph of the metal sample from Fig. 3 (detail), etched, bright field. We observe elongated grains with slip lines as well as grey copper sulphide inclusions,

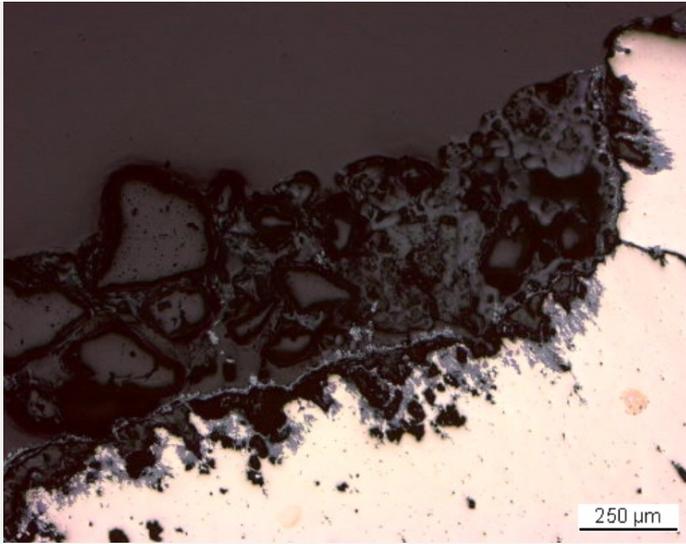
The corrosion crust has a thickness between 0.1mm and 0.7mm (Fig. 3). In bright field (Fig. 7), one can observe that the metal has been replaced by light-grey corrosion products. Adjacent to the metal is a thick, heterogeneous, dark-grey layer with a band of light-grey corrosion products. In polarised light (Fig. 8), all corrosion products which were previously light-grey appear brown-orange, the dark-grey layer turquoise. The elemental chemical distribution of the SEM images (Figs. 9 and 10) reveals that the inner corrosion products are Sn-rich whereas the adjacent band is Cu and S-rich (Fig. 11). The outer layer contains large inclusions (quartz and others, Si, Al and Na, see Figs. 10-11) and is most probably composed of malachite/ $\text{Cu}_2(\text{CO}_3)(\text{OH})_2$ (only Cu and O are detected – Fig. 11). S is distributed throughout this layer. XRD analyses indicated the presence of posnjakite/ $\text{Cu}_4\text{SO}_4(\text{OH})_6\text{H}_2\text{O}$, chalcocite/ Cu_2S and djurleite/ $\text{Cu}_{1.93}\text{S}$ (Schweizer 1994).

Fig. 7: Micrograph of the metal sample from Fig. 3 (detail), unetched, bright field. The inner light-grey corrosion products extend into the metal surface (in pink) and appear as a line within the dark-grey corrosion layer,

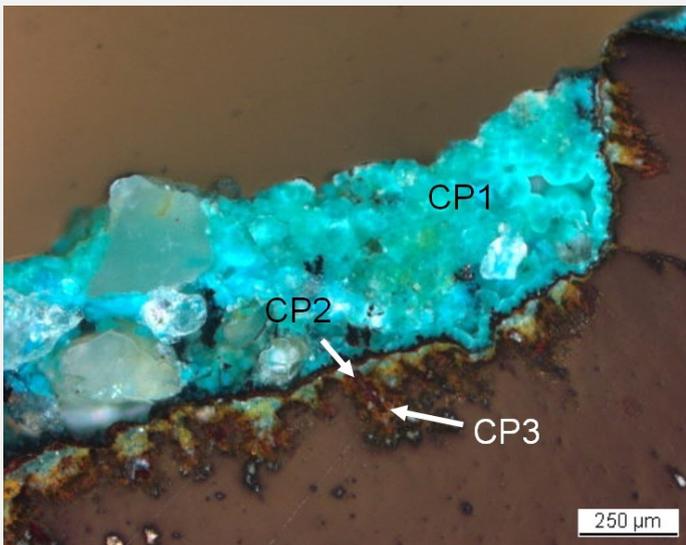
Fig. 8: Micrograph similar to Fig. 7 and corresponding to the stratigraphy of Fig. 4, polarized light. One can see that large mineral features are incorporated only in the corrosion layers above the brown-orange corrosion band,

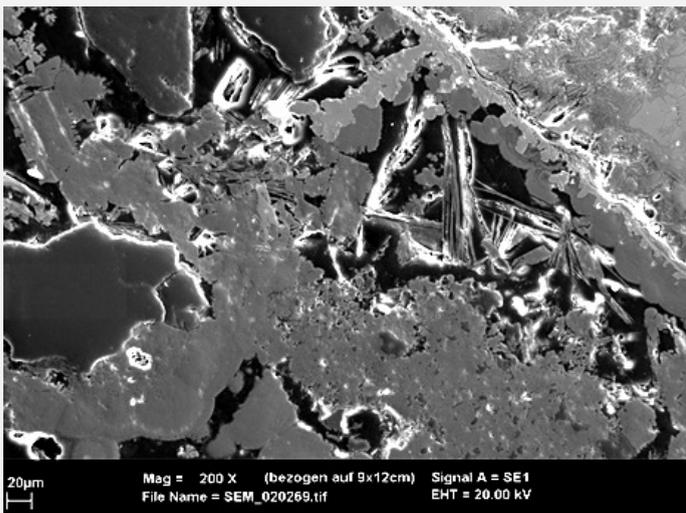
Fig. 9: SEM image (detail of Fig. 7), SE-mode. From bottom to top right: the thick, porous outer corrosion layer, the light-grey band and the remaining metal,

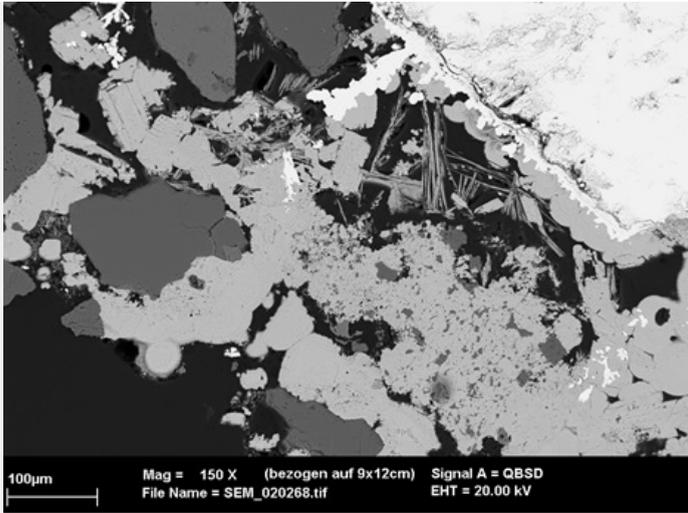
Fig. 10: SEM image, similar to Fig. 9, BSE-mode,

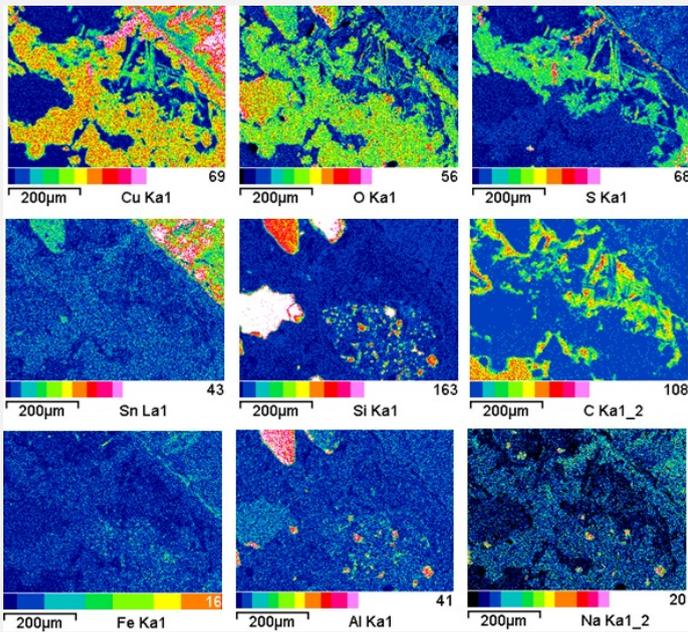
Fig. 11: EDS elemental chemical distribution of the SEM image of Fig. 9. Method of examination: SEM/EDS, Laboratory of Analytical Chemistry, Empa,
