# TANG FRAGMENT OF A KNIFE HR-6246 - TIN BRONZE - LATE BRONZE AGE - SWITZERLAND

<b>Artefact name</b>	Tang fragment of a knife HR-6246
<b>Authors</b>	Marianne. Senn (EMPA, Dübendorf, Zurich, Switzerland) & Christian. Degryny (HE-Arc CR, Neuchâtel, Neuchâtel, Switzerland)
<b>Url</b>	/artefacts/322/

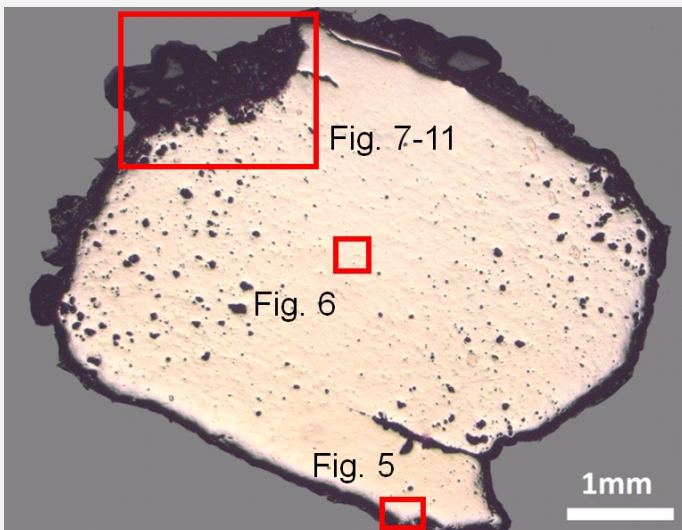
Fig. 3: Micrograph of the cross-section showing the location of Figs. 5 to 11,

The cross-section corresponds to a lateral cut (Fig. 2). The surface is covered with a thick corrosion crust (Fig. 3).

The remaining metal is a tin bronze (Table 1) with high porosity and large cracks both on the left and right edges of the sample (Fig. 3). The metal contains small, elongated copper sulphide (Table 2) and Pb inclusions that are oriented parallel to the cracks. Near the metal surface, slip lines are outlined by the development of intergranular corrosion (Fig. 5). The etched metal shows small, elongated grains with slip lines (Fig. 6). Annealing is visible in areas near the surface. The average hardness of the metal is HV1 145, but significant variations are observed, depending on where the measurements are taken.

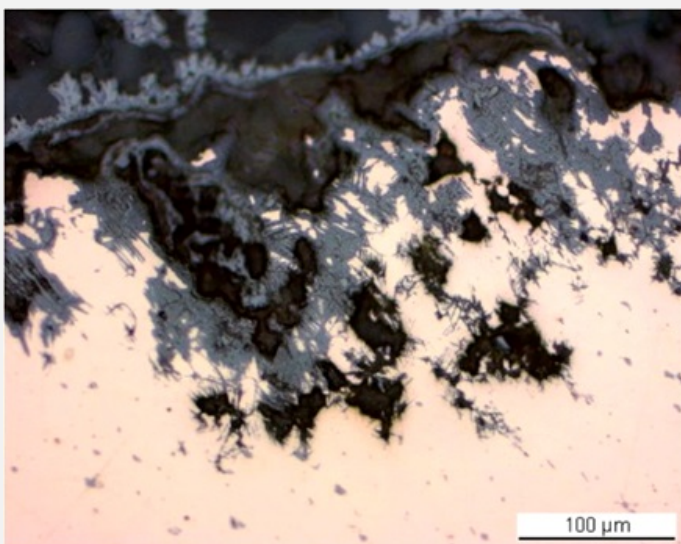
Fig. 5: Micrograph of the metal sample from Fig. 3 (inverted and reversed picture, detail), unetched, bright field. Corrosion products are in dark-grey whereas the metal is in pink. Slip lines are outlined by the development of intergranular corrosion,

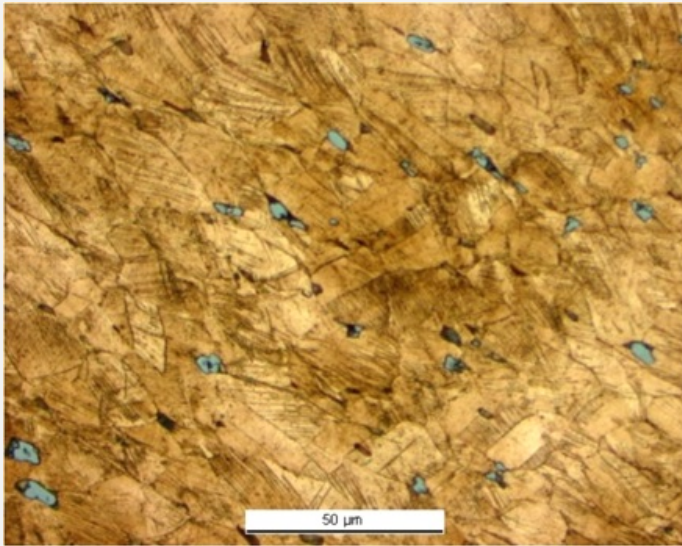
Fig. 6: Micrograph of the metal sample from Fig. 3 (detail), etched, bright field. We observe elongated grains with slip lines as well as grey copper sulphide inclusions,

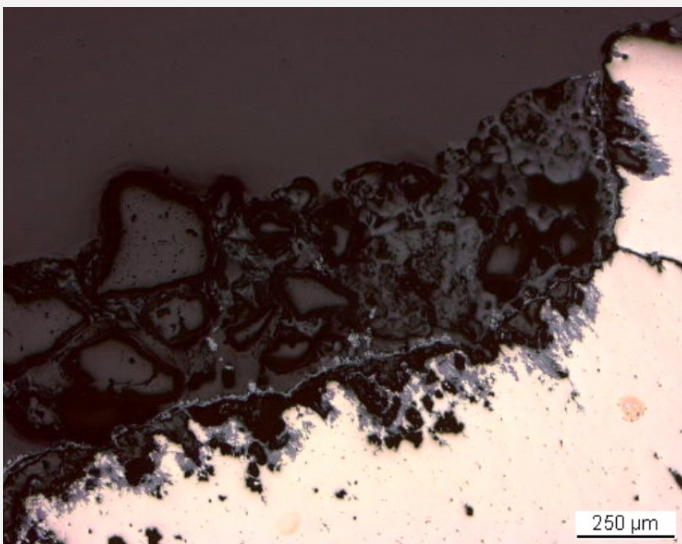
The corrosion crust has a thickness between 0.1mm and 0.7mm (Fig. 3). In bright field (Fig. 7), one can observe that the metal has been replaced by light-grey corrosion products. Adjacent to the metal is a thick, heterogeneous, dark-grey layer with a band of light-grey corrosion products. In polarised light (Fig. 8), all corrosion products which were previously light-grey appear brown-orange, the dark-grey layer turquoise. The elemental chemical distribution of the SEM images (Figs. 9 and 10) reveals that the inner corrosion products are Sn-rich whereas the adjacent band is Cu and S-rich (Fig. 11). The outer layer contains large inclusions (quartz and others, Si, Al and Na, see Figs. 10-11) and is most probably composed of malachite/ $\text{Cu}_2(\text{CO}_3)(\text{OH})_2$  (only Cu and O are detected – Fig. 11). S is distributed throughout this layer. XRD analyses indicated the presence of posnjakite/ $\text{Cu}_4\text{SO}_4(\text{OH})_6\text{H}_2\text{O}$ , chalcocite/ $\text{Cu}_2\text{S}$  and djurleite/ $\text{Cu}_3\text{S}_2$  (Schweizer 1994).

Fig. 7: Micrograph of the metal sample from Fig. 3 (detail), unetched, bright field. The inner light-grey corrosion products extend into the metal surface (in pink) and appear as a line within the dark-grey corrosion layer,

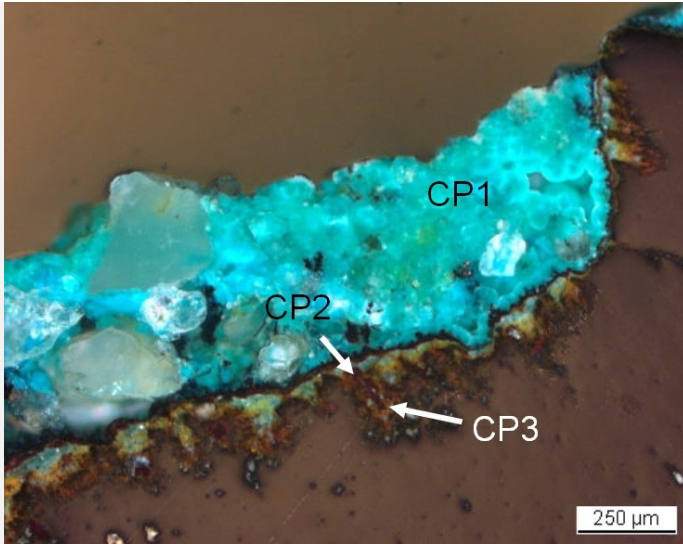
Fig. 8: Micrograph similar to Fig. 7 and corresponding to the stratigraphy of Fig. 4, polarized light. One can see that large mineral features are incorporated only in the corrosion layers above the brown-orange corrosion band,

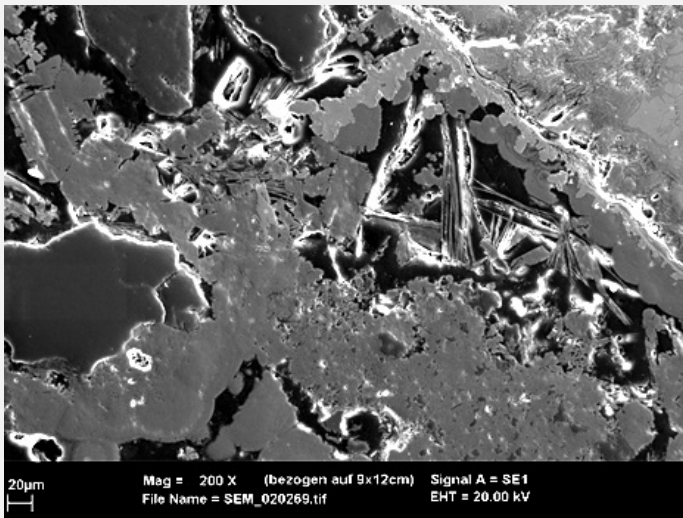
Fig. 9: SEM image (detail of Fig. 7), SE-mode. From bottom to top right: the thick, porous outer corrosion layer, the light-grey band and the remaining metal,

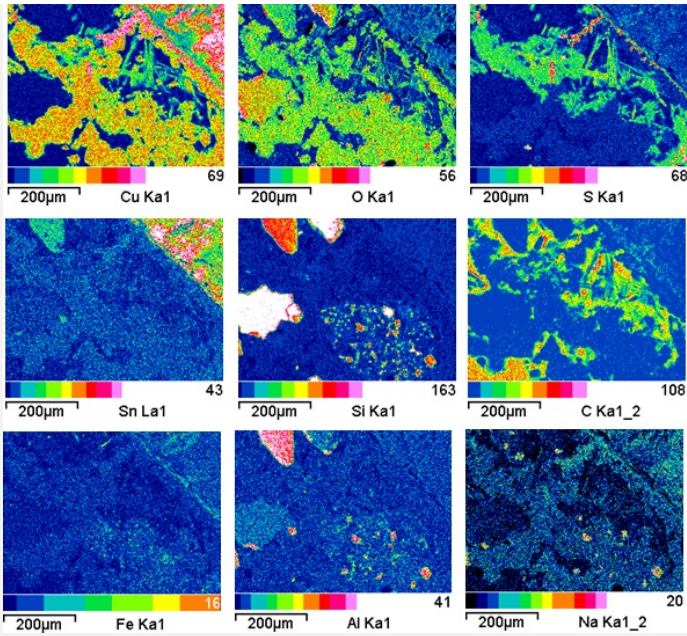
Fig. 11: EDS elemental chemical distribution of the SEM image of Fig. 9. Method of examination: SEM/EDS, Laboratory of Analytical Chemistry, Empa,

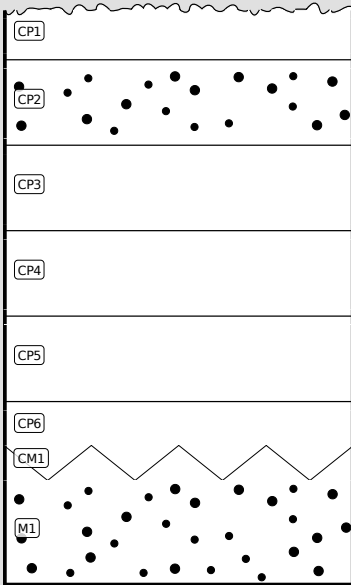
Fig. 4: Stratigraphic representation of the object in cross-section using the MiCorr application. This representation can be compared to Fig. 8.
