TANG FRAGMENT OF A KNIFE HR-6246 - TIN BRONZE - LATE BRONZE AGE - SWITZERLAND

Artefact name Tang fragment of a knife HR-6246

Authors Marianne. Senn (EMPA, Dübendorf, Zurich, Switzerland) & Christian. Degrigny (HE-Arc CR, Neuchâtel, Neuchâtel, Switzerland)

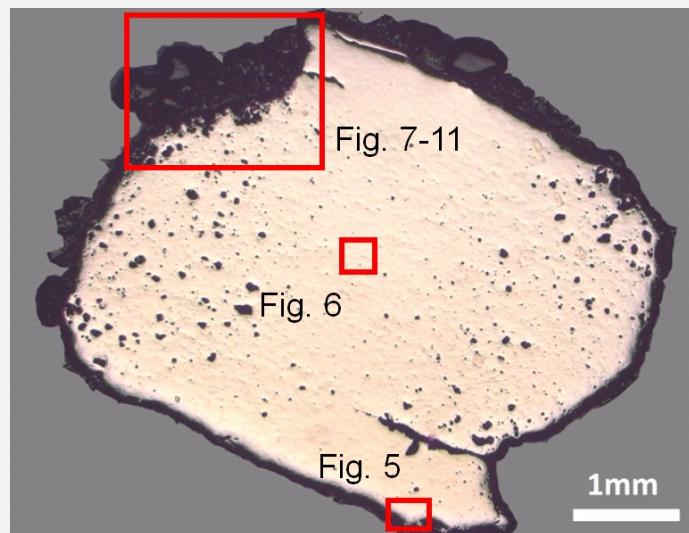
Fig. 3: Micrograph of the cross-section showing the location of Figs. 5 to 11,

The cross-section corresponds to a lateral cut (Fig. 2). The surface is covered with a thick corrosion crust (Fig. 3).

The remaining metal is a tin bronze (Table 1) with high porosity and large cracks both on the left and right edges of the sample (Fig. 3). The metal contains small, elongated copper sulphide (Table 2) and Pb inclusions that are oriented parallel to the cracks. Near the metal surface, slip lines are outlined by the development of intergranular corrosion (Fig. 5). The etched metal shows small, elongated grains with slip lines (Fig. 6). Annealing is visible in areas near the surface. The average hardness of the metal is HV1 145, but significant variations are observed, depending on where the measurements are taken.

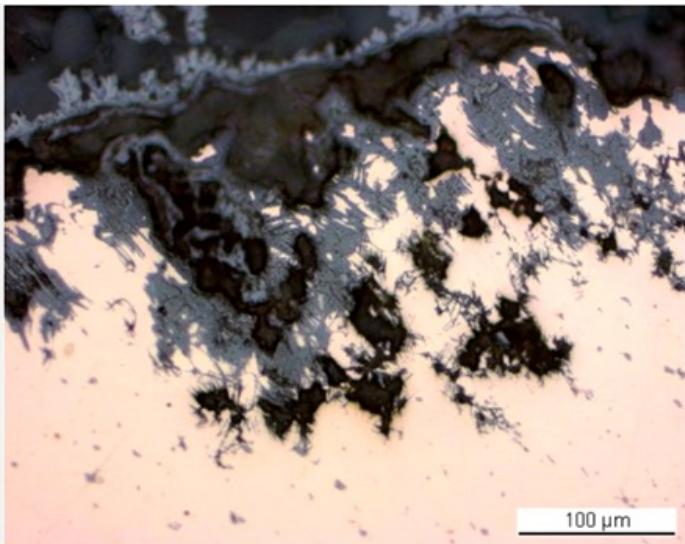
Fig. 5: Micrograph of the metal sample from Fig. 3 (inverted and reversed picture, detail), unetched, bright field. Corrosion products are in dark-grey whereas the metal is in pink. Slip lines are outlined by the development of intergranular corrosion,

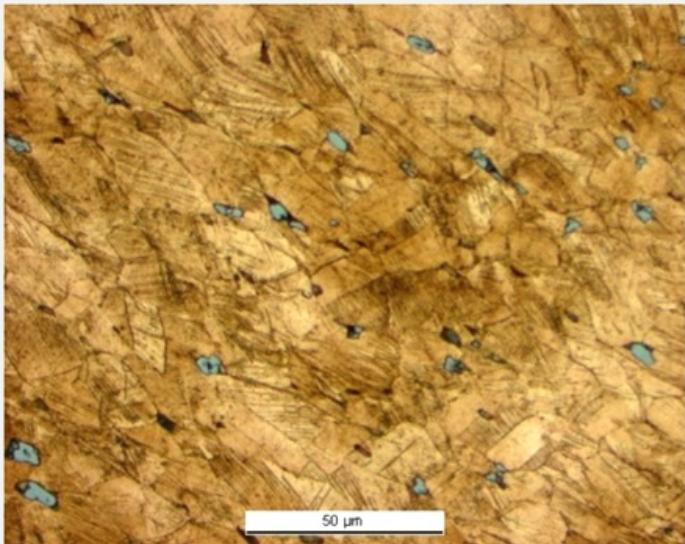
Fig. 6: Micrograph of the metal sample from Fig. 3 (detail), etched, bright field. We observe elongated grains with slip lines as well as grey copper sulphide inclusions,

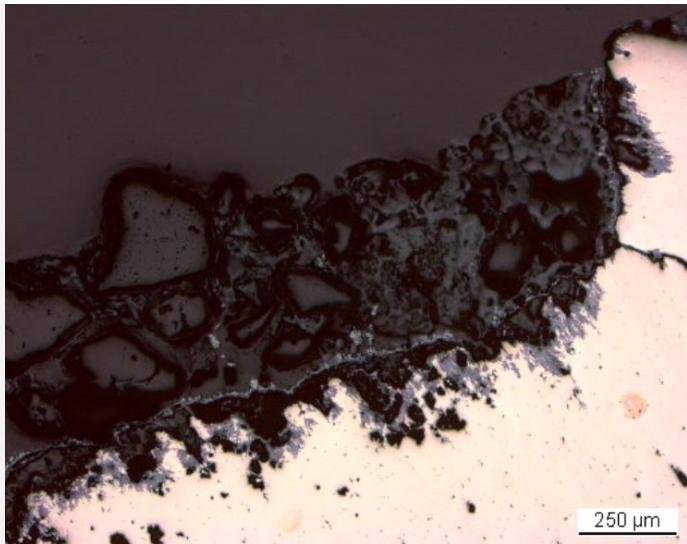
The corrosion crust has a thickness between 0.1mm and 0.7mm (Fig. 3). In bright field (Fig. 7), one can observe that the metal has been replaced by light-grey corrosion products. Adjacent to the metal is a thick, heterogeneous, dark-grey layer with a band of light-grey corrosion products. In polarised light (Fig. 8), all corrosion products which were previously light-grey appear brown-orange, the dark-grey layer turquoise. The elemental chemical distribution of the SEM images (Figs. 9 and 10) reveals that the inner corrosion products are Sn-rich whereas the adjacent band is Cu and S-rich (Fig. 11). The outer layer contains large inclusions (quartz and others, Si, Al and Na, see Figs. 10-11) and is most probably composed of malachite/Cu₂(CO₃)(OH)₂ (only Cu and O are detected – Fig. 11). S is distributed throughout this layer. XRD analyses indicated the presence of posnjakite/Cu₄SO₄(OH)₆H₂O, chalcocite/CuS and djurleite/Cu_{1.93}S (Schweizer 1994).

Fig. 7: Micrograph of the metal sample from Fig. 3 (detail), unetched, bright field. The inner light-grey corrosion products extend into the metal surface (in pink) and appear as a line within the dark-grey corrosion layer,

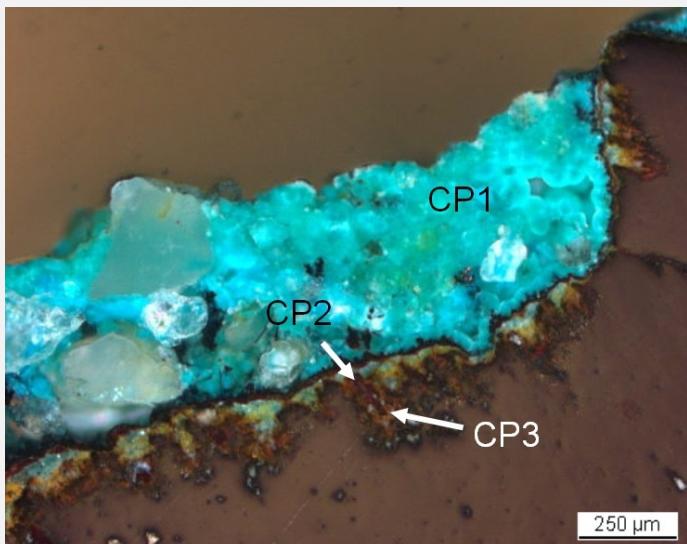
Fig. 8: Micrograph similar to Fig. 7 and corresponding to the stratigraphy of Fig. 4, polarized light. One can see that large mineral features are incorporated only in the corrosion layers above the brown-orange corrosion band,

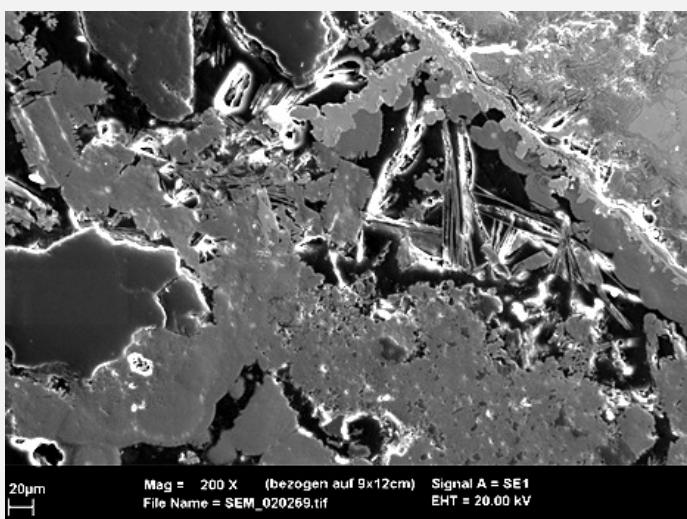
Fig. 9: SEM image (detail of Fig. 7), SE-mode. From bottom to top right: the thick, porous outer corrosion layer, the light-grey band and the remaining metal,

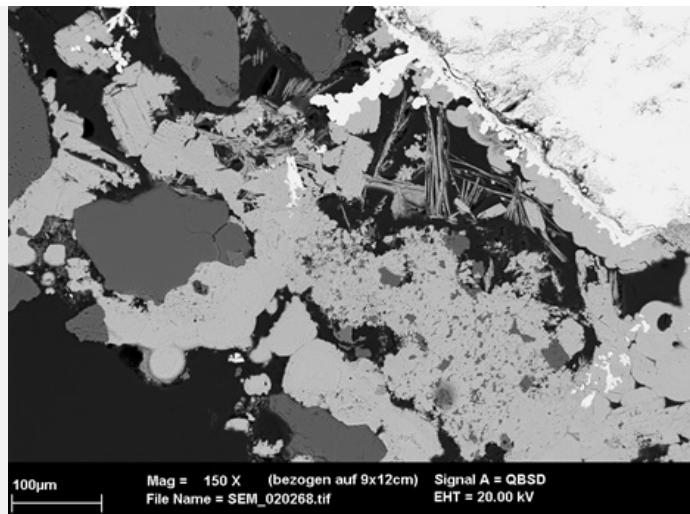
Fig. 10: SEM image, similar to Fig. 9, BSE-mode,

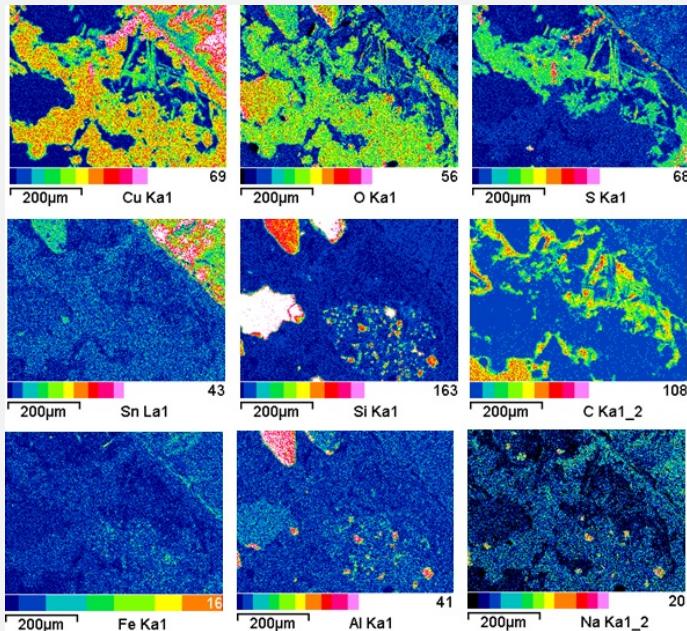
Fig. 11: EDS elemental chemical distribution of the SEM image of Fig. 9. Method of examination: SEM/EDS, Laboratory of Analytical Chemistry, Empa,

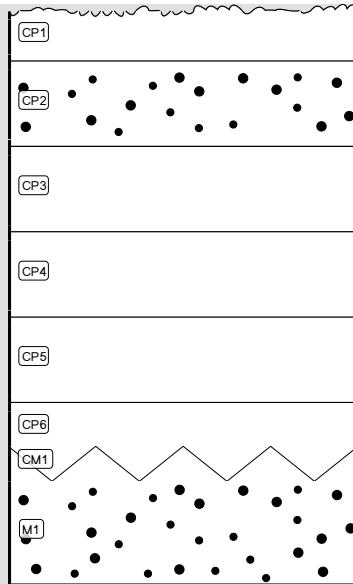
Fig. 4: Stratigraphic representation of the object in cross-section using the MiCorr application. This representation can be compared to Fig. 8.
