TANG FRAGMENT OF A KNIFE HR-6246 - TIN BRONZE - LATE BRONZE AGE - SWITZERLAND

Artefact name	Tang fragment of a knife HR-6246
Authors	Marianne. Senn (EMPA, Dübendorf, Zurich, Switzerland) & Christian. Degrigny (HE-Arc CR, Neuchâtel, Neuchâtel, Switzerland)
Url	/artefacts/322/

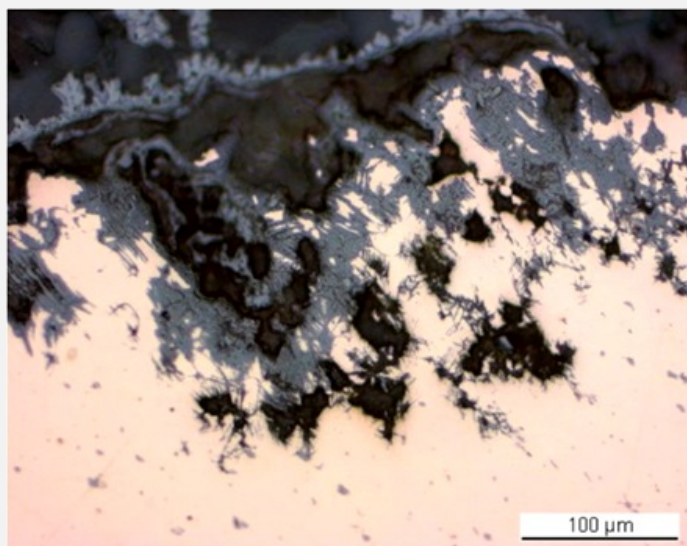
Fig. 5: Micrograph of the metal sample from Fig. 3 (inverted and reversed picture, detail), unetched, bright field. Corrosion products are in dark-grey whereas the metal is in pink. Slip lines are outlined by the development of intergranular corrosion,

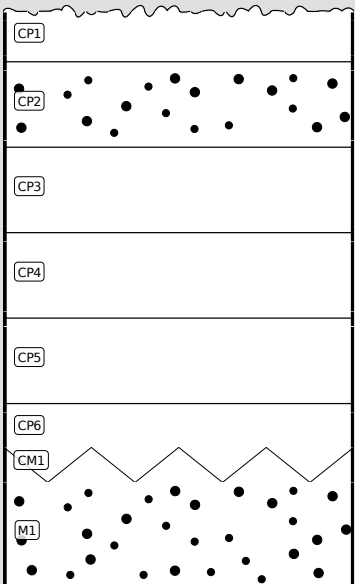
Fig. 4: Stratigraphic representation of the object in cross-section using the MiCorr application. This representation can be compared to Fig. 8.
