TANG FRAGMENT OF A KNIFE HR-6246 - TIN BRONZE - LATE BRONZE AGE - SWITZERLAND

Artefact name Tang fragment of a knife HR-6246

Authors Marianne. Senn (EMPA, Dübendorf, Zurich, Switzerland) & Christian. Degrigny (HE-Arc CR, Neuchâtel, Neuchâtel,

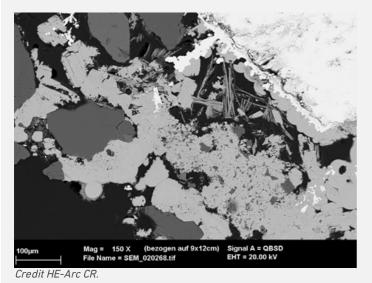
Fig. 10: SEM image, similar to Fig. 9, BSE-mode,
